COMPLIANCE EVALUATION INSPECTION (CEI) REPORT

Name: **bioMérieux, Inc.**
EPA ID Number: **NCD982157125**
Type of Facility: Small Quantity Generator (SQG)
Facility Location: 100 Rodolphe St., Durham, NC 27712

4. DATE OF INSPECTION: **June 20, 2014** On-site: 10:15 hrs.
Off-site: 15:40 hrs.

BioMerieux - NCD982157125
100 Rodolphe St., Durham, NC
Compliance Evaluation Inspection – 6/20/14

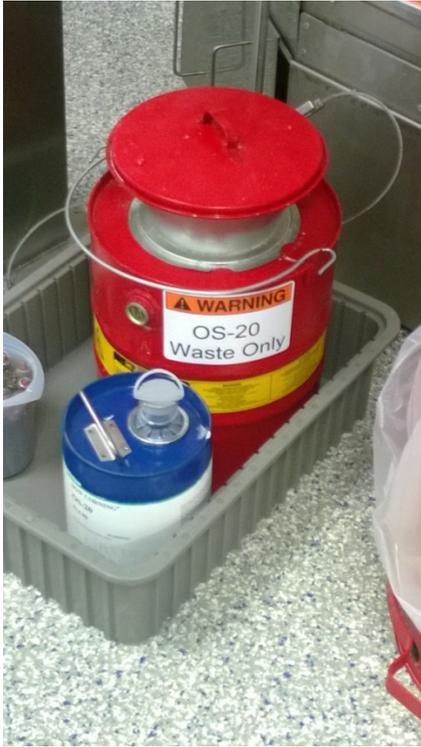
bioMérieux, Inc. is in violation of this regulation in that one 5-gallon container accumulating OS-20 waste (D001 Methyl Siloxane liquid waste) at Line 3 in the manufacturing area was not properly closed. The container had a custom fitted funnel attached to it and an oversized lid on the funnel. The lid was not and could not be properly secured to the funnel. Therefore, the container is considered open by the fact that liquid waste would spill out if the container were to be knocked on its side. Picture 1.

Picture 1. - One 5-gallon container accumulating OS-20 waste (D001) at Line 3 in the manufacturing area was not properly closed. The container had a custom fitted funnel attached to it and an oversized lid on the funnel. The lid was not and could not be properly secured to the funnel.

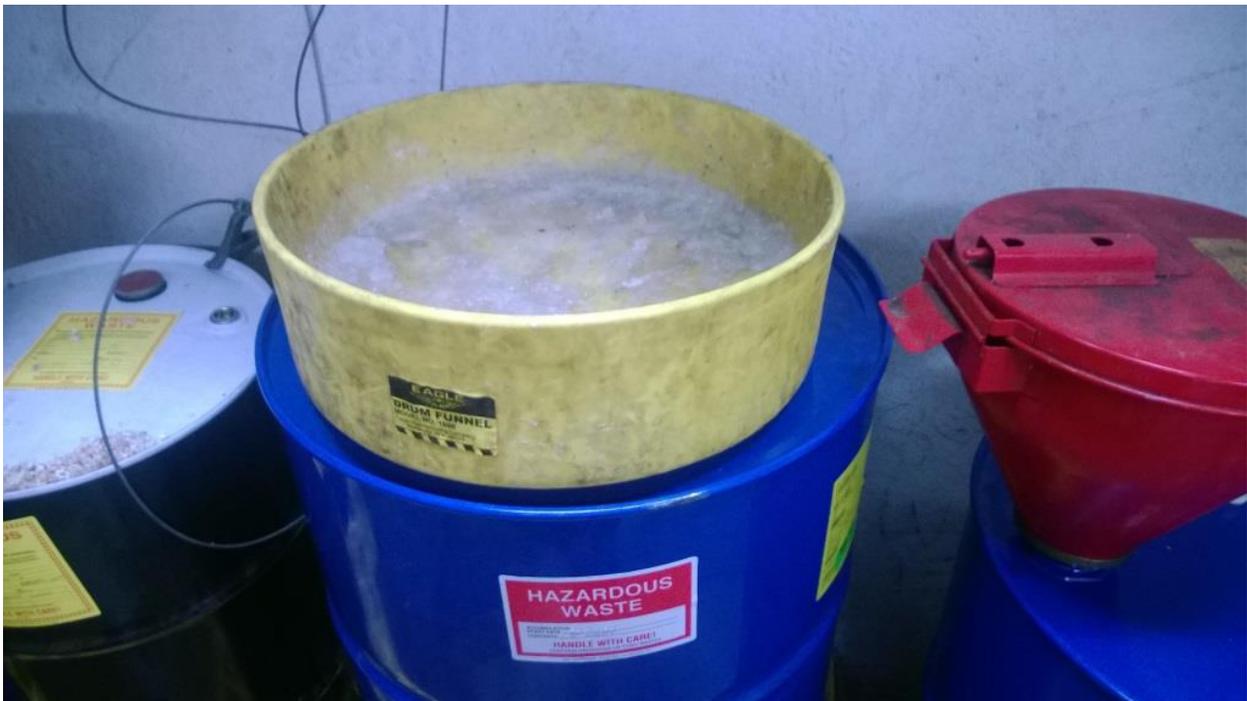
bioMérieux, Inc. is in violation of this regulation in that one 55-gallon steel container holding an adhesion promoter waste (AP-Waste) was observed with a wide-diameter drum funnel placed in the bung hole. The funnel had no lid on it and is designed to sit on top of the drum without threading it into the bung hole. Therefore, the container was considered open. AP-waste is a D003-reactive hazardous waste. In addition, the inside surface of the funnel and one 1-gallon container used to pour the AP-waste into the 55-gallon container had a significant amount of the adhesive waste adhered to the

Picture 2. - One 55-gallon steel drum (blue) holding AP- Adhesion Promoter waste (a D003-reactive hazardous waste) was observed with a wide-diameter drum funnel placed in the bung hole. The funnel had no lid on it and is designed to sit on top of the drum without threading it into the bung hole. Therefore, the drum was considered open.

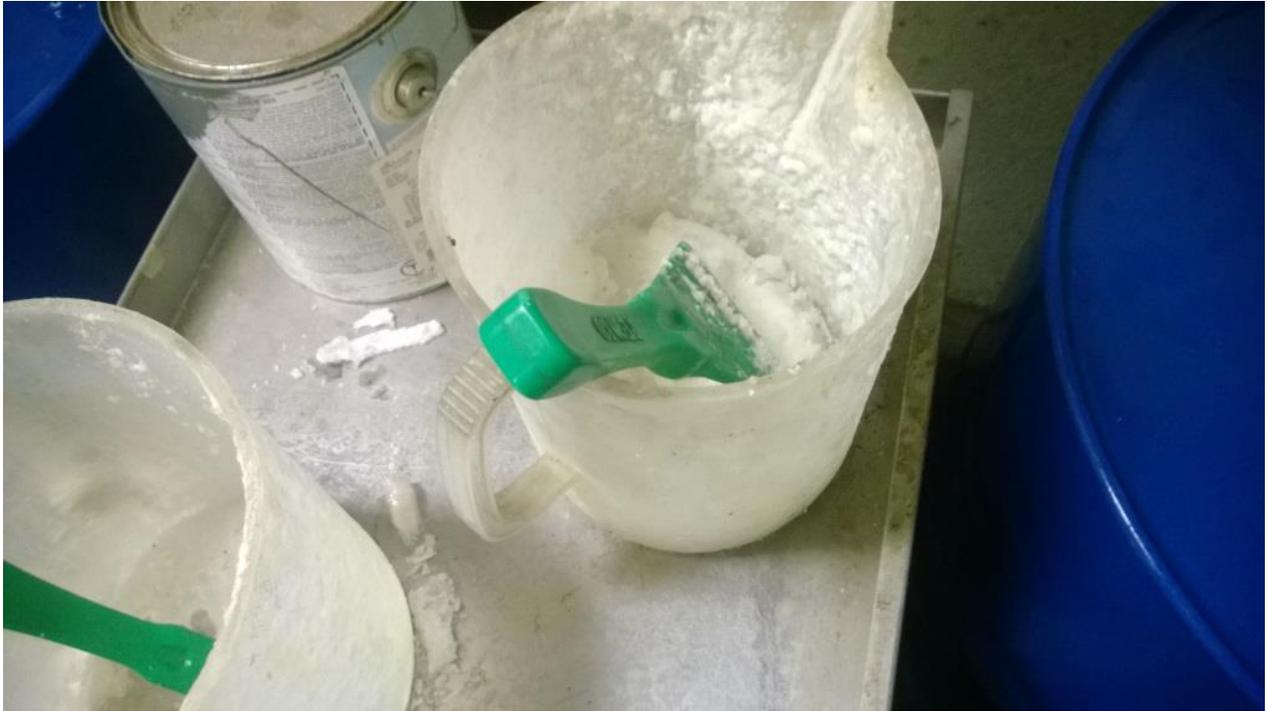
surface. The pour off container had approximately one cup of AP-waste that had solidified at the bottom of it. Therefore, it was also considered an open container. Pictures 2 & 3.

Picture 3. – One pour off container had approximately one cup of AP-waste that had solidified at the bottom of it. Therefore, it was also considered to be an open container holding hazardous waste. It was not properly marked with the words “Hazardous Waste” or an accumulation start date.

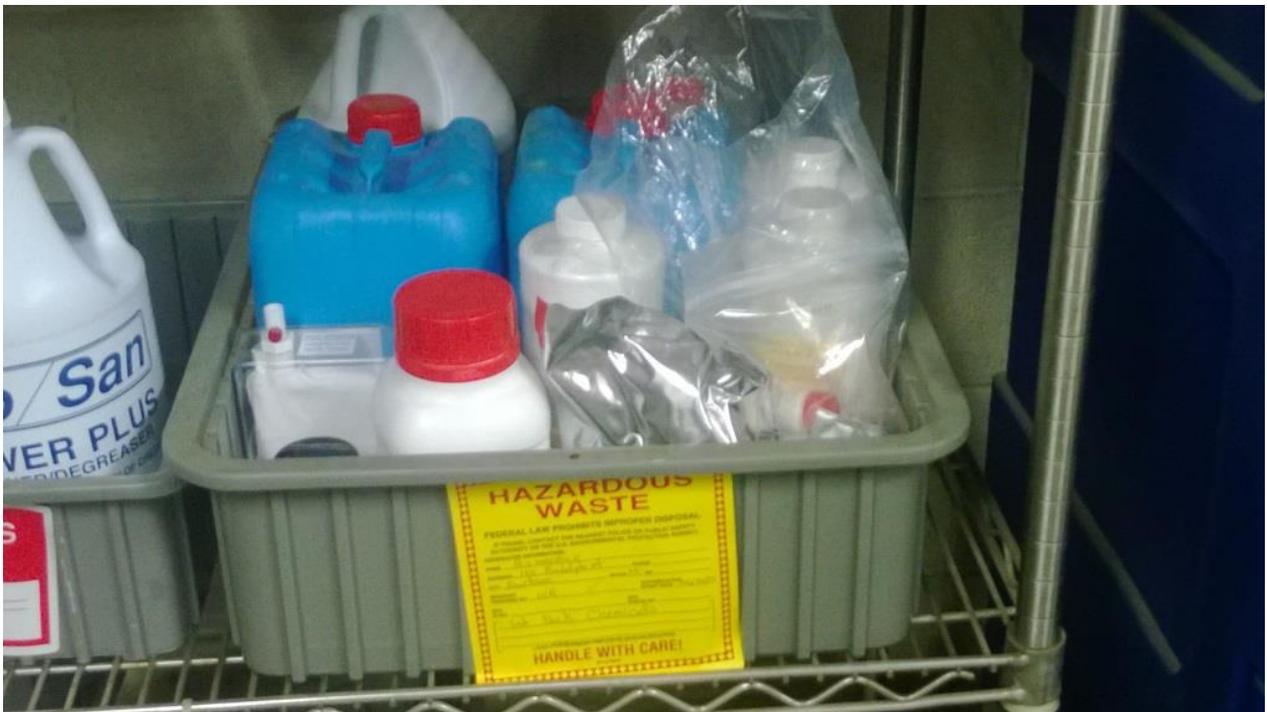
bioMérieux, Inc. is in violation of this regulation in that the facility did not mark two containers in the hazardous waste storage area with an accumulation start date. The containers held a combined total of 7kg (~1.75 gallons) of RBS 35 Detergent, a D002 corrosive and D003 reactive waste. The two containers not marked with an accumulation start date were sitting in a secondary containment bin with 12 other small containers. The other containers in the bin were determined not to be hazardous waste. A hazardous waste label with a start date of accumulation marked on it was placed on the side of the open bin, but not on the subject hazardous waste containers. In addition, one 55-gallon container holding AP-waste located in the hazardous waste storage area was not marked with an accumulation start date. Picture 4.

bioMérieux, Inc. is in violation of this regulation in that the facility did not mark two containers in the hazardous waste storage area with the words "Hazardous Waste". The containers held a combined total of 7kg (~1.75 gallons) of RBS 35 Detergent, a D002 corrosive and D003 reactive waste. In addition, one 55-gallon container holding AP-waste located in the hazardous waste storage area was not marked or labeled with the words "Hazardous Waste". Picture 4.

Picture 4. – Two containers in the bin (shown on the right) located in the primary hazardous waste storage area were not marked with the words “Hazardous Waste” or the accumulation start date. The subject containers held 7 kg of RBS 35 Detergent, a D003 Reactive waste. It was determined that all other containers shown held non-RCRA regulated waste.

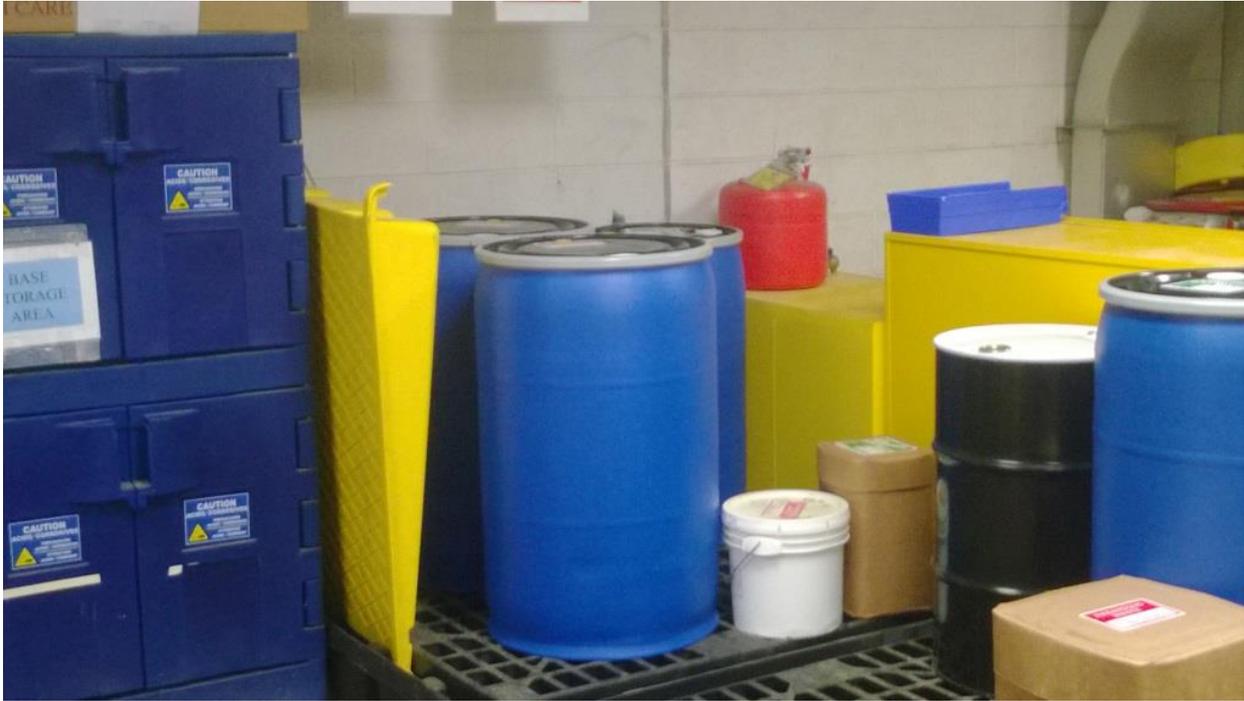
bioMérieux, Inc. is in violation of this regulation in that the facility failed to maintain two feet (24 inches) of aisle space between containers holding hazardous waste in the main hazardous waste storage area located at the waste dock. Pictures 5 & 6.

Picture 5. – An aisle space of 24” was not maintained between four containers holding hazardous waste located on the secondary containment pallets shown in the picture. Some of the containers shown above held non-RCRA regulated waste.

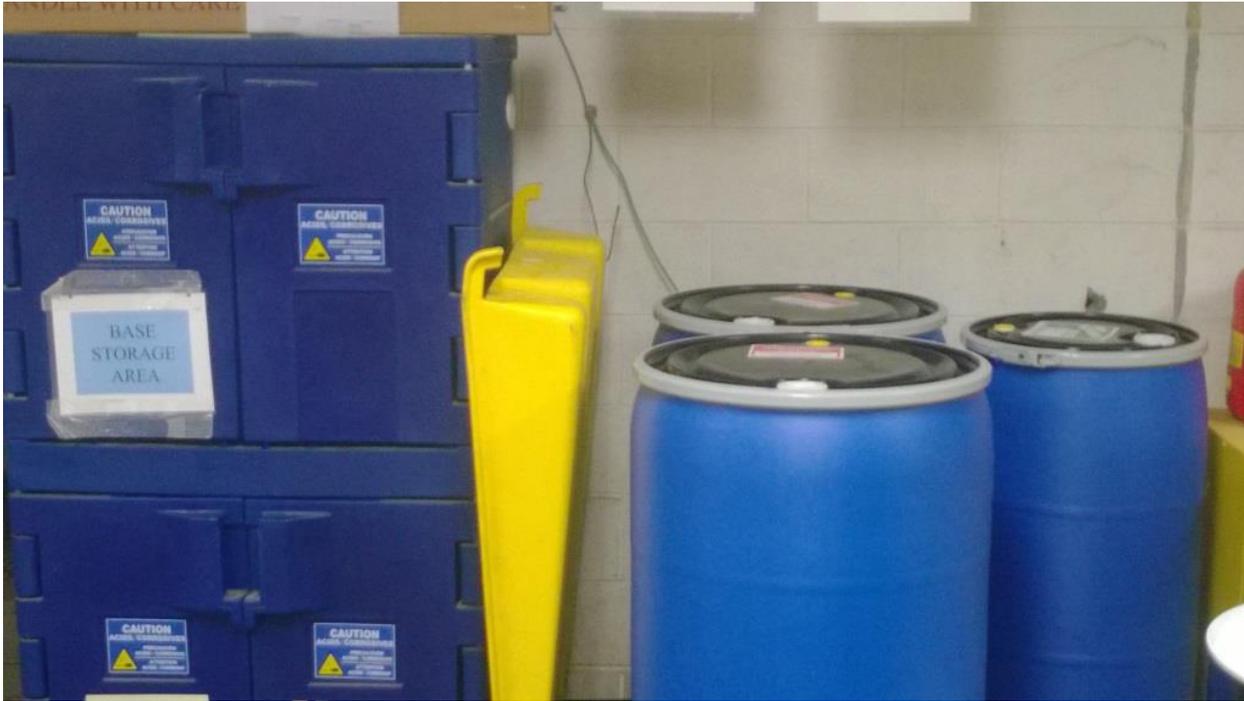
Picture 6. – An aisle space of 24” was not maintained between the two drums on the right of the picture. These are the same containers shown in Picture 5.

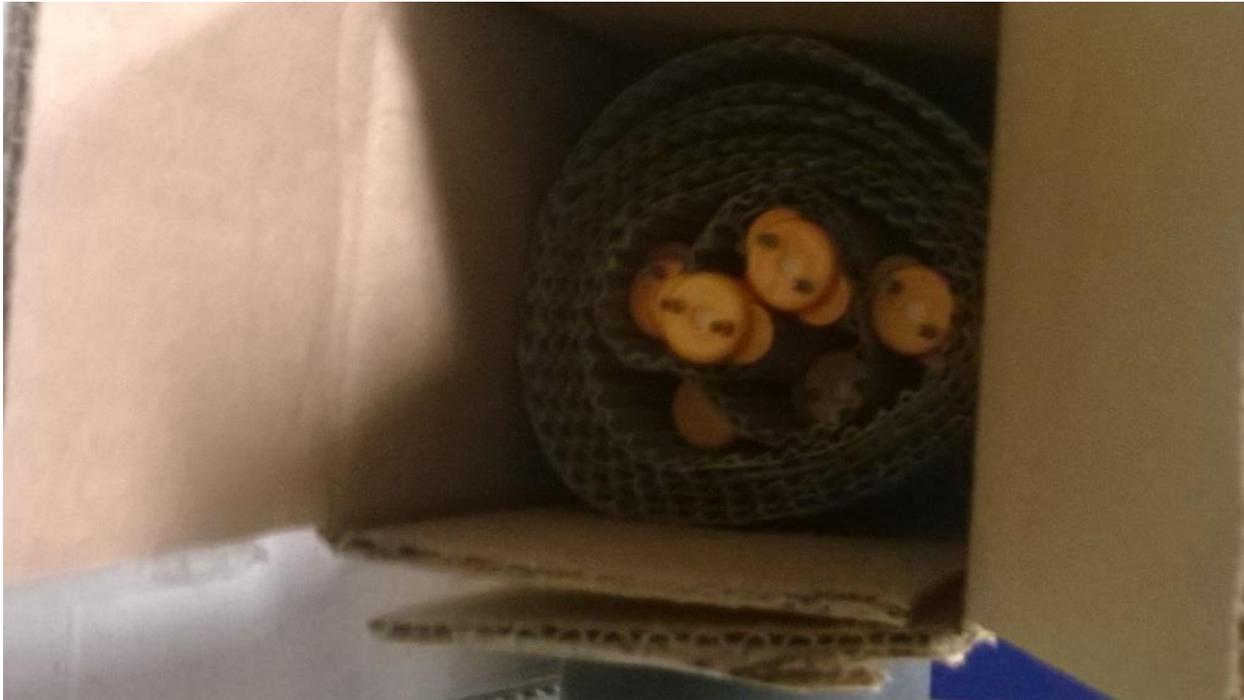
bioMérieux, Inc. is in violation of this regulation in that it failed to close one box holding six used UV lamps. Picture 7.

Picture 7. – A box holding six used UV lamps in the primary HW storage area was observed open.
