FACILITY COMPLIANCE INSPECTION REPORT
Division of Waste Management
Solid Waste Section

Date of Site Inspection: April 14, 2016 Date of Last Inspection: September 16, 2015

Gann Brothers Septic Tank Service, Inc.
367 Case Road
Madison, North Carolina 27025

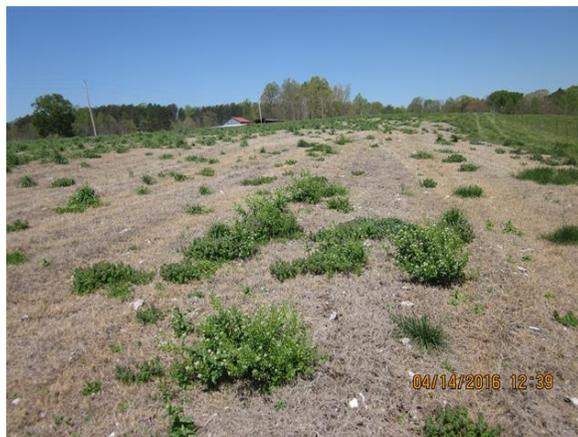
Gann Brothers Septic Tank Service, Inc. was in violation of 15A NCAC 13B .0838 (a)(7) because the approved Nutrient Management Plan (Plan) Section B paragraph 2 states in part: "In order for this fescue field to receive septage, a 80% stand should be maintained". Field 2 appeared to have less than 80% coverage of fescue. The other vegetation was either dormant, dead or damaged at the time of inspection.

8. There is no evidence of standing liquid or pooled waste. The waste appeared to be evenly distributed throughout the fields.
9. Dead, damaged or dormant areas & vegetation other than fescue was observed in Field 2.

Northern Section of Field 2

In order to come into compliance, Gann Brothers Septic Tank Service, Inc. must immediately follow the nutrient management plan for SLAS-79-04.

You can also contact the Rockingham County Cooperative Extension at 336-342-8230 for advice on field maintenance and weed control. If another cropping system other than fescue be desired or recommended, a revised Plan, written by a certified technical specialist, reflecting the change must be submitted. Contact Connie Wylie at connie.wylie@ncdenr.gov or 910-433-3352 to update the Plan.
