FACILITY COMPLIANCE INSPECTION REPORT
Division of Waste Management
Solid Waste Section

Date of Site Inspection: June 2, 2016 **Date of Last Inspection:** January 15, 2016

Halifax Coal Ash Landfill
 921 Liles Road
 Halifax, NC 27839

Comprehensive Inspection

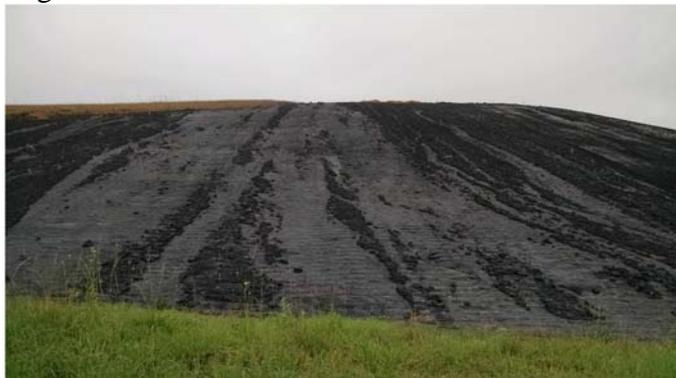
The northern slope of the landfill has had soil cover placed, and been graded and seeded per the Cover Plan. The western slope has been prepared for placement of intermediate cover (identified as Sequence No. 3B in the Cover Plan). Other slopes have been regraded to reduce erosion. **Continue to place intermediate cover on all slopes in accordance with the Cover Plan. Unresolved.**

Toe of the western slope; being prepared for cover

11. Heavy rains occurred the night before the inspection. Erosion was observed on side slopes such that coal ash had washed into perimeter ditches. During the August 10, 2015 inspection, significant erosion was observed on side slopes such that coal ash had washed into perimeter ditches and had washed into the sediment basin. On October 20, 2015 the Division of Waste Management, Solid Waste Section (Section) received *Halifax County Ash Monofill (NC Permit 42-04-INDUS-1994), Conceptual Filling and Intermediate Cover Plan*, prepared for Halifax County, prepared by Smith-Gardner. On October 22, 2015, the Solid Waste Section concurred with the plan. The northern slope of the landfill has had soil cover placed, and been graded and seeded per the plan. The western slope has been prepared for placement of intermediate cover (identified as Sequence No. 3B in the Cover Plan). Intermediate cover is scheduled to be placed by the end of July 2016. Other slopes have been regraded to reduce erosion. **Continue to place intermediate cover on all slopes in accordance with the Cover Plan.**

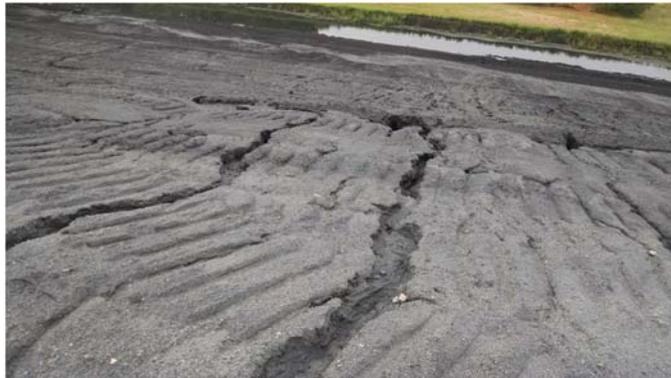
Erosion on southern slope after heavy rains

12. As a reminder, per Permit to Operate, Condition # 59 “Ash which has been placed to final elevations around the perimeter of the facility must be covered with a minimum of 12 inches of soil. Final cover and seeding must be implemented within 30 days of an area reaching final grade.” Additionally, per 15A NCAC 13B .0505(3)(c) “After final termination of disposal operations at the site or a major part thereof, or upon revocation of a permit, the area shall be covered with at least two feet of suitable compacted earth.”
