**FACILITY COMPLIANCE INSPECTION REPORT**  
**Division of Waste Management**  
**Solid Waste Section**

Pearman Quarry Road LCID Landfill  
7612 Pearman Quarry Road  
Kernersville, NC 27284

Comprehensive Inspection (to ensure that the notified land clearing and inert debris (LCID) landfill is in compliance with 15A North Carolina Administrative Code (NCAC) 13B .0563, .0564, and .0566)

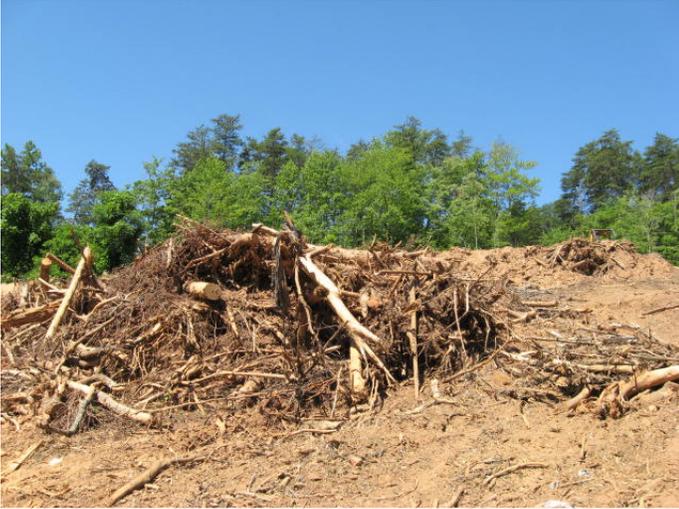
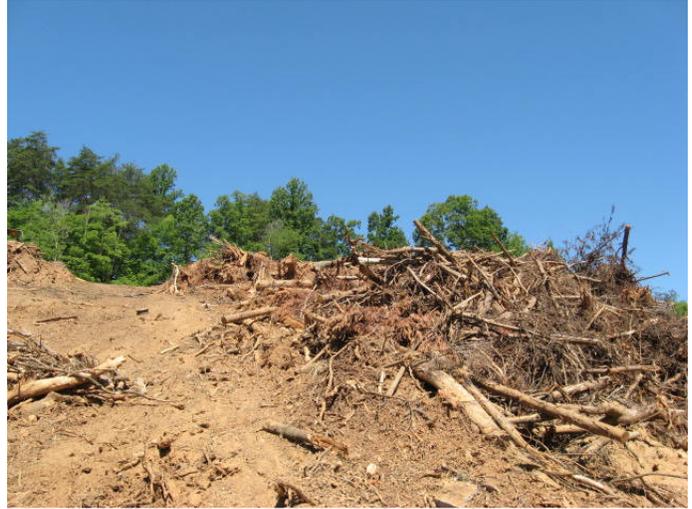
6. Mr. Richardson stated that LCD on site has been received within the last month.
7. The facility has been working across the landfill, from top to bottom. It was stated that the LCD will be moved to create a lift, stepped along the rear side slope, and covered with soil.

Notified LCID landfill working face area
