FACILITY COMPLIANCE INSPECTION REPORT
Division of Waste Management
Solid Waste Section

Date of Site Inspection: June 14, 2016

Brame LCID Landfill
8735 Warner Road
Kernersville, NC 27284

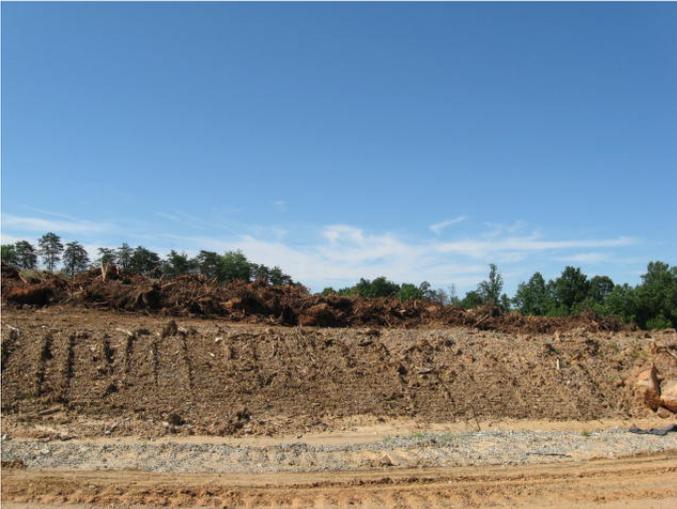
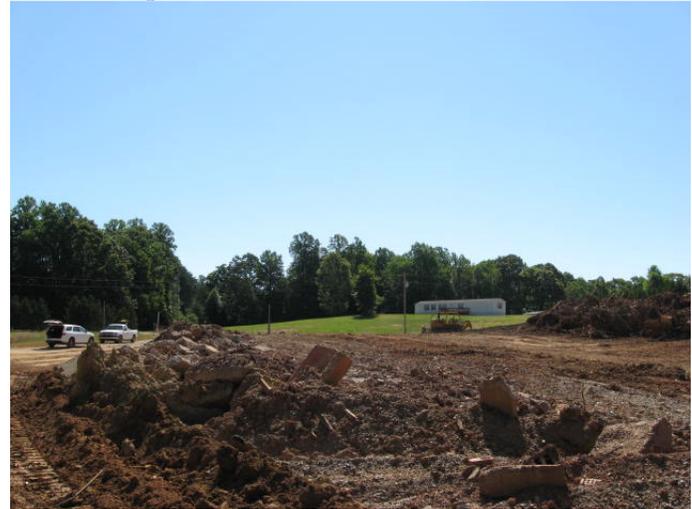
8. Side slopes should be graded such that a 3:1 slope ratio is obtained or a ratio of which no indication of erosion or runoff is observed.
9. The LCID landfill has edge of waste markers (white plastic pipe) along the side slope.

LCID landfill side slope

13. Rebar shall be removed from concrete prior to being placed in the LCID landfill.
14. Mr. Lilly stated that the steel parking bollards dumped at the side slope will be removed.

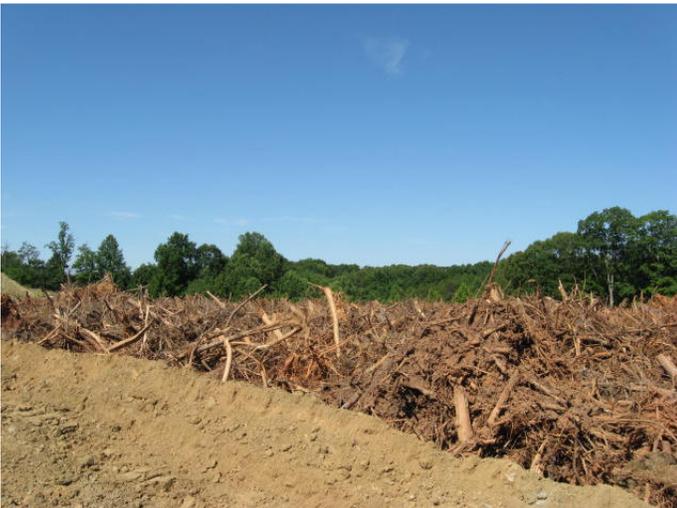
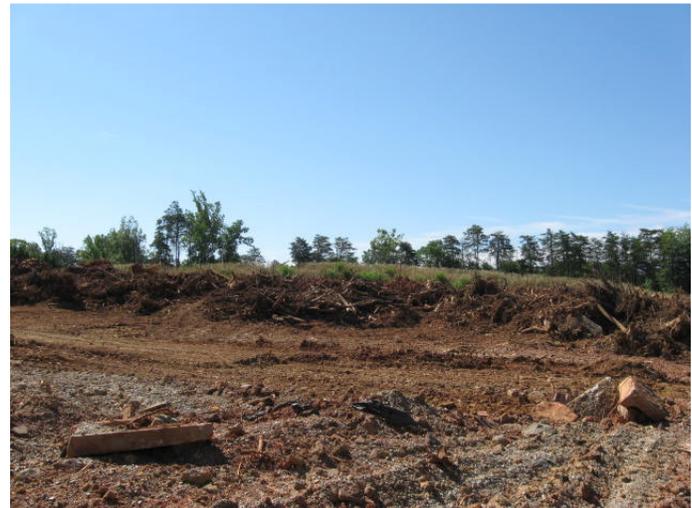
4. The LCID landfill is primarily used by the grading company.
5. Mr. Lilly stated that land clearing debris (LCD) on site has been received within the last month and is positioned to be covered with soil in the next few days.

LCD to be covered with soil

6. Per 15A NCAC 13B .0566(3), "Solid waste shall be restricted to the smallest area feasible and compacted as densely as practical into cells."
7. Per 15A NCAC 13B .0566(4), "Adequate soil cover shall be applied monthly, or when the active area reaches one acre in size, whichever occurs first."
