FACILITY COMPLIANCE INSPECTION REPORT
Division of Waste Management
Solid Waste Section

Date of Inspection: 7 June 2016

MCAS Cherry Point Transfer Station
Mockingbird Road
MCAS Cherry Point, NC 28533

Partial Facility Compliance Inspection without records review

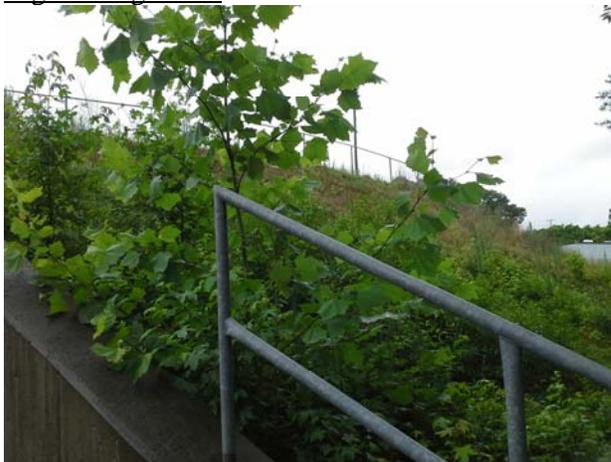
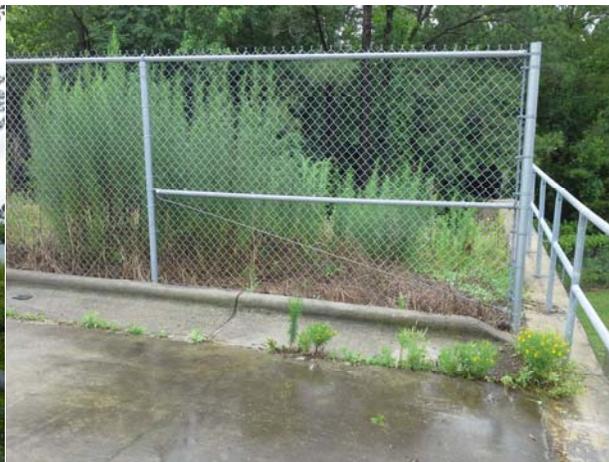
- 14) This Facility manages +/-20 tons of solid waste per day.
- 15) Access around the Facility is generally stable with a healthy cover crop of native warm season grasses established to prevent erosion. Please continue to monitor and maintain this cover crop on all Facility slopes. Small trees and other woody vegetation was observed growing on the Facility sideslopes. \*Please remove all small trees and woody vegetation and establish a mowing/maintenance schedule that prevents this type of vegetative growth.

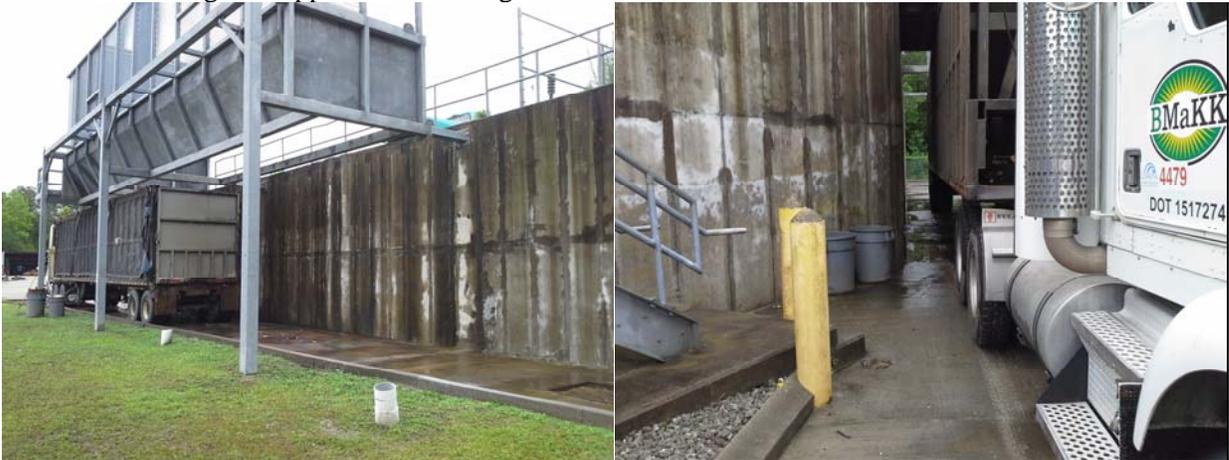
- 21) Windblown debris was minimal and no windblown debris was noted as leaving the Facility during this Facility Compliance Inspection. Windblown debris is being well managed at this time.
- 22) The trailer loading area appears well managed at this time.
