FACILITY COMPLIANCE INSPECTION REPORT
Division of Waste Management
Solid Waste Section

Date of Site Inspection: June 8, 2016

Dunn-Erwin C&D Landfill
449 Daniels Road,
Dunn, NC 28334

Partial audit

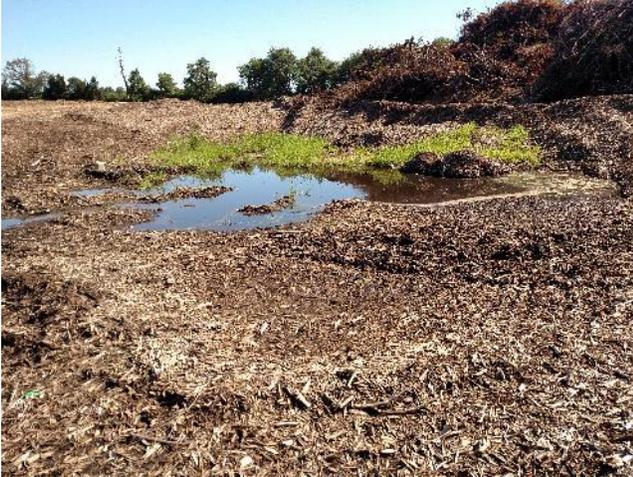
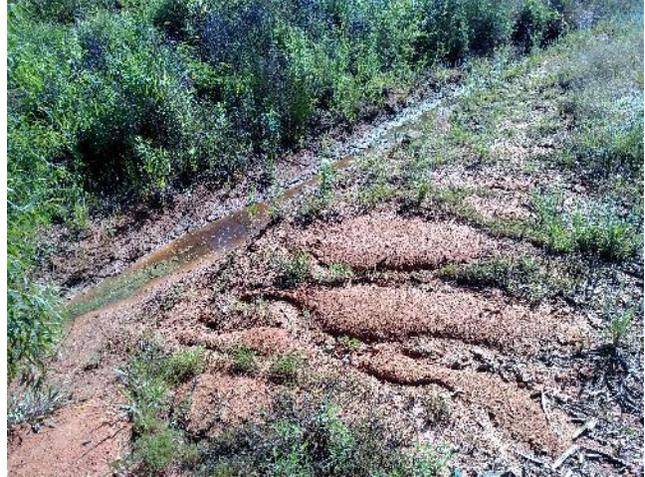
Per 15A NCAC 13B .0566(14), states “Leachate shall be properly managed on site through the use of current best management practices.”

Leachate was running out of the yard waste area and from the mulch windrow being stored on top of the LCID to the southern ditch behind the LCID, running to drain pipe and possibly into wetlands. Leachate flow needs to be stopped immediately.

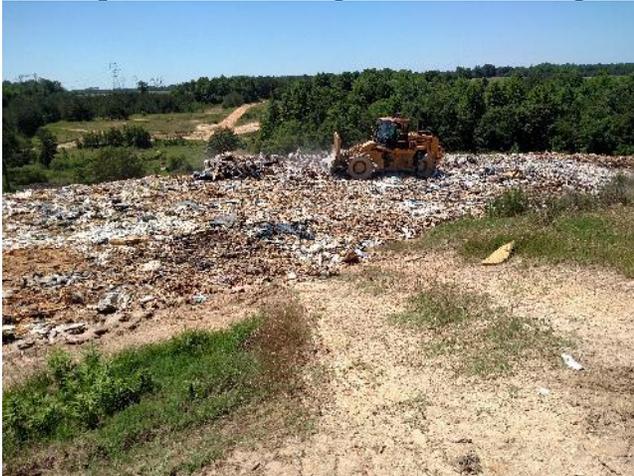
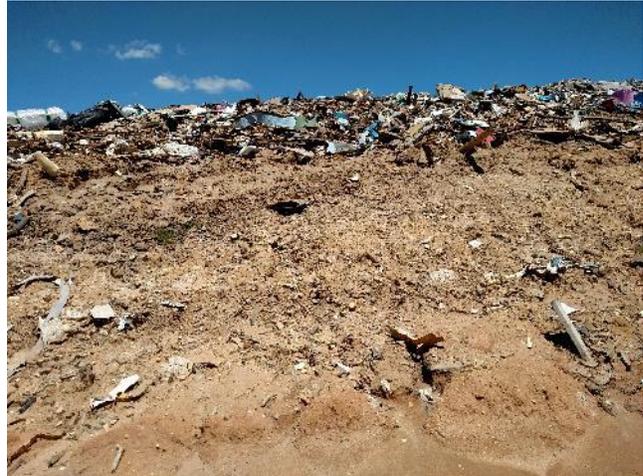
Per 15A NCAC 13B .0542(f)(1), states “(f) Cover material requirements. (1) Except as provided in Subparagraph (3) of this Paragraph, the owners and operators of all C&DLF units must cover the solid waste with six inches of earthen material when the waste disposal area exceeds one-half acre and at least once weekly. Cover must be placed at more frequent intervals if necessary to control disease vectors, fires, odors, blowing litter, and scavenging. A notation of the date and time of the cover placement must be recorded in the operating record as specified in Paragraph (n) of this Rule.”

At time of inspection the working face was exceeding one-half acre in size.

6. **C&DLF units must restrict solid waste into the smallest feasible area. Solid waste must be compacted as densely as practical into cells. I recommend that you devise a method to ensure that the working face does not exceed the ½ acre limit.**

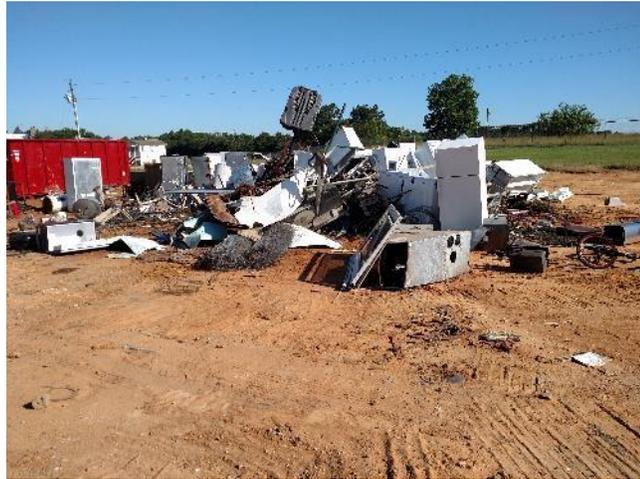
White goods and scrap metal area

10. Per permit condition #90 under Operational Conditions – White Goods and Scrap Metal Handling Area, The permittee must separately store white goods containing Freon from the non-Freon white goods and scrap metals. White goods need to be stored standing up to prevent standing water inside and vectors.

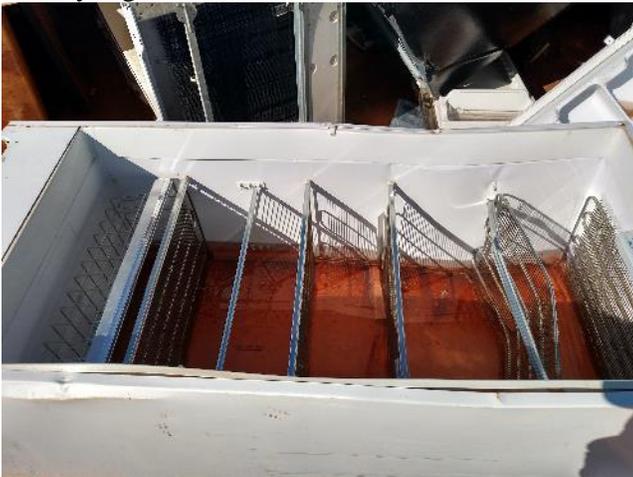
Standing water in white good

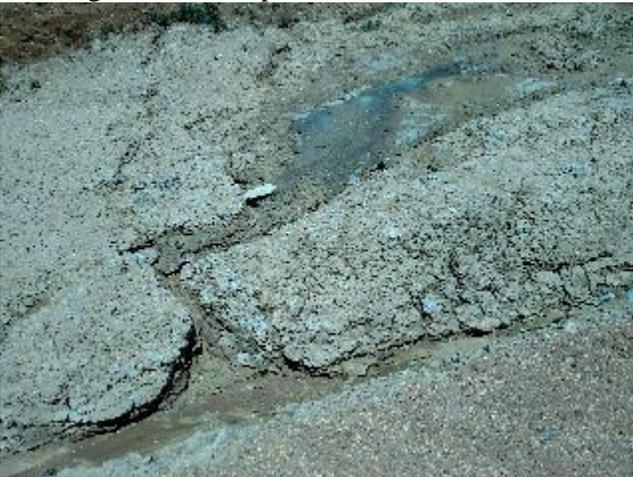
13. **Several leachate seeps were observed along the eastern and southern side slopes draining into the perimeter drainage channel. The flow appeared to terminate before flowing into a drain leading the sediment pond outside the waste footprint. Seeps observed during the operator’s in-house inspections must be repaired as soon as practical when they are observed. Repair every leachate seep draining into the perimeter channel on the south side of the landfill. Areas where persistent seeps are occurring need to be investigated to determine the cause and corrective actions implemented to eliminate the problem.**

Leachate seep on south side of landfill

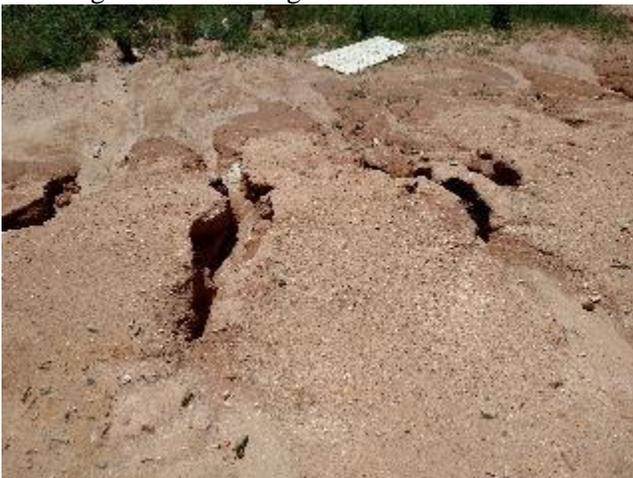
8. **Significant areas of erosion were noted on side slopes.**
9. The waste type was reviewed and was construction and demolition waste. No unacceptable waste streams were noted.

Area of erosion on southwestern slope

7. **Adequate sediment control measures consisting of vegetative cover, materials, structures or devices must be utilized to prevent excessive on-site erosion of the C&DLF facility or unit. Additional areas of waste outside the working face were exposed and needed additional cover. Areas that become uncovered from other activities or erosion need to be covered as they are noticed.**

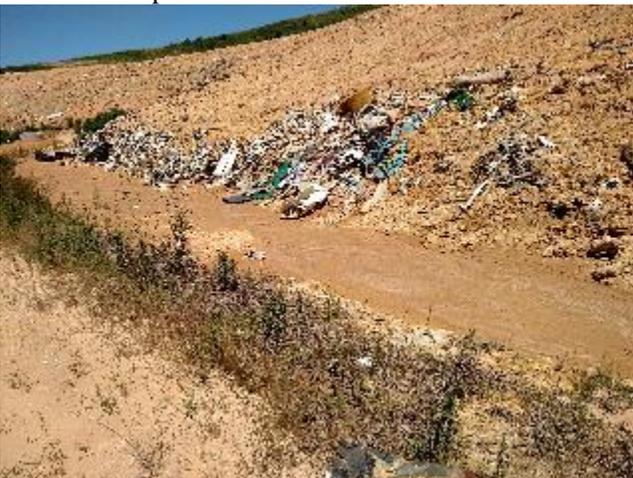
Uncovered waste on western slope of landfill
