**HAZARDOUS WASTE SECTION - COMPLIANCE BRANCH
FILE TRANSMITTAL & DATA ENTRY FORM**

Facility Name: Compaero, Inc.

Document Type: I - Complaint Investigation (CMP)

File Description/Comments: Used Oil complaint. No violations cited.

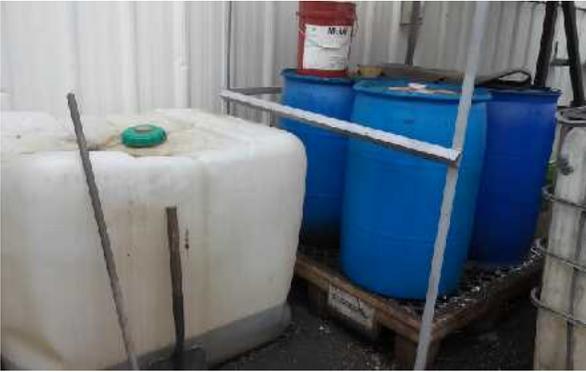
Photo 1

NOTES 4/7/2016: Four unlabeled 55-gallon containers of used oil and One unlabeled approximately

Noble oil picks up used oil at the facility approximately two times a year. During the inspection, four 55-gallon containers of used oil and one approximately 250-gallon tote of used oil were observed staged outside on pavement. All five used oil containers were unlabeled. Mr. Small was directed to label each used oil container as "used oil". During the inspection, four approximately 250-gallon open top totes containing metal turnings from facility manufacturing activities were observed stored outside on pavement in the same area as the used oil containers. One of the metal turning totes was leaking coolant oil from a closed valve on to the pavement. Mr. small was directed to clean up any used oil (used coolant) spills and insure that the used turnings oil is properly contained and any spills cleaned immediately. Mr. Small was requested to provide photo documentation that the used oil containers were labeled properly and that the spills in the areas of the turning we're also cleaned up.

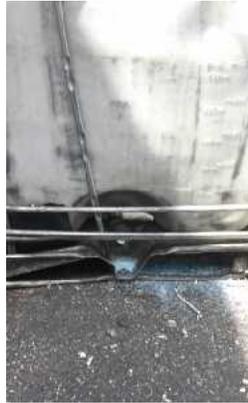
Photo 2

NOTES 4/7/2016: Turning coolant oil leaking out of a closed valve from an approximate 250-gallon IBC

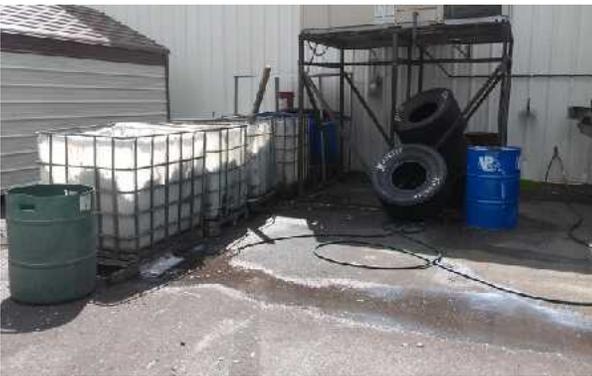
Photo 3

NOTES 4/7/2016: Outside area where metal turnings in IBC totes and used oil is stored.

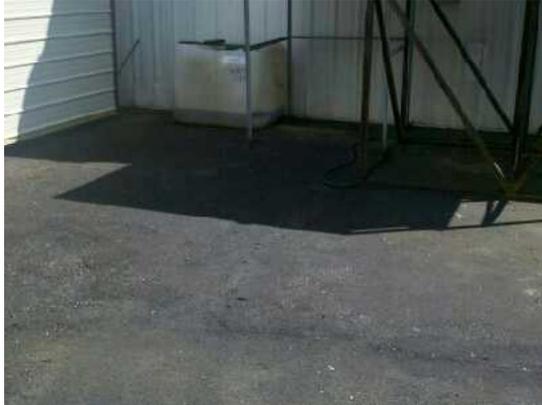
Photo 4

NOTES 4/7/2016: Photo from Mr. Small: Outside area where metal turnings and used oil was staged

On 4/7/2016, Mr. Small provided a pictures of the outside used oil and metal turning staging area after cleaned up activities. Mr. Small also provided pictures of the used oil containers properly labeled and a brief outline of plans to manage the area and prevent spills for the area.
