FACILITY COMPLIANCE INSPECTION REPORT
Division of Waste Management
Solid Waste Section

Date of Site Inspection: April 19, 2016

Veach LCID Landfill
4261 Old Thomasville Road, Winston-Salem, Davidson County

Partial Inspection

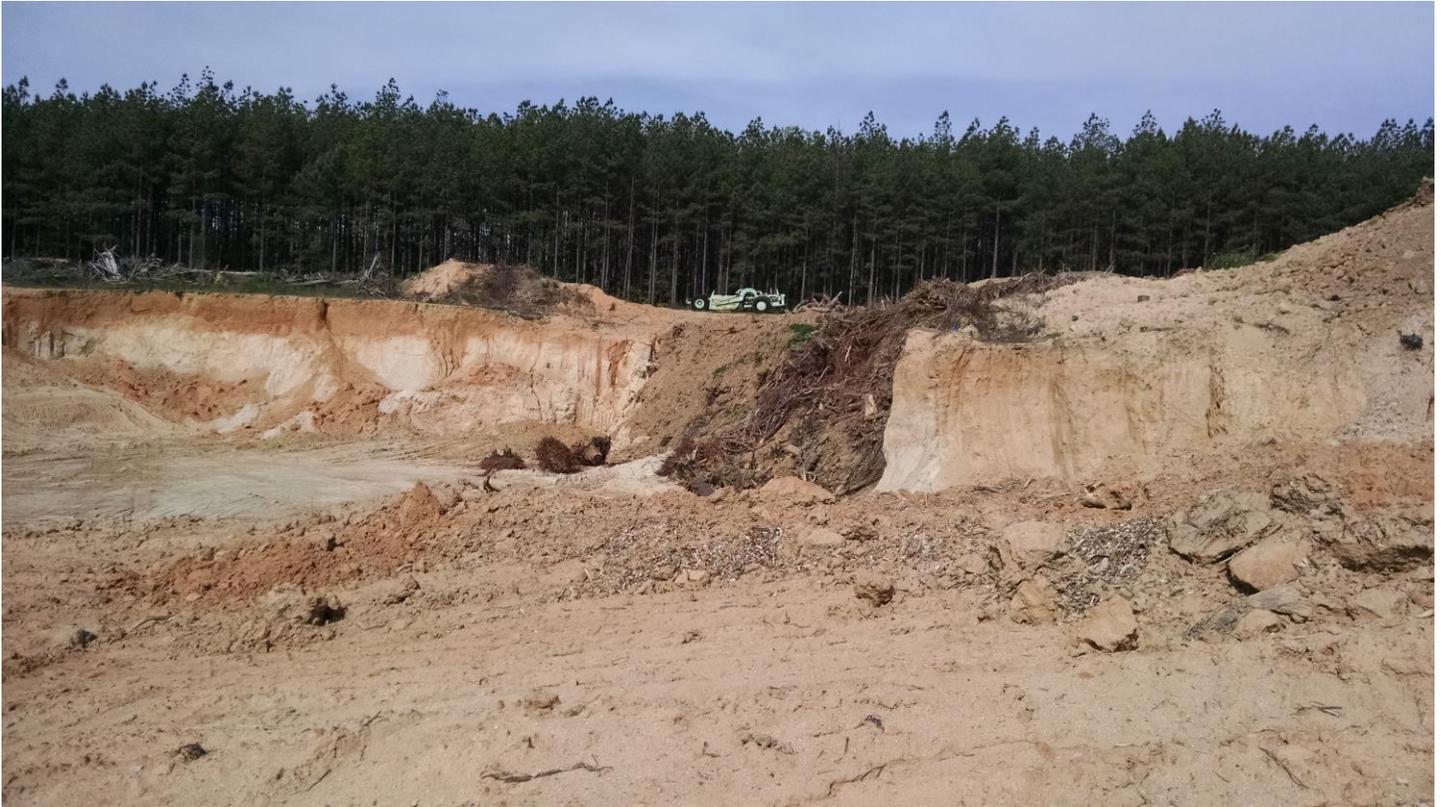
13. Clean soil for use as cover is stored adjacent to the working face.
14. At the time of this inspection, the working face appeared to have been adequately covered recently.

16. The current working face was observed to be near vertical at the time of the inspection. In order to prevent fire, achieve maximum compaction, and allow the safe operation of equipment on the working face, the slope should not exceed a ratio of 3:1 as required by PART I, item 8 of the facility Permit to Operate.

Current working face with recently covered area to the left.

17. Ensure that excavation, grading and fill material side slopes do not exceed a ratio of 3:1.
18. Ensure that waste being landfilled is restricted to the smallest area feasible and compacted as densely as practical into cells, as provided for in 15A NCAC 13B .0566(3).
