## FACILITY COMPLIANCE INSPECTION REPORT

### Division of Waste Management Solid Waste Section

**Date of Site Inspection:** June 2, 2016

BB Pierce Coal FlyAsh Structural Fill Site  
301 River Road  
Weldon, NC 27890

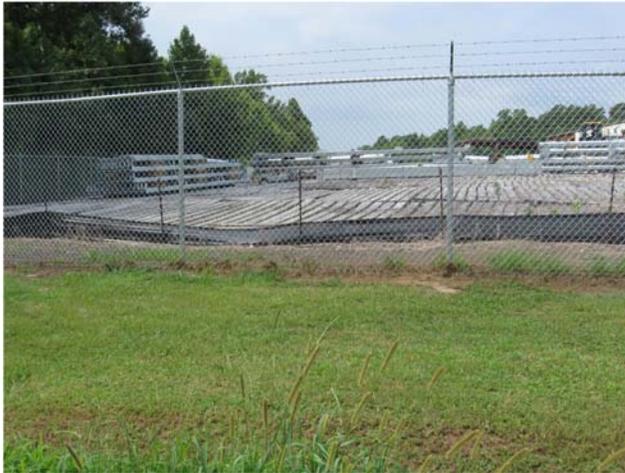
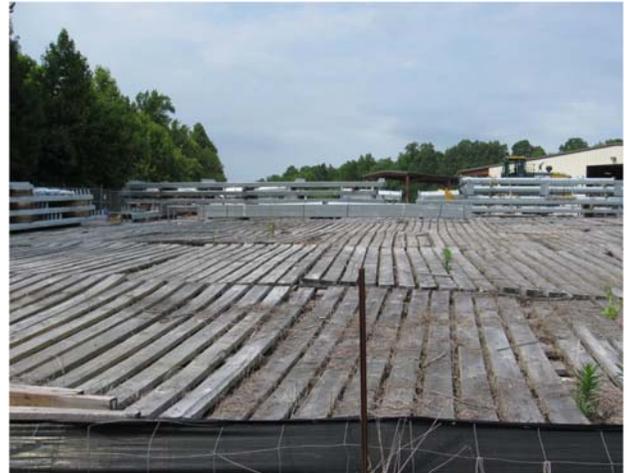
Pictures taken July 27, 2015 - Decking covering most of the site.

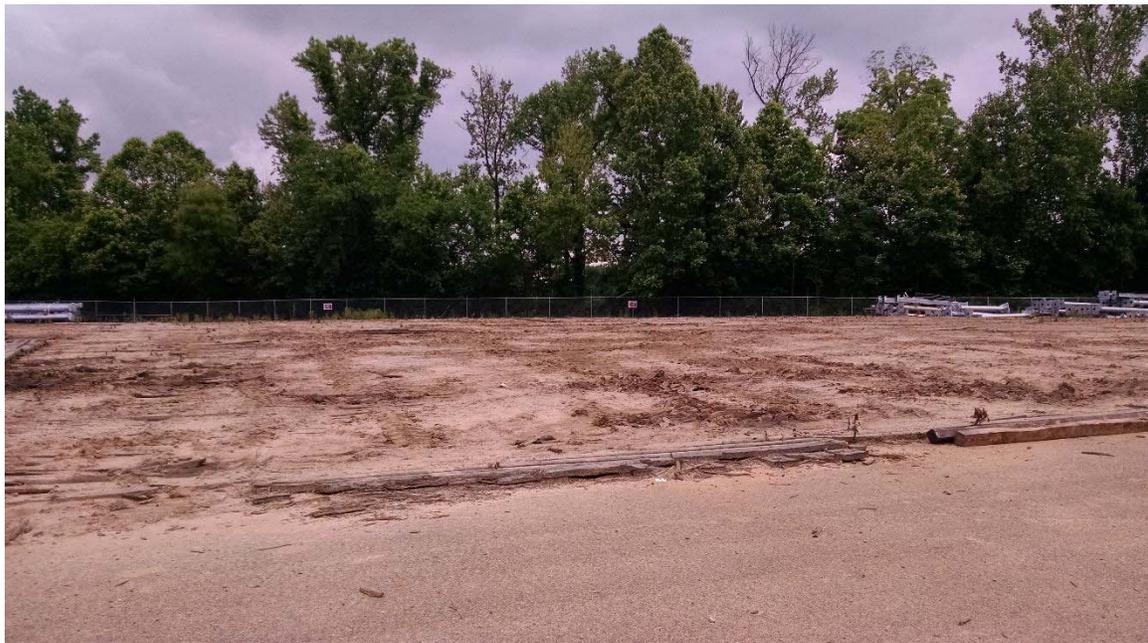
1. Most of the wood decking on previously covering the unpaved portion of the site appears to have been removed. No coal ash was observed in the bare areas however the soil was rutted from vehicle tires. **Proper grading should be maintained to prevent ponding of water over the structural fill and minimize erosion.**

Picture taken June 2, 2016 – Decking has been removed

2. **If the unpaved portion of the structural fill is to be used for vehicular traffic, the area should be either paved or graveled and maintained to prevent exposure of the underlying coal ash.**
