March 28, 2016
Project #15-072

RE: Phase I Environmental Site Assessment Supplemental Findings
West Salem Square
1001 Marshall Street, SW
Winston-Salem, North Carolina 27101

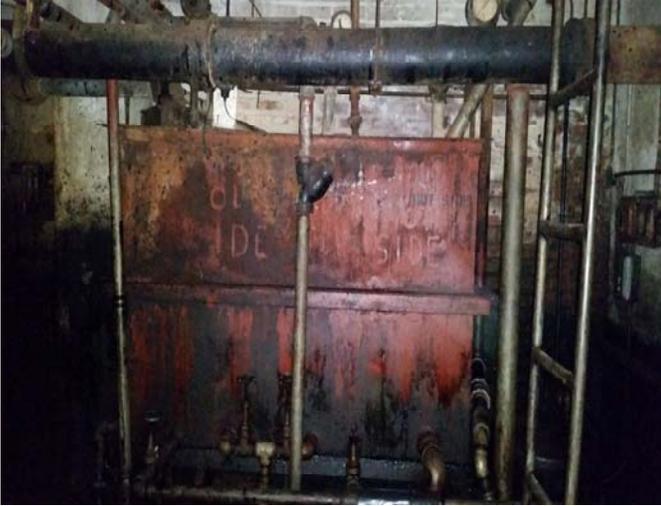
Photograph 1 – Steam Process Tank

It is noted that during our inspection of the subsurface mechanical rooms and vault, the rooms and vault are constructed of reinforced concrete. No evidence of cracking or failure of the concrete was observed; reducing the likelihood that the CoC migrated beyond the confines of these rooms. The probable cause of the oil and water that was contained within in these rooms and vault is due to gravity draining of water from the boiler(s) and associated piping when the boiler(s) were taken out of service. Likewise, the oil contained within the water is believed to be from the fuel lines that were disconnected from the AST and steam process tank during boiler(s) decommissioning.

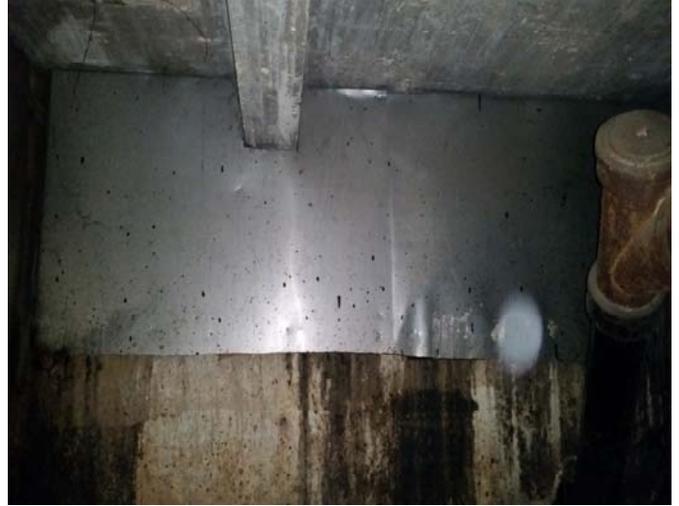
Photograph 2 – Metal Sheeting to Outside

During our re-inspection, organic vapor readings were collected continuously from within and immediately outside the mechanical room utilizing a PID (Photo-Ionization Detector). PID readings held a consistent 4 ppm within the mechanical room and 1 to 2 ppm outside the mechanical room. The CoC (Contaminant of Concern) is believed to be #6 fuel oil. Fuel oil is categorized as an aliphatic paraffin containing minor quantities of PAHs (Poly Aromatic Hydrocarbons). OSHA (Occupational Safety and Health Administration) has not established any PEL (Permissible Exposure Limits) for #6 fuel oil; however, some PAHs are known carcinogens. The MSDS (Material Safety Data Sheet) for #6 fuel oil is attached for record. Based on our findings, potential fuel vapors emanating from the subterranean mechanical room and vaults can be mitigated by venting the mechanical room to the outside ambient air. Currently, sheet metal covers the upper portion of a concrete wall that separates the outside from this room. Removal of the sheet metal with replacement of a metal grate will sufficiently ventilate the rooms and vault; reducing organic vapors in this area of the facility to <1ppm. Upon removal of the sheet metal and installation of

the grate, air samples should be collected and analyzed for PAHs to document ambient air concentrations within the facility and insure that no PAHs exhibiting concentrations above OSHA PELs are present within the facility.

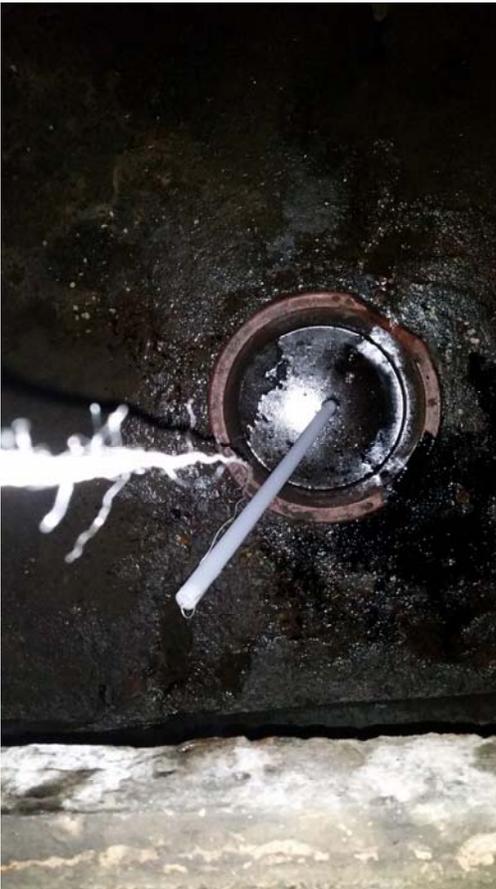
Photograph 3 – Concrete Bottom Sump in Vault

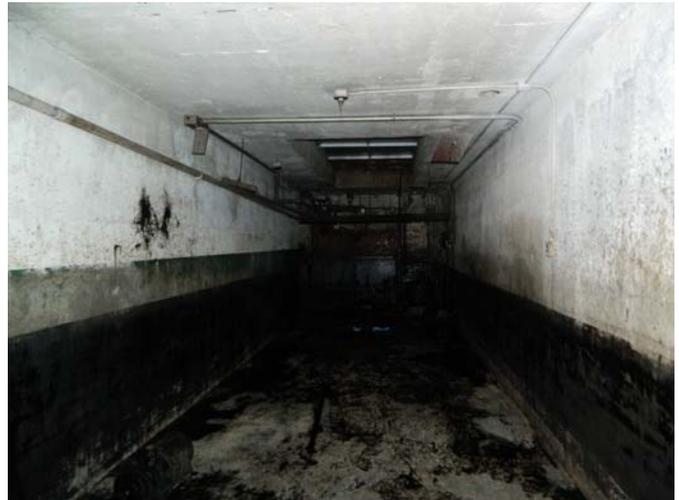
Photograph 4 – Mechanical Room Former AST Area

On March 15, 2016, Swift Creek Environmental, Incorporated re-inspected the facility to document current conditions. During our inspection it was determined that ECS Carolinas, LLP adequately cleaned and removed the oil containing materials from the submerged rooms and vault. Photographic documentation of the cleaned rooms and vault are attached. It is our belief that the primary purpose of the rooms and vault served as a mechanical room which housed a #6 oil AST, a steam process tank to facilitate in reducing viscosity in #6 oil utilized to supply fuel to the facility's boilers and an overflow vault to capture water from the condensed steam in the steam process tank overflow. The AST was believed to be located in the empty portion of the mechanical room. This is based on the presence of disconnected fuel lines exiting the steam process tank and ending abruptly overhead midway in the larger portion of the vacant room. Based on the arrangement of mechanical components contained within the mechanical room, it does not appear that any other ASTs or USTs (Underground Storage Tanks) were associated with the facility's heating system.
