**FACILITY COMPLIANCE INSPECTION REPORT**  
**Division of Waste Management**  
**Solid Waste Section**

**Date of Site Inspection:** June 2, 2016

Wayne Long Mini Storage  
Hwy 125  
Halifax, NC 27839

Coal Combustion Products Structural Fill constructed per 15A NCAC 13B .1700 Solid Waste Rules

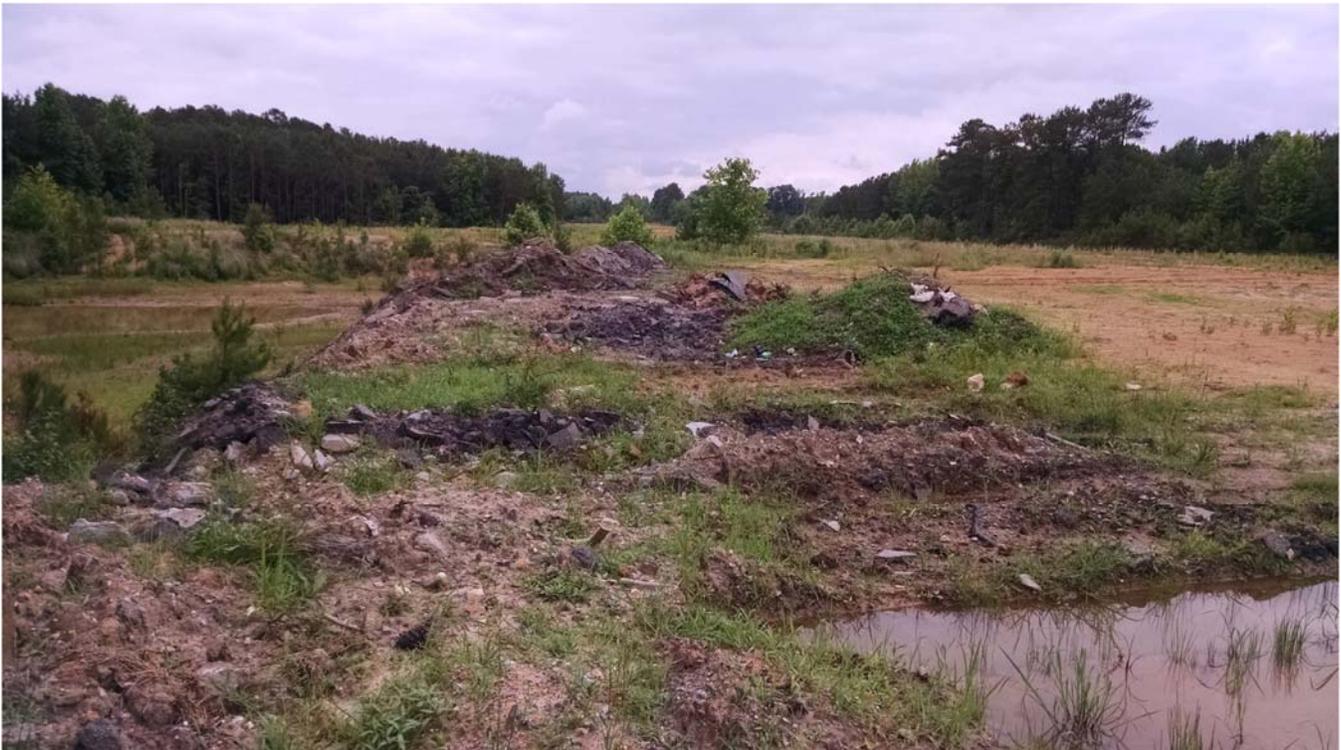
Standing water was observed on the structural fill at the time of the inspection. **UNRESOLVED**

1. 15A NCAC 13B .1705 (j) states All structural fills shall be covered with a minimum of 12 inches compacted earth, and an additional surface six inches of soil capable of supporting native plant growth. Additional soil appears to have been brought to the site. **Some vegetative growth was visible at the time of the inspection but additional seeding will be necessary to establish a vegetative cover capable of preventing erosion.**

Ponded water visible in lower right corner.

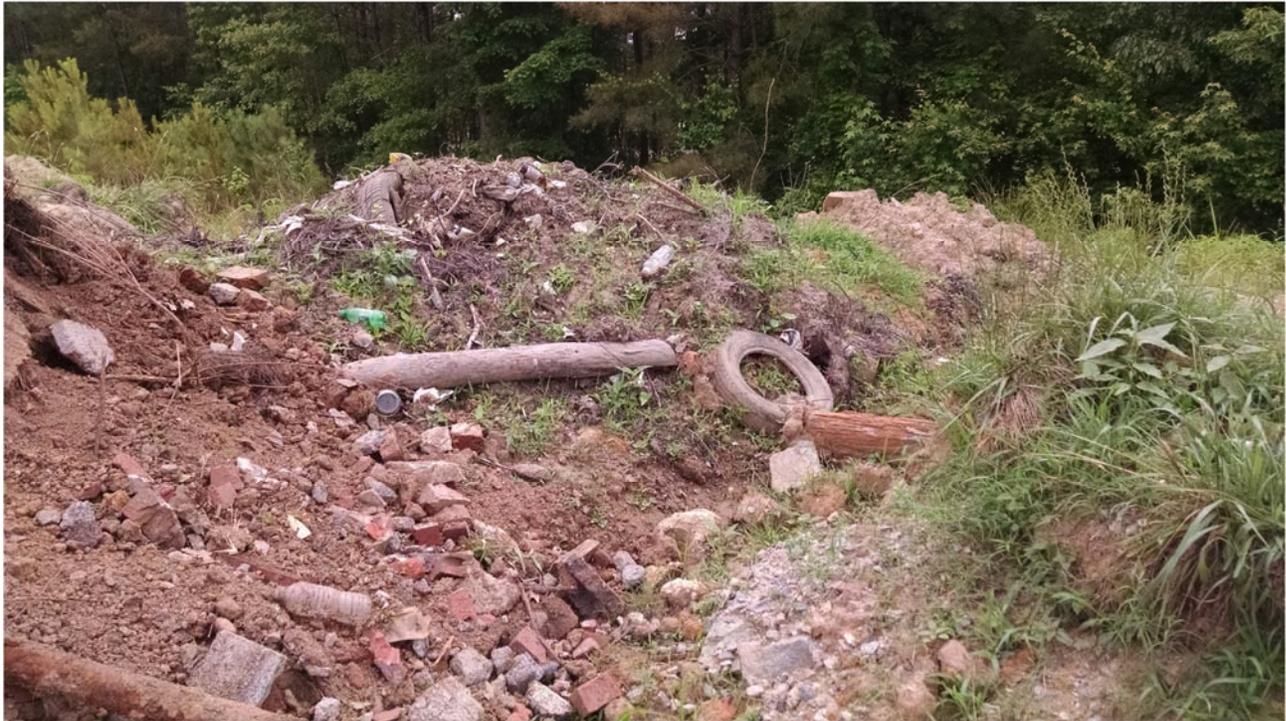
2. There was no exposed coal ash observed.
3. Piles of soil had been dumped on the site. Many of the piles contained miscellaneous waste including tires, bottles and other trash. **It is strongly recommended that gates, berms, chains, etc. be put at entrances to prevent illegal dumping or Mr. Long is going to have to remove waste on a more frequent basis.**

Mixed waste onsite including tires and bottles.
