FACILITY COMPLIANCE INSPECTION REPORT
Division of Waste Management
Solid Waste Section

Date of Site Inspection: 6/22/2016

Haywood Jordan's Septic Tank Service
221 Beulah Road
Clinton, NC 28328

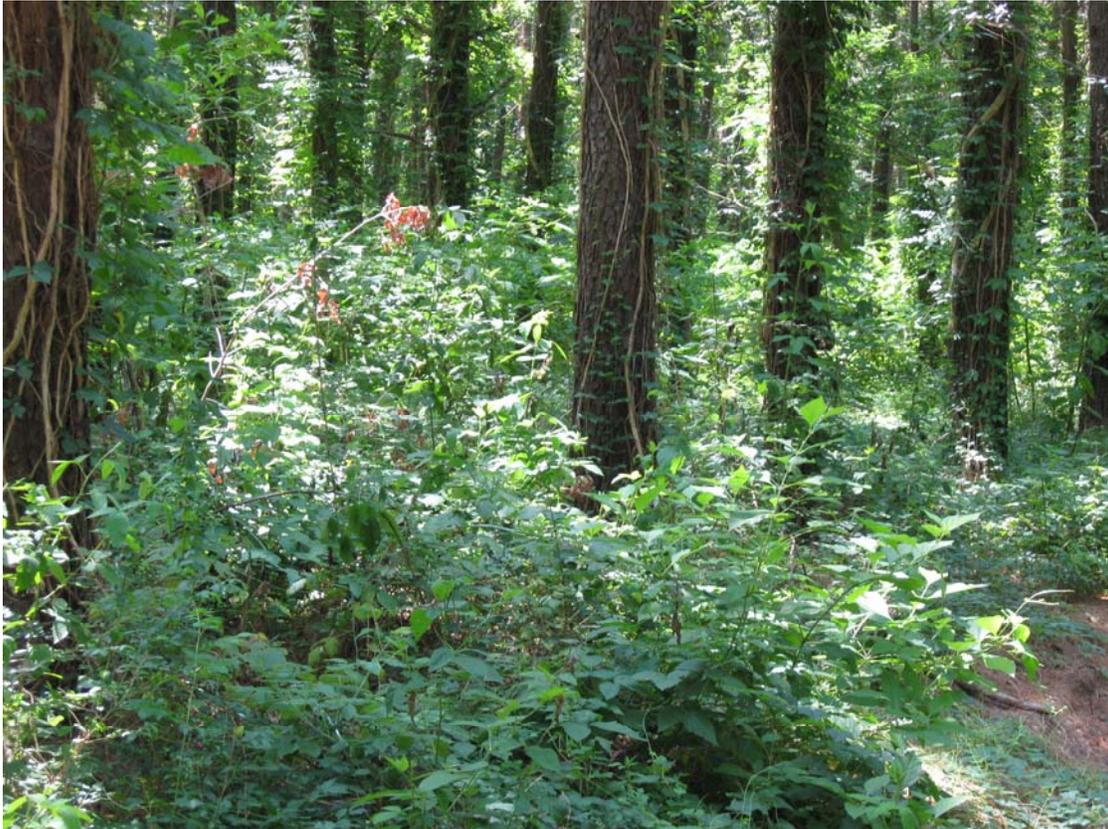
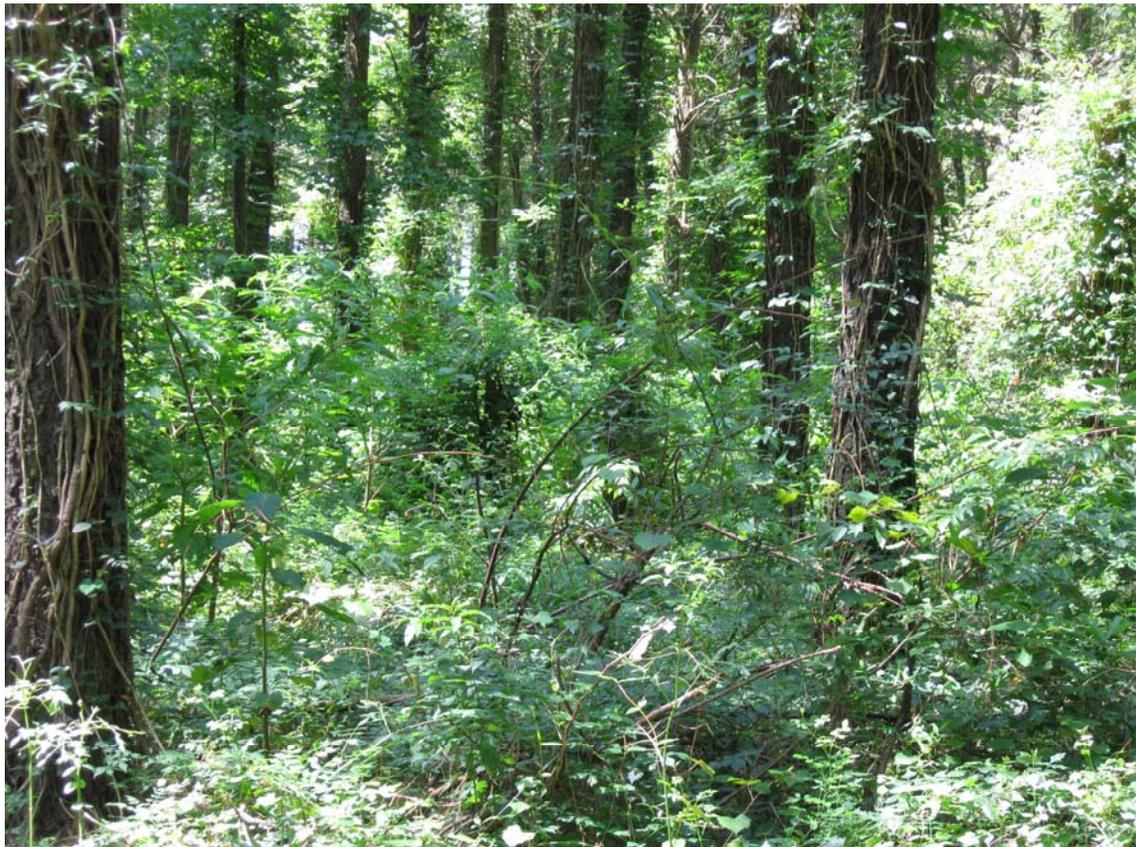
- 1. Permit Condition 2. This site shall be operated and maintained in accordance with the nutrient management plan submitted. Annual bush hogging or herbicide application will be used as necessary. Rule .0838(a)(18) Approved nutrient management plans shall be followed. Excessive understory growth is present thru out the permitted site including driving lanes. Bush hog/cut/spray etc to remove the understory growth (by September 15th) within the permitted boundaries to bring the site into compliance and to allow soil sampling this fall.

1. **Post the required signs** "No Trespassing & Septage Land Application Site". The access road is adequate.
2. Unsure that adequate field markers are present or that the approved setbacks are being met due to the excessive understory growth. However, it does not appear that land application has occurred outside the permitted boundaries.
3. No sign of recent application. No odors noted.
