FACILITY COMPLIANCE INSPECTION REPORT
Division of Waste Management
Solid Waste Section

Date of Site Inspection: 07/07/2016

Town of Tryon – Yard Waste Facility
 1526 E. Howard St.
 Tryon, NC 28782

Comprehensive Inspection

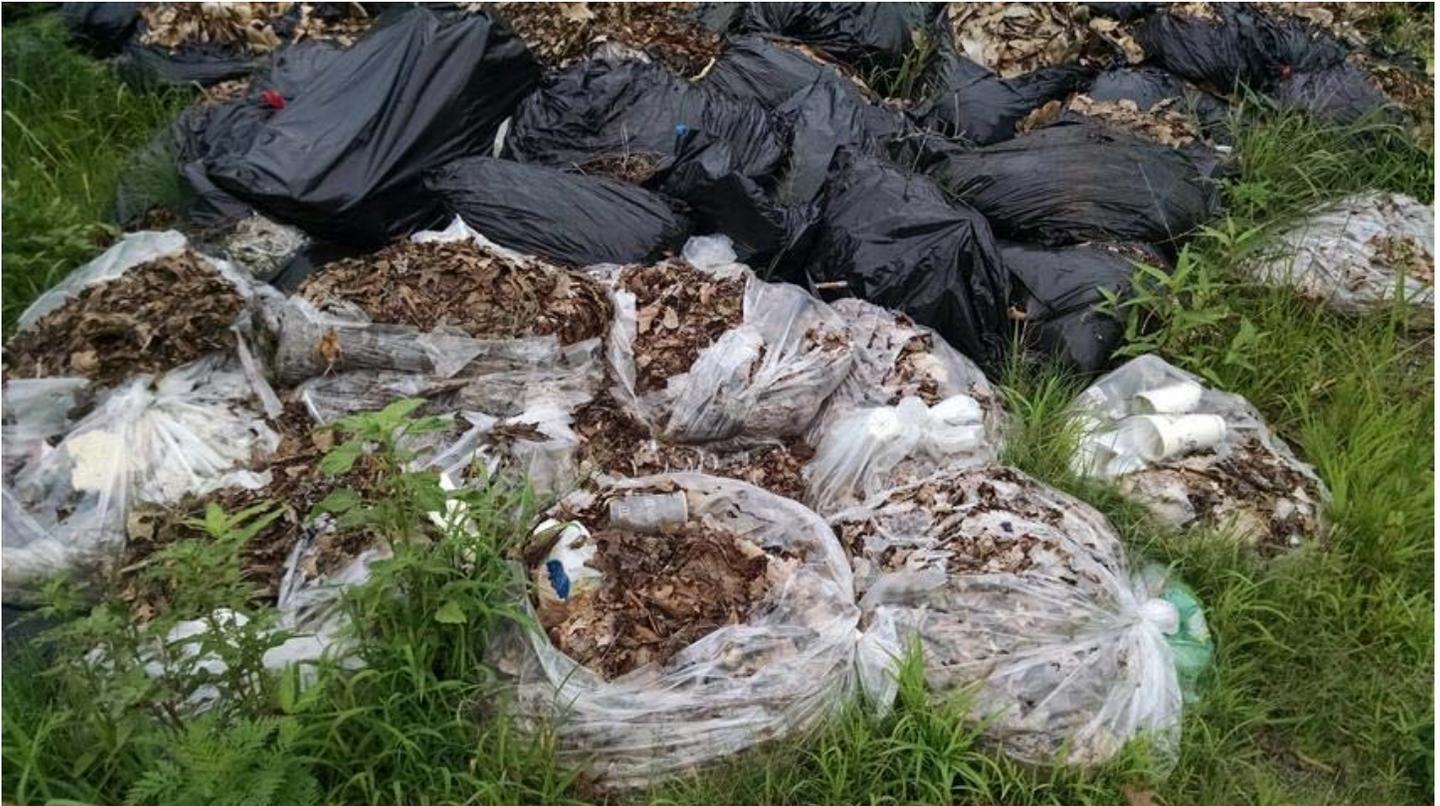
The Town of Tryon is in violation of 15A NCAC 13B .1406(6) in that numerous plastic bags containing leaves were observed in the operations area during the July 7, 2016 inspection. Some of the bagged leaves also contained MSW.

Plastic Bagged leaves with MSW.

- Numerous plastic bags of leaves were observed at the time of inspection. Some of the bagged leaves contained MSW. **All plastic bags and MSW must be removed and disposed of in the proper location. Please see observed violations section of this report.**
- The road was constructed of gravel and was in good condition at the time of inspection.
- Adequate access was provided for firefighting equipment.
- It appeared that less than 6000 yds³ of material was on site at the time of inspection.

Within fifteen (15) days the Town of Tryon must remove all plastic bags and MSW from the Yard Waste area and dispose of the material in the proper location.
