FACILITY COMPLIANCE INSPECTION REPORT
Division of Waste Management
Solid Waste Section

UNIT TYPE:												
Lined MSWLF		LCID		YW		Transfer		Compost		SLAS	X	COUNTY: Halifax PERMIT NO.: SLAS-42-06 FILE TYPE: COMPLIANCE
Closed MSWLF		HHW		White goods		Incineration		T&P		FIRM		
CDLF		Tire T&P / Collection		Tire Monofill		Industrial Landfill		DEMO		SDTF

James Greene Jr.
Greene's Septic Tank Service
1215 Daniel Str.
Weldon, NC 27890

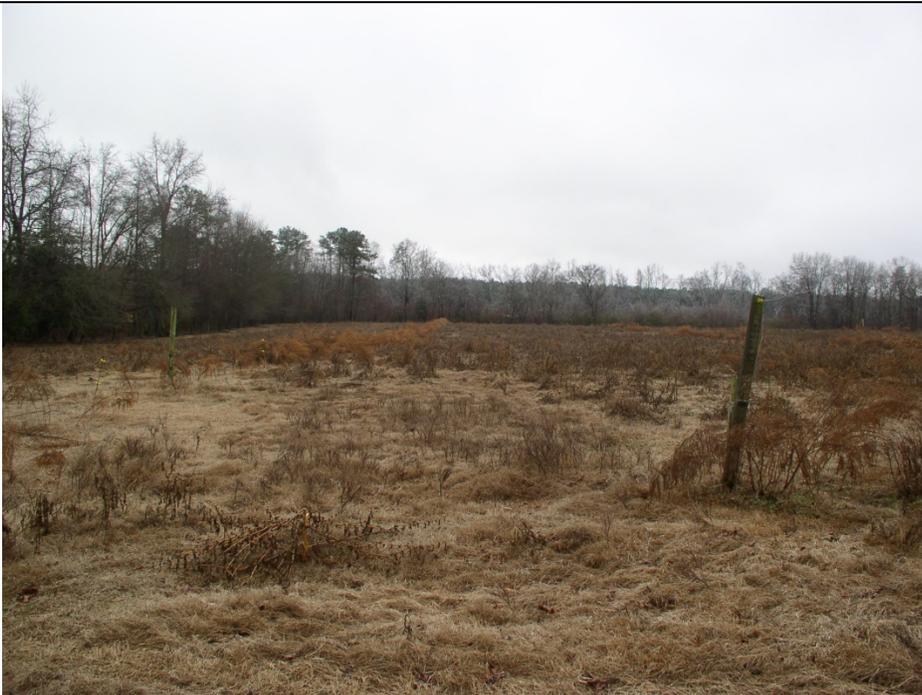
1. The appropriate signage was present today.
2. Access road still has deep potholes in multiple areas.
3. Fences that serve as markers were up.
4. No evidence of any recent applications to the site.
5. Fields have not been maintained and weeds have grown up in the fields.
6. No objectionable odors noticed.
7. No change noticed with any of the setbacks.
8. No activity noticed on the fields. Pump truck still broke down is along the path near Hwy 903. Only one cow noticed at the site today.
9. **SITE IS NOT IN COMPLIANCE. SITE CLOSED TO ANY SEPTAGE DISPOSAL.**

Fields are not being maintained. Picture of Field 4.

- 2) The fields are not being maintained. This is a violation of Rule .0838(a)(18) that states "Approved nutrient management plans shall be followed." Your nutrient management plan is written for common bermudagrass overseeded in rye or ryegrass.
