FACILITY COMPLIANCE INSPECTION REPORT
Division of Waste Management
Solid Waste Section

Date of Site Inspection: July 26, 2016

Stokesdale LCID, Inc. Landfill
7719 Pearman Quarry Road
Stokesdale, NC 27310

Comprehensive Inspection (to ensure that the notified land clearing and inert debris (LCID) landfill is in compliance with 15A North Carolina Administrative Code (NCAC) 13B .0563, .0564, and .0566)

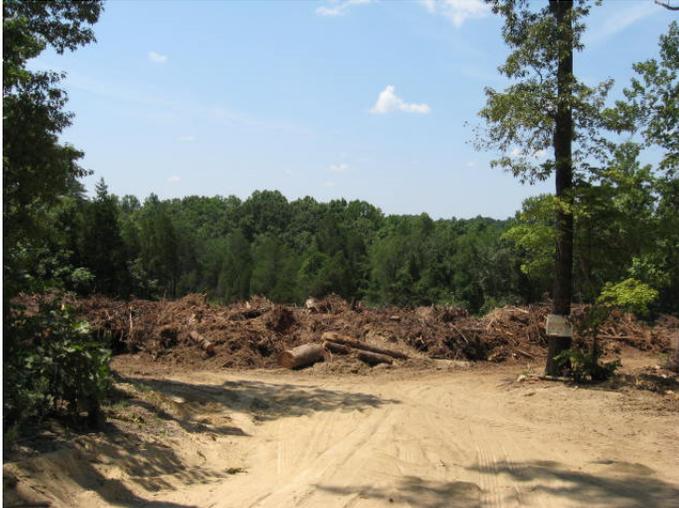
LCID landfill – material to be moved and covered w/soil

4. The facility off-loads material atop the landfill then moves it into place to be covered with soil.
5. Per 15A NCAC 13B .0566(3), "Solid waste shall be restricted to the smallest area feasible and compacted as densely as practical into cells."

6. Per 15A NCAC 13B .0566(4), "Adequate soil cover shall be applied monthly, or when the active area reaches one acre in size, whichever occurs first."

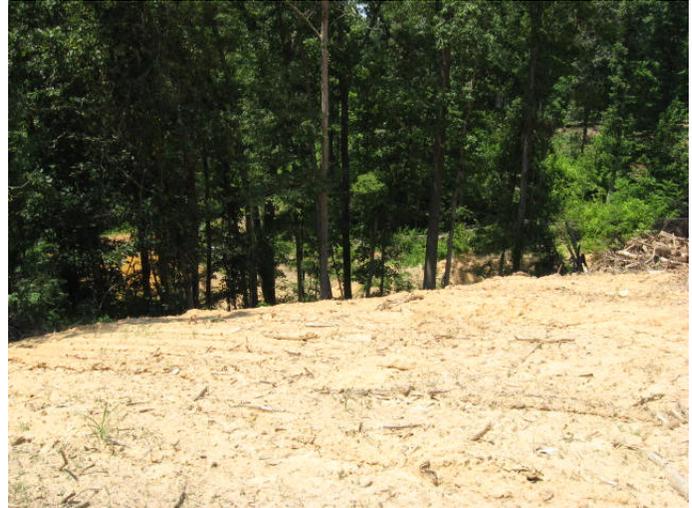
LCID landfill working face area
