**HAZARDOUS WASTE SECTION - COMPLIANCE BRANCH
FILE TRANSMITTAL & DATA ENTRY FORM**

Facility Name: S&W Ready Mix Concrete

COMPLIANCE EVALUATION INSPECTION REPORT

Subject: **Multimedia
Compliance
Inspection**
S & W Ready Mix –
Southport Plant
Brunswick County

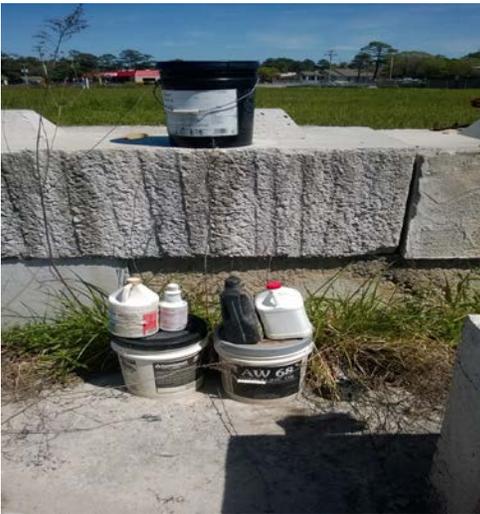
9. ACTION ITEMS: During the inspection I observed seven small containers near the concrete barrier form area. Two of the containers contained cleaners (muriatic acid and an industrial cleaner) which were being used to clean trucks. The other containers held a petroleum ingredient used as a release agent for the concrete forms. Mr. Gay stated he would deal with the material (i.e put it in its appropriate storage area), none of which was waste.

The site was well maintained overall. Be sure to store chemicals and bottled materials in the appropriate storage location, such as the on site shed.

Comment: Be sure to store bottles and chemicals undercover or storage sheds on site
