FACILITY COMPLIANCE INSPECTION REPORT

Division of Waste Management

Solid Waste Section

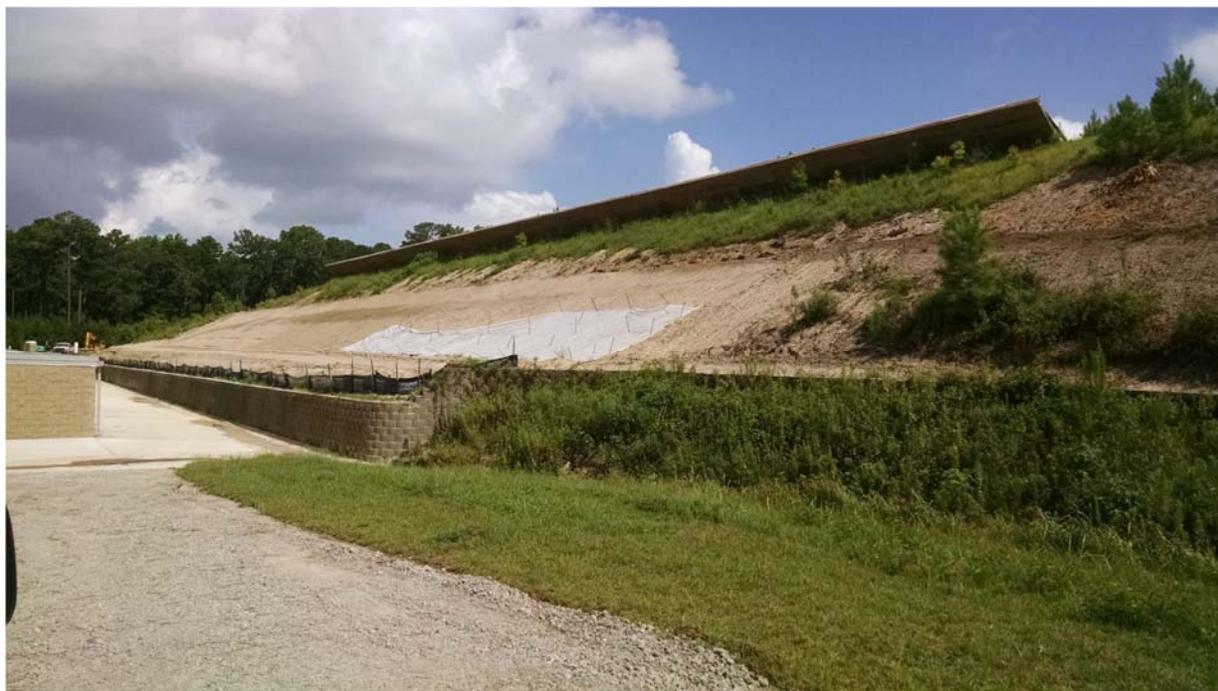
Coal ash is being used for fill inside the impact berm (front/range side).

3. No exposed ash was visible at the time of the inspection.
4. No ponded water was observed on the structural fill at the time of the inspection.
5. The impact berm on the front towards the range is being rebuilt. The slope will be revegetated with non-seedbearing vegetation. The backside of the berm is heavily vegetated and maintained as needed.
