FACILITY COMPLIANCE INSPECTION REPORT
Division of Waste Management
Solid Waste Section

Date of Site Inspection: 08/22/2016

Whitmire LCID
 Israel Road
 Brevard, NC 28712

Comprehensive Inspection

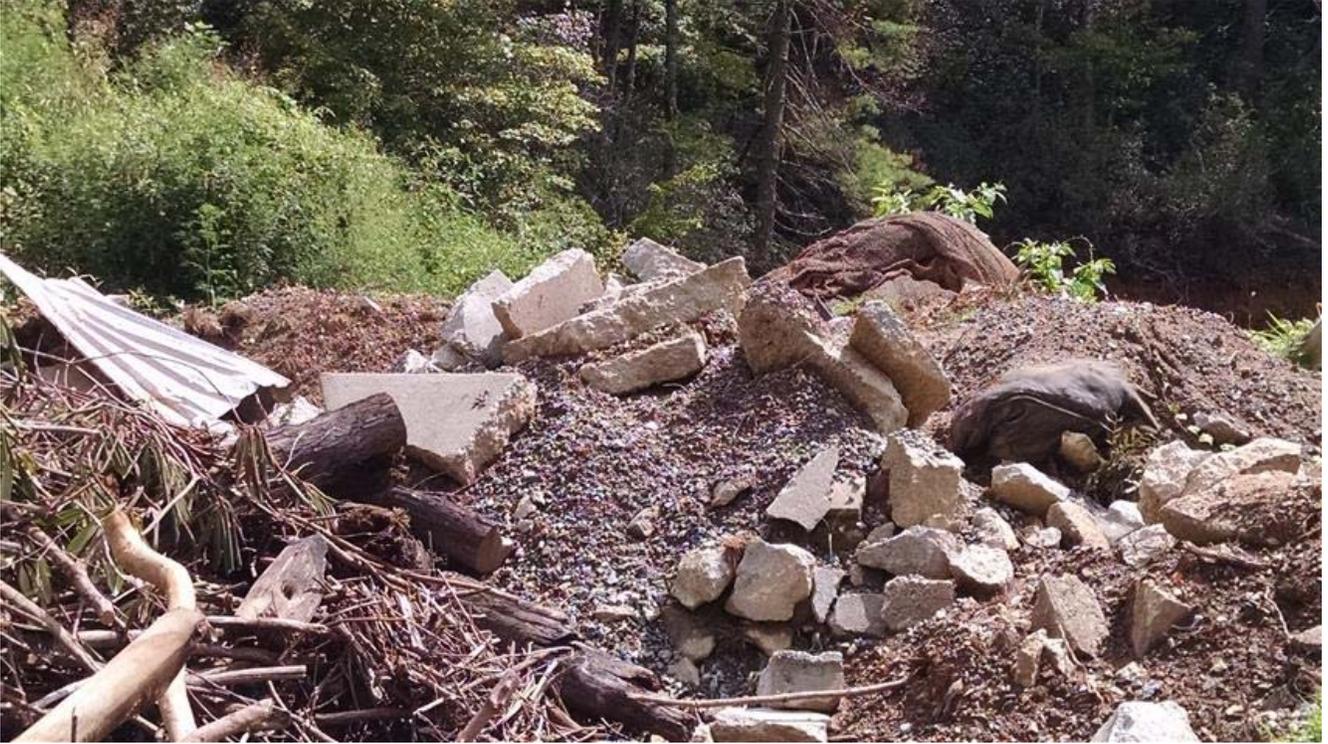
Whitmire LCID is in violation of 15A NCAC 13B .0566(2) by accepting unpermitted materials. On August 22, 2016 metal roofing, fabric, and coir erosion control matting was observed on the working face of the landfill.

Unapproved material on working face.

To achieve compliance, Whitmire LCID must immediately remove all unapproved materials from the LCID landfill and dispose of properly.
