Site Name (Subject): TREND LINE FURNITURE CORP.

Report Segment:  
Description: FIT Screening Site Inspection, Phase I

Subject: **Screening Site Inspection, Phase I** *FIT*  
 Trend Line Furniture Corporation  
 Maiden, Catawba County, North Carolina  
 EPA ID No. NCD000648436  
 TDD No. F4-8909-53

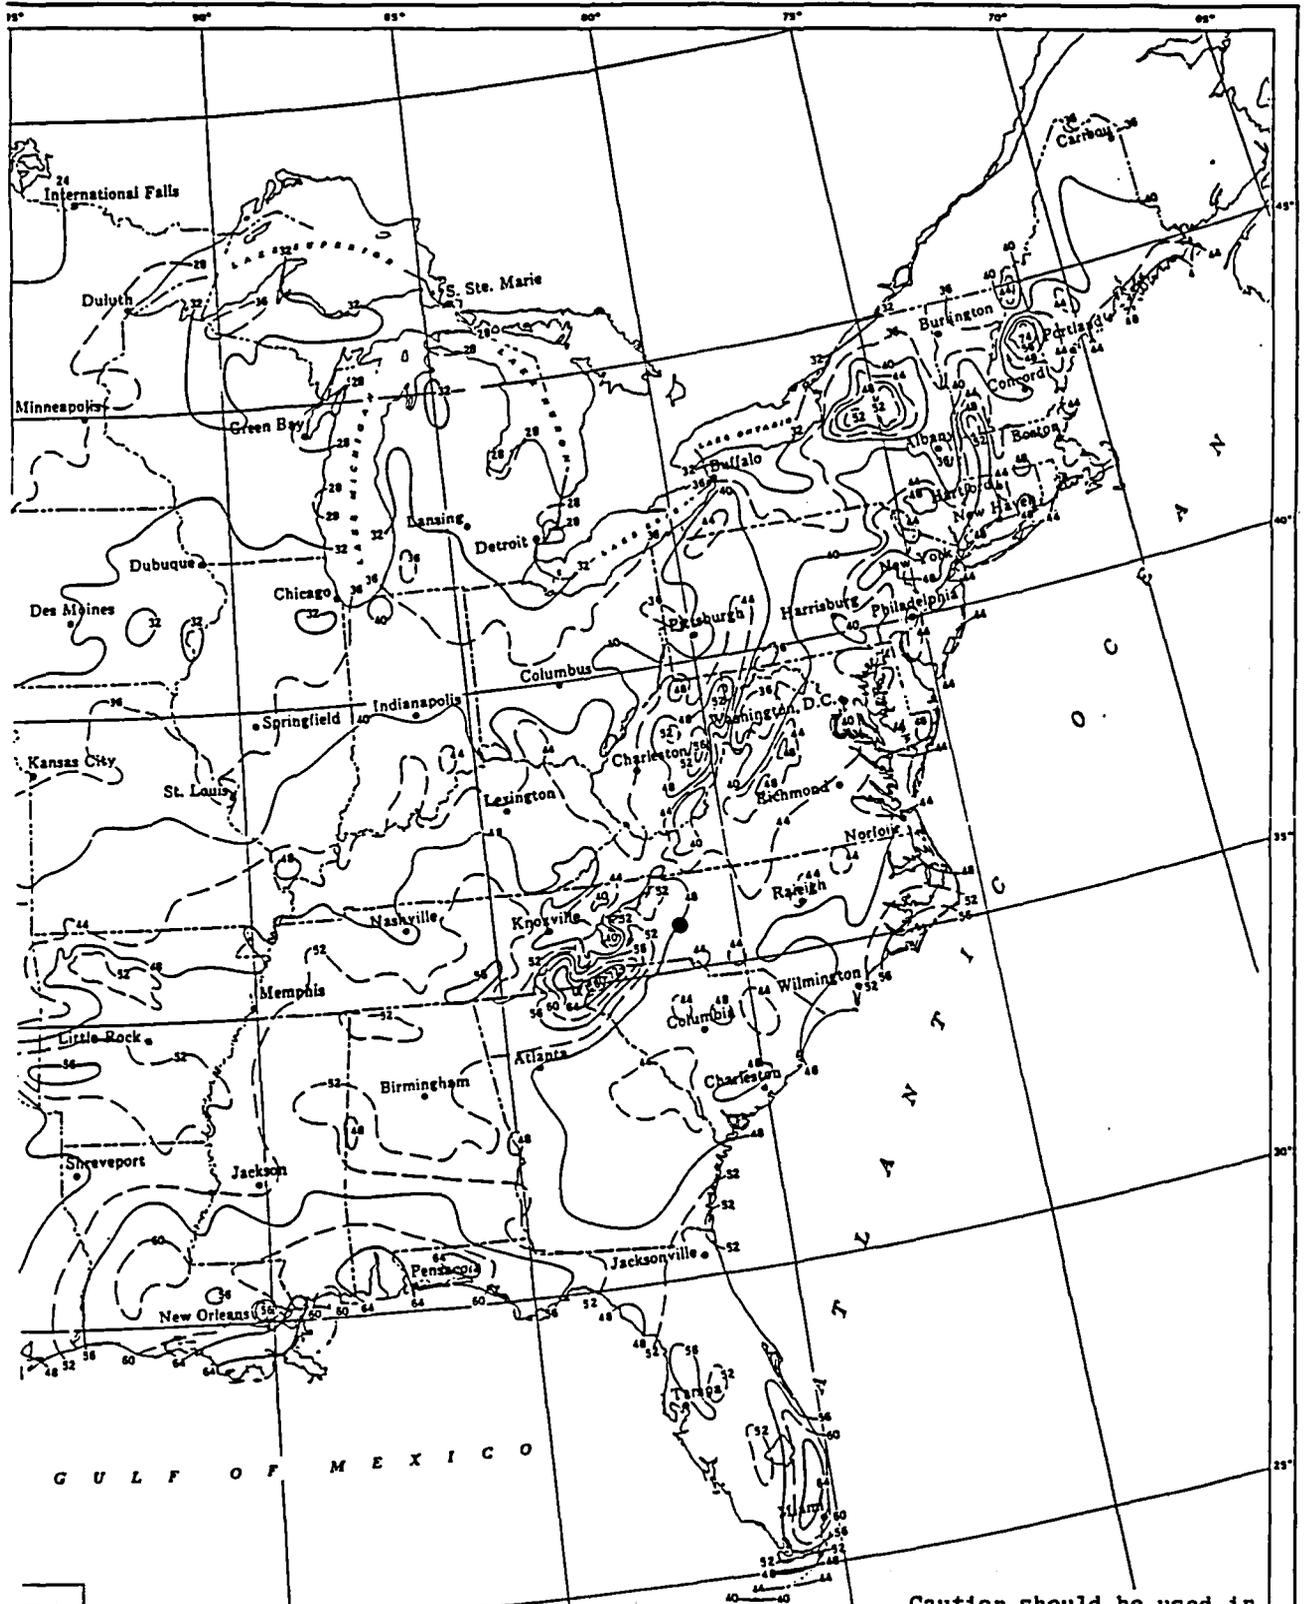
# PRECIPITATION (Inches)

Caution should be used in interpolating on these generalized maps, particularly in mountainous areas.
