FACILITY COMPLIANCE INSPECTION REPORT
Division of Waste Management
Solid Waste Section

Washington County C&D Landfill
718 Landfill Rd
Mackeys, NC 27970

Partial Facility Compliance Inspection without records review

9404_INSP_20160330

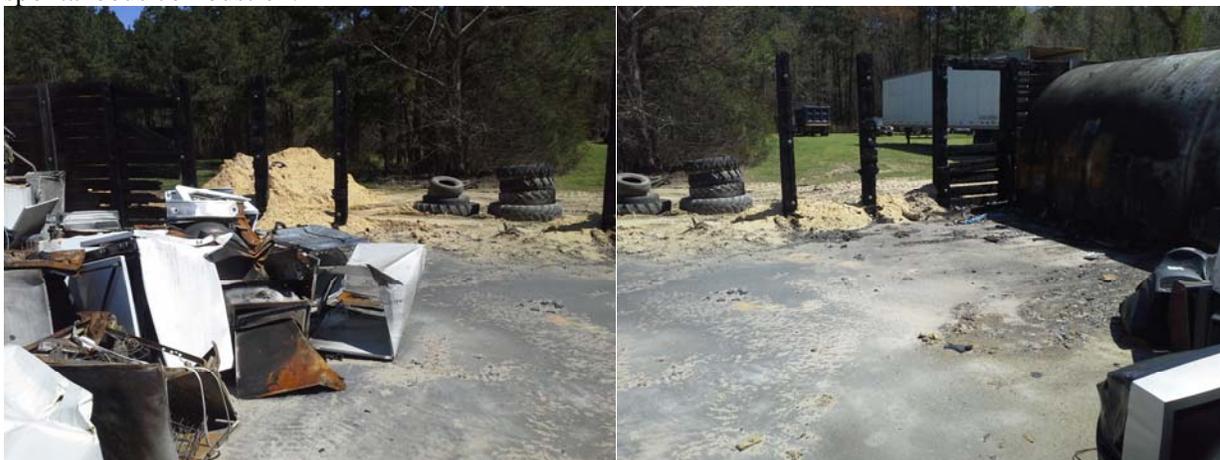
- 10) This Facility experience a fire event in the electronics storage area on 23 March 2016. During the fire event, several pallets of televisions and computer monitors which had been packaged for shipment to the electronics recycling facility caught fire and burned. A portion of the back retaining wall was destroyed by the fire. Investigation by the Washington County Fire Marshal determined the fire to have been caused by spontaneous combustion.

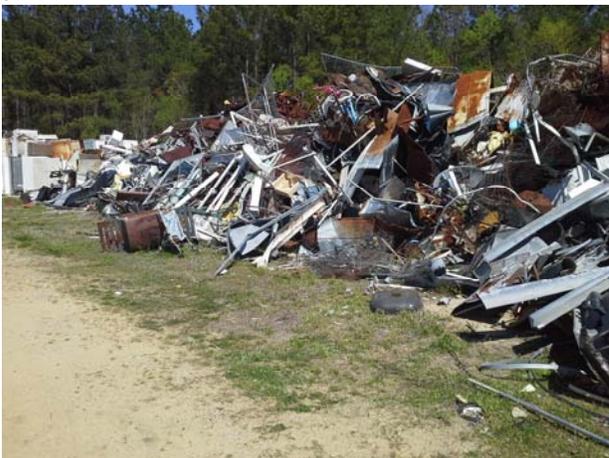
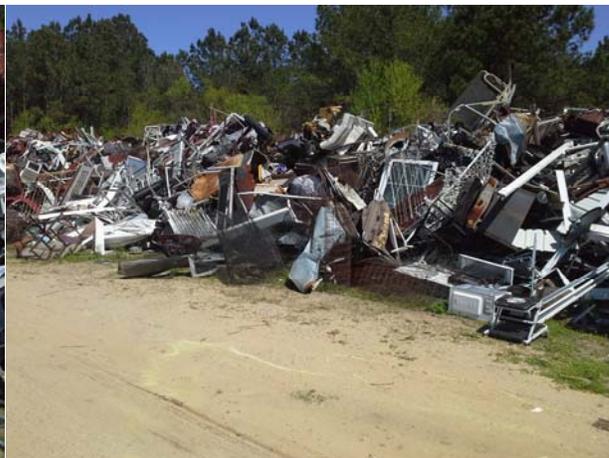
- 11) The recycling area was reviewed during this Facility Compliance Inspection. The white goods/metal recycling area is being well managed at this time:
 - All metal containing materials collected for recycling are deposited on-site on the concrete pad and are maintained in an orderly fashion until collected by the metal salvage contractor.
 - All Freon containing white goods are placed and maintained in an upright condition and are kept separate from non-Freon containing white goods/metals.
 - All recyclable electronics are maintained in an enclosed container and separate from the other recyclable materials.
- 12) The scrap metal pile is approaching the maximum allowable volume that can be maintained on the concrete pad. *Plans need to be underway for the collection and transport of all recyclable metals to the metal recycling facility.

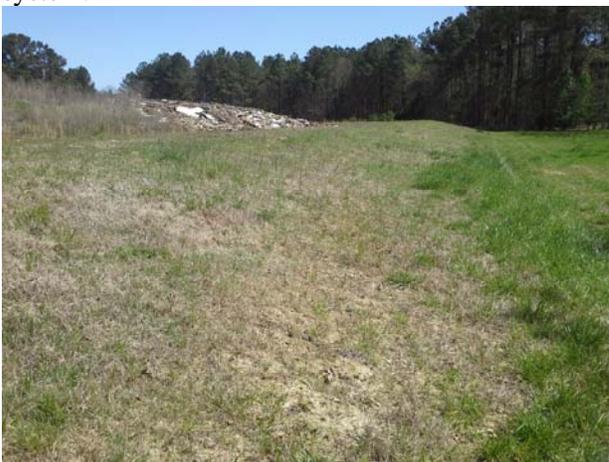
- 16) Permanent Edge of Waste Markers are in place around the footprint of the landfill and are being maintained as required.
- 17) The outside slopes of Phase II have a cover crop established suitable to prevent erosion of the landfill cap system.
