# FACILITY COMPLIANCE INSPECTION REPORT

**Date of Site Inspection:** 4/28/2016

Langley LCID Landfill  
7400 Brooks Bridge Road  
Gibsonville, NC 27249

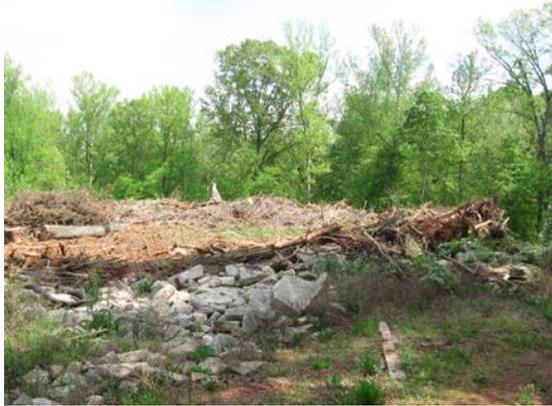
<p data-bbox="797 632 1040 657">NOTES LCID landfill area</p>
Photo 2	Photo 3

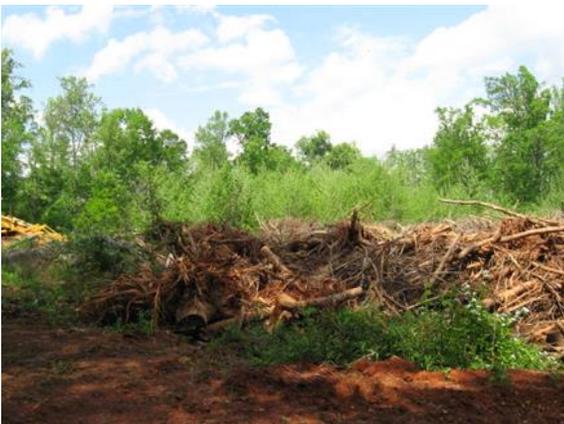
<p data-bbox="164 1188 591 1213">NOTES LCID landfill external side slope view</p>

7. Side slopes should be graded such that a 3:1 slope ratio is obtained or a ratio of which no indication of erosion or runoff is observed.
8. Ensure a ready supply of soil is available on site for soil cover.

9. Open burning of solid waste is prohibited.
10. There was no indication of erosion or runoff.
11. The facility has an all-weather access road.
12. The facility is secured by a locked gate.

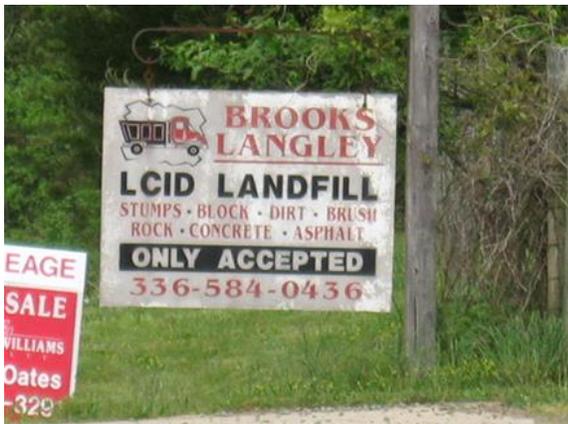
<p data-bbox="797 1188 1040 1213">NOTES LCID landfill sign</p>
Photo 4	Photo 5
<p data-bbox="164 1730 233 1755">NOTES</p>	<p data-bbox="797 1730 867 1755">NOTES</p>

13. The facility has a proper sign. It is suggested that the facility identification number is also posted: N0583.
14. The SWS will conduct a follow-up inspection by the end of May 2016 to observe that LCD has been adequately covered with soil.
