FACILITY COMPLIANCE INSPECTION REPORT
Division of Waste Management
Solid Waste Section

Date of Inspection: 11 May 2016

Greene County C&D Landfill
105 Landfill Rd
Walstonburg, NC 27888

Partial Facility Compliance Inspection without records review

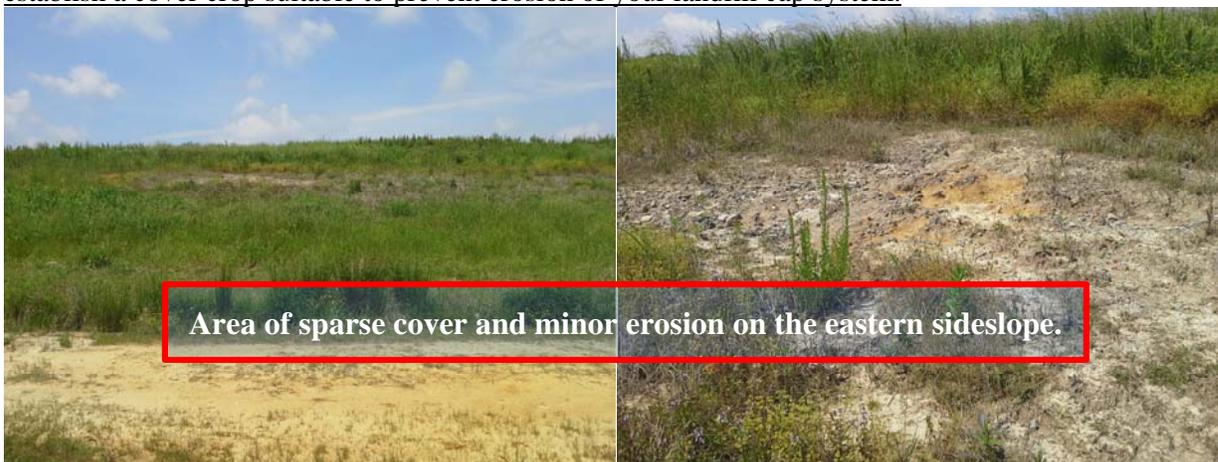
- 12) Overall, the landfill has a well-established cover crop of native warm season grasses suitable to prevent erosion of the landfill cap system.
- 13) The cover crop is mowed throughout the year as needed. *Portions of the cover crop are in need of mowing.

- 14) Some areas were observed as having a sparse cover crop. *Please grade, seed, and mulch these areas to establish a cover crop suitable to prevent erosion of your landfill cap system.

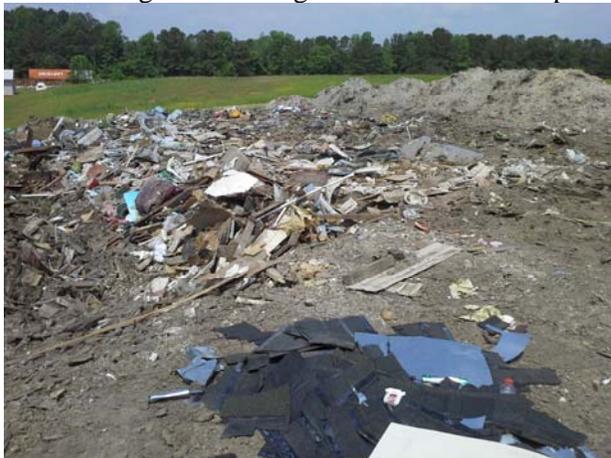
- 15) Soil is being stockpiled adjacent to the landfill and on the top lift of the landfill in an area adjacent to the active working face for use as weekly cover.
- 16) The working face is being maintained in a compact size and appears well managed at this time.

- 18) *Please continue to ensure that all waste is being covered with a minimum of six inches of soil at least once per week or when the active disposal area reaches ½ acre in size, whichever occurs first.

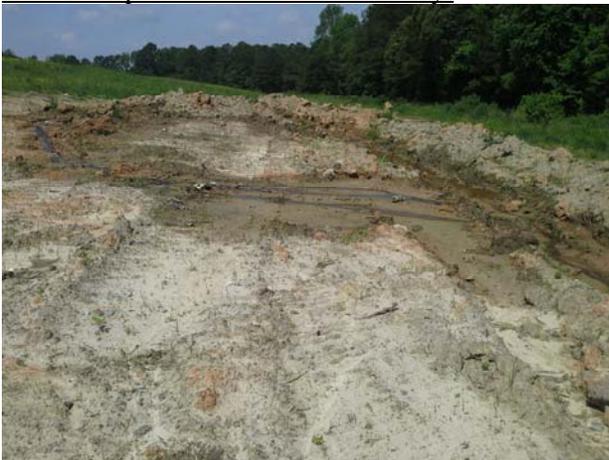
- 21) An area of leachate seepage was observed at the northeastern corner of the landfill. Clay berms have been constructed to contain the leachate and prevent the migration of leachate from the permitted landfill boundary. No leachate was observed leaving the landfill during this Facility Compliance Inspection. *Measures should be taken as soon as possible to correct and repair this issue. Please monitor this area to ensure that no leachate leaves the permitted landfill boundary.

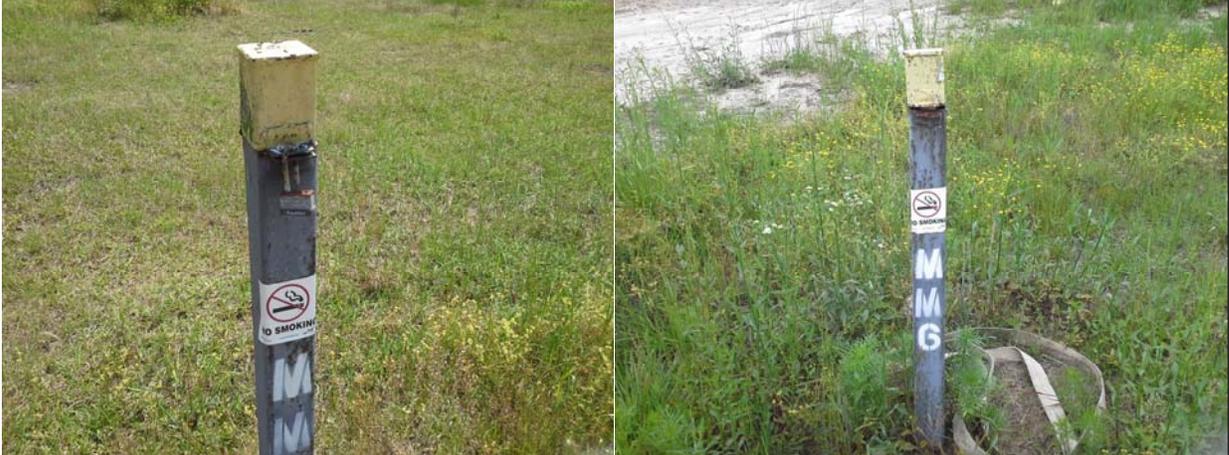
- 31) The landfill gas monitoring wells were observed during this Facility Compliance Inspection. All the wells were readily accessible and properly labeled. The landfill gas monitoring wells were not secured. With the exception of monitoring well #6 which was lacking a lock, all other wells observed had locks in place that were not locked. *Please ensure all landfill gas monitoring wells are properly secured with functioning locks.
