FACILITY COMPLIANCE AUDIT REPORT
Division of Waste Management
Solid Waste Section

FACILITY NAME AND ADDRESS:

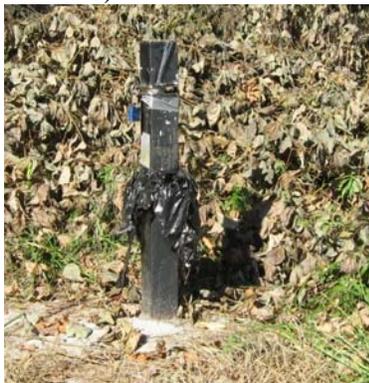
MW-14D, 11/10/10

- e. No unacceptable wastes were noted at the landfill.
 - f. Some of the side slopes of the inactive portions of the CDLF exhibited tree growth.
14. Several monitoring wells were inspected. MW-14D was in need of repair (pad was loose/eroded and the casing cap was damaged). The other wells inspected were in good external condition (MW-11, MW-14, MW-9, MW-9D, and M-2).
