FACILITY COMPLIANCE AUDIT REPORT
Division of Waste Management
Solid Waste Section

Henson's Inc. Mulch & More
 116 Pond Road
 Asheville, NC 28806

Large Type II Compost Facility
 Active - **Permit expires: 12/31/2010**
 Disaster Debris site #: DS11-006

Comprehensive Inspection

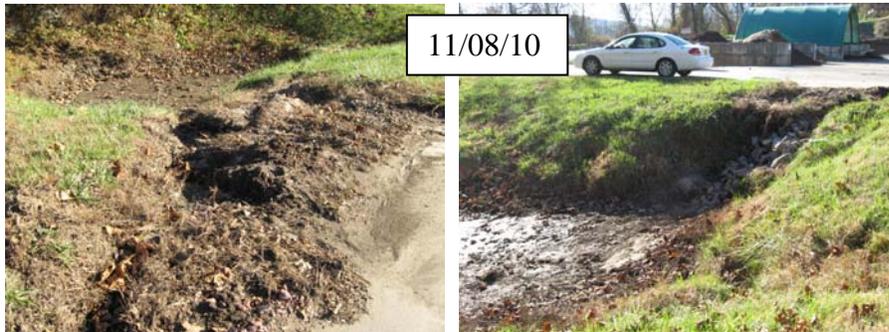
3. In accordance with the permit (section 2.3.2 and 2.3.5 regarding buffer requirements between processing and storage area and property lines/surface waters), product piles appeared to meet the 50-foot buffer requirement. A barrier/berm of soil was in place in a region between product piles and Hominy Creek.
4. Adequate erosion control measures were in place (sedimentation ponds, berms) and surface water appeared to be diverted away from the operational, curing, and storage areas. Note that the currently approved Operations Plan includes and Operator Checklist details annual cleanout of storm basins and monthly checks on the runoff control devices. Note that the sed-basin below the bin area had experienced some erosion and may be due for maintenance.
