FACILITY COMPLIANCE AUDIT REPORT
Division of Waste Management
Solid Waste Section

Date of Audit: July 8, 2010

Columbus County LCID Landfill
 107 Landfill Road
 Whiteville, North Carolina 28472

Comprehensive Audit

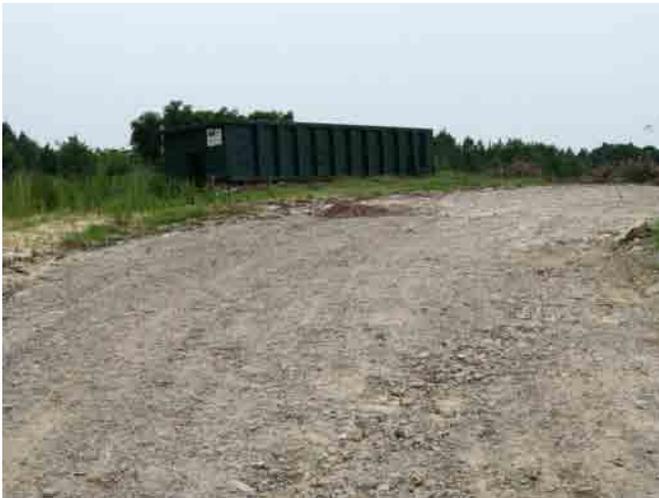
Container near the working face.

8. The incidental waste items are being removed and placed in a roll-off container for proper disposal.
9. The perimeter slopes need to be maintained at 3:1 slope or flatter. Some of the slopes appear to be steeper than a 3:1 slope. Be sure when covering debris and/or contouring that the slopes are maintained as required. It is noted that grading work and mowing is scheduled for this week. Adequate ground cover will need to be provided within 30 days of grading activities if the area(s) will not be active before the 30 days. Temporary seeding will be required as a minimum.

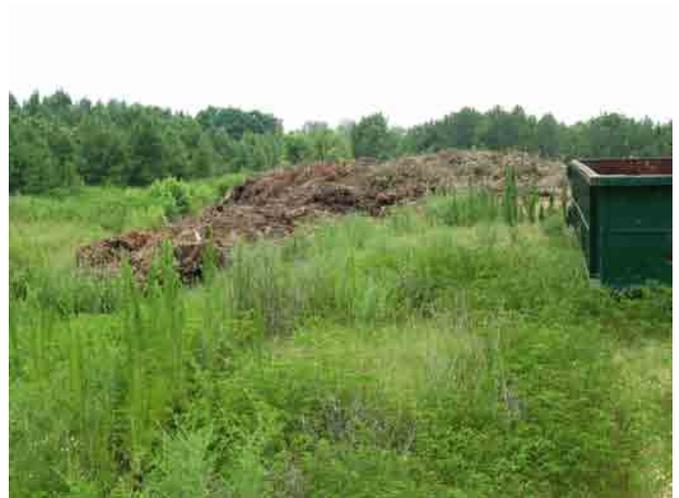
Small working face.

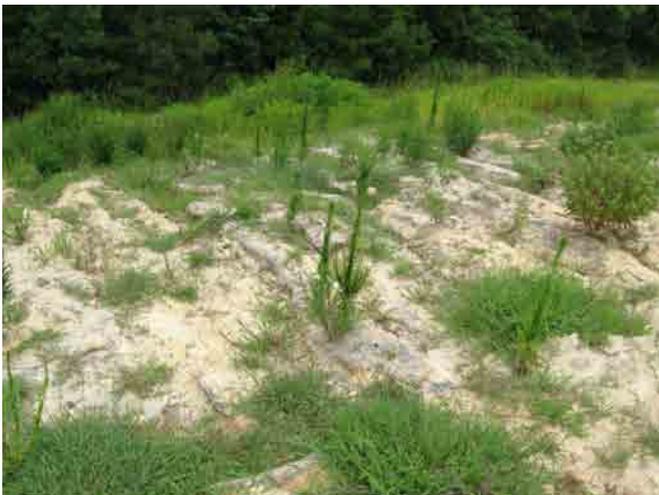
5. The site is secured with a gate at the entrance and has controlled access for safety
6. No unacceptable waste was noted during the visit.
7. There were several gullies on the slopes. These will need to be repaired to prevent further erosion and potential exposure of debris.

Finger washing beginning on the North slope.

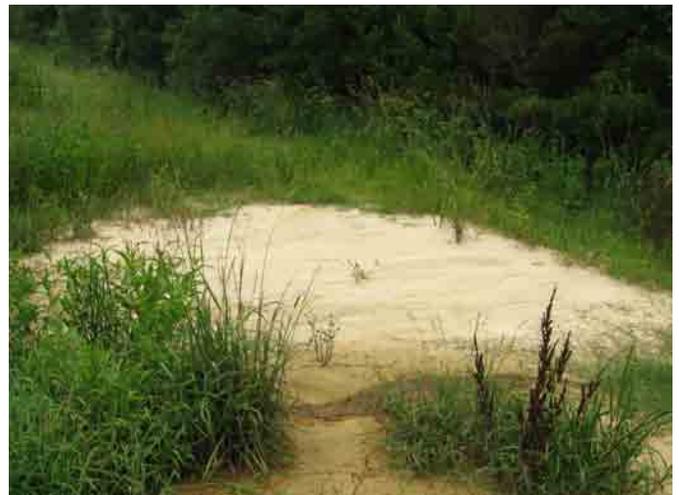
Sediment deposit and staining at the toe of the North slope.
