**FACILITY COMPLIANCE AUDIT REPORT**  
**Division of Waste Management**  
**Solid Waste Section**

<b>UNIT TYPE:</b>											
Lined MSWLF		LCID		YW		Transfer	<input checked="" type="checkbox"/>	Compost		SLAS	<b>COUNTY:</b> Craven <b>PERMIT NO.:</b> 25-10T <b>FILE TYPE:</b> COMPLIANCE
Closed MSWLF		HHW		White goods		Incin		T&P		FIRM	
CDLF		Tire T&P / Collection		Tire Monofill		Industrial Landfill		DEMO		SDTF

**Date of Audit:** 5 May 2011

MCAS Cherry Point Transfer Facility  
 Mockingbird Road  
 MCAS Cherry Point, NC 28533

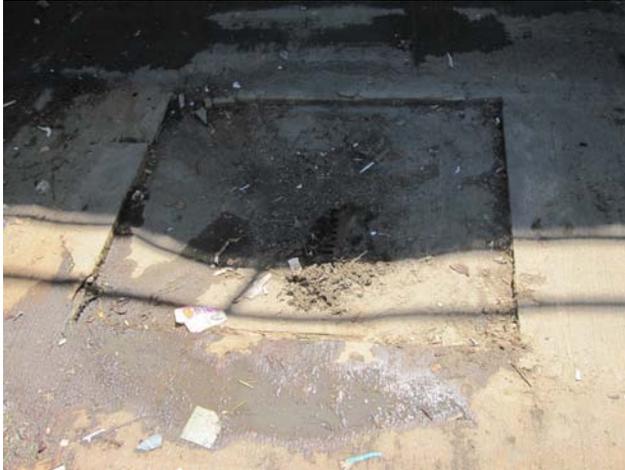
- 14) One of the leachate drains in the trailer loading area was blocked with sediment and debris. \*To ensure proper collection and management of leachate, please ensure that all leachate collection drains are cleaned daily or more often if necessary.

Blocked leachate collection drain

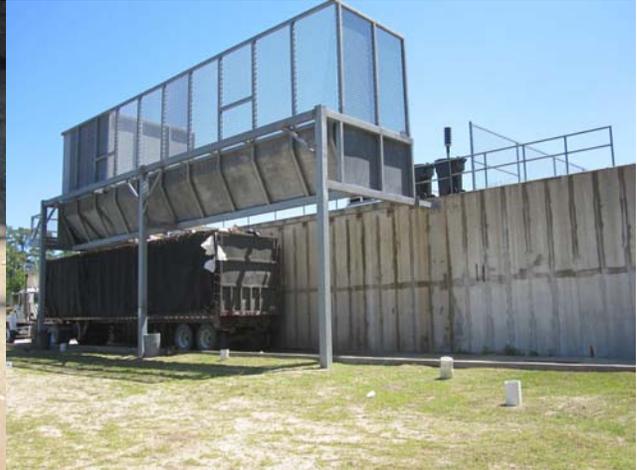
- 9) All wastes managed at this facility are dumped directly into transfer trailers; MSW is dumped into a hopper, which directs the waste into the MSW trailer, wood waste is loaded directly into a separate roll-off container.

Hopper and trailer loading bay

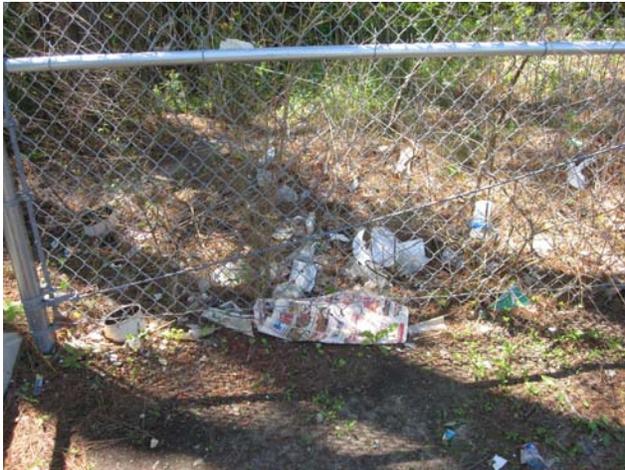
- 17) Overall, the trailer loading area and windblown debris are being well maintained at this time; however a small amount of windblown debris was noted on the outside of the perimeter security fence. \*Please ensure that all windblown debris both inside and outside the perimeter fence is collected and disposed in the MSW trailer at the end of each workday.

Wind-blown debris outside of perimeter fence

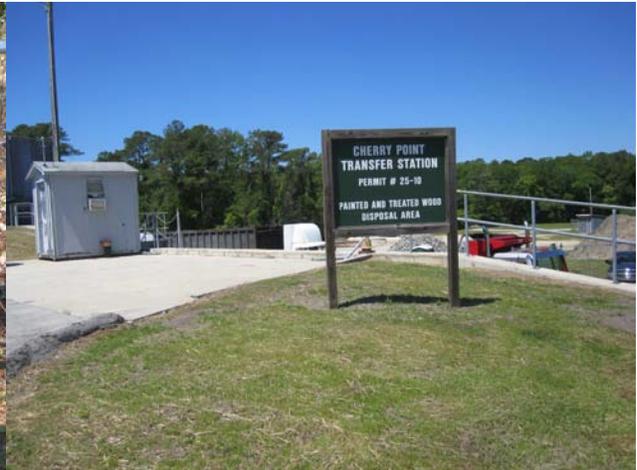
- Sam Onorio: Certified Transfer Station Operations Specialist; expires 26 Aug 2011
- 23) Access around the facility is generally stable with a healthy cover crop of native warm season grasses established to prevent erosion. Please continue to monitor and maintain this cover crop on all facility slopes.

Previously noted area of sparse cover graded and seeded
