FACILITY COMPLIANCE AUDIT REPORT

Division of Waste Management Solid Waste Section

Date of Audit: 12 November 2009**Date of Last Audit:** 12 April 2007**FACILITY NAME AND ADDRESS:**

MCAS Cherry Point LCID Landfill
 Rifle Range Road
 MCAS Cherry Point, NC 28533

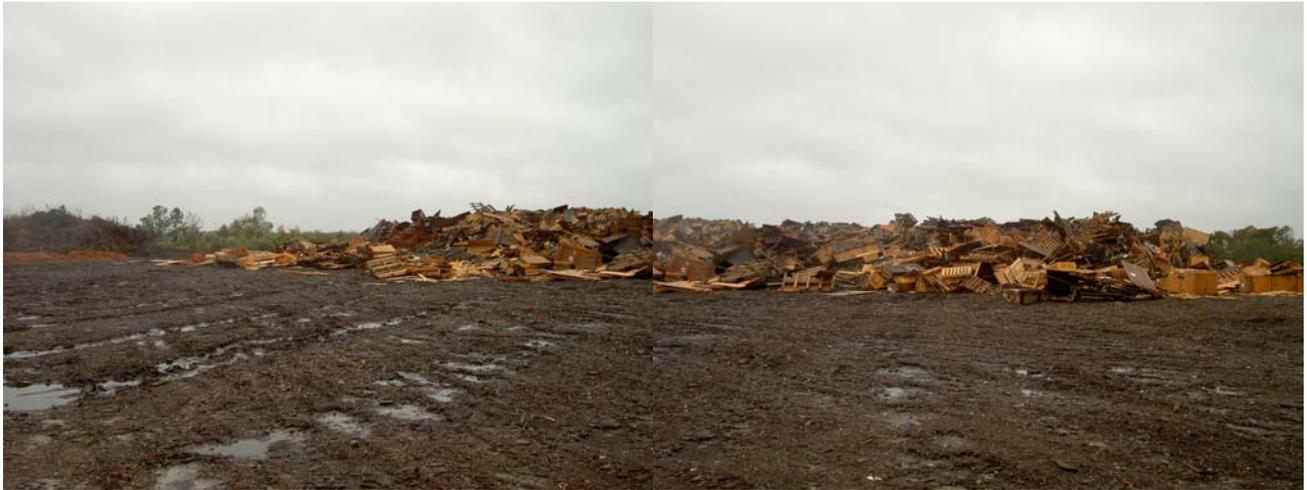
Wood waste staged for grinding

- 11) Wood waste brought on-site is stored in an area adjacent to the landfill and ground periodically to be removed from the site and used as boiler fuel.

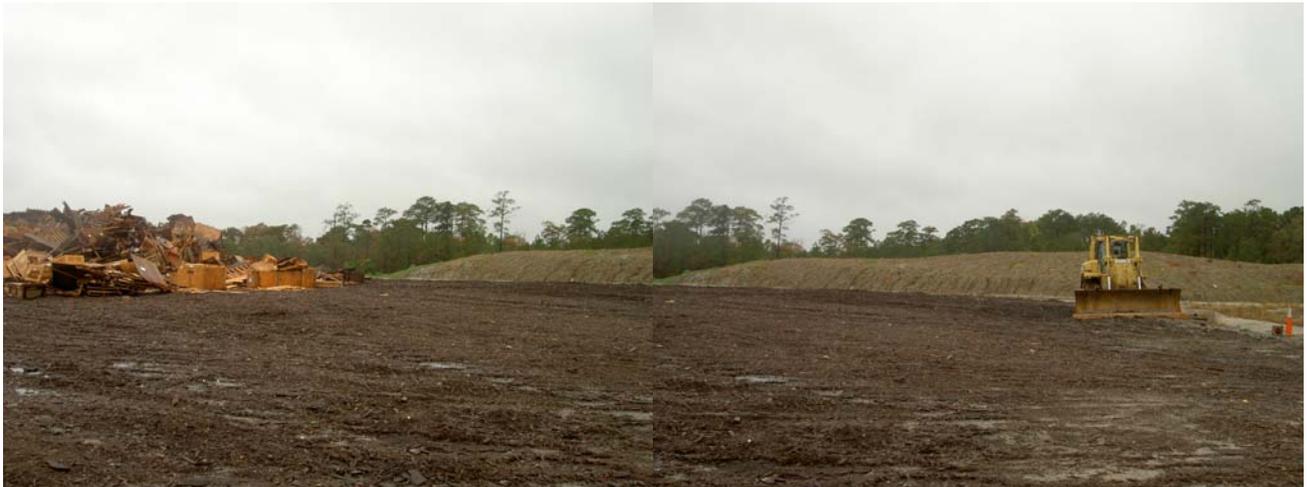
Wood waste staged adjacent to LCID landfill

LCID Landfill active area

- 14) Due to the crushing and grinding activities at the site, only a limited amount of material is landfilled. The active disposal area is being maintained in a compact, manageable size.

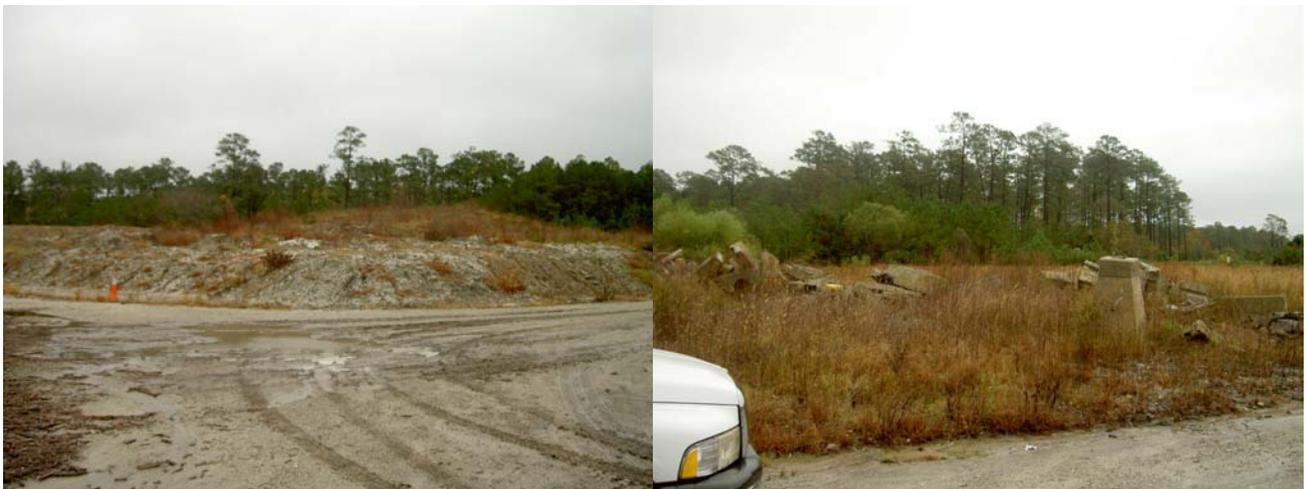
LCID landfill inactive area in need of cover crop

Concrete staged for crushing

- 15) The sideslopes of the landfill have adequate cover and are graded properly. *However, the inactive areas lack an adequate cover crop. As per our conversation, please seed and mulch these areas to establish a cover crop suitable to prevent erosion of your cap system.
