# FACILITY COMPLIANCE AUDIT REPORT

## Division of Waste Management Solid Waste Section

Date of Audit: 26 February 2010Date of Last Audit: 12 November 2009**FACILITY NAME AND ADDRESS:**

Cieszko Construction Company LCID Landfill  
 NC Hwy 101 Havelock, NC

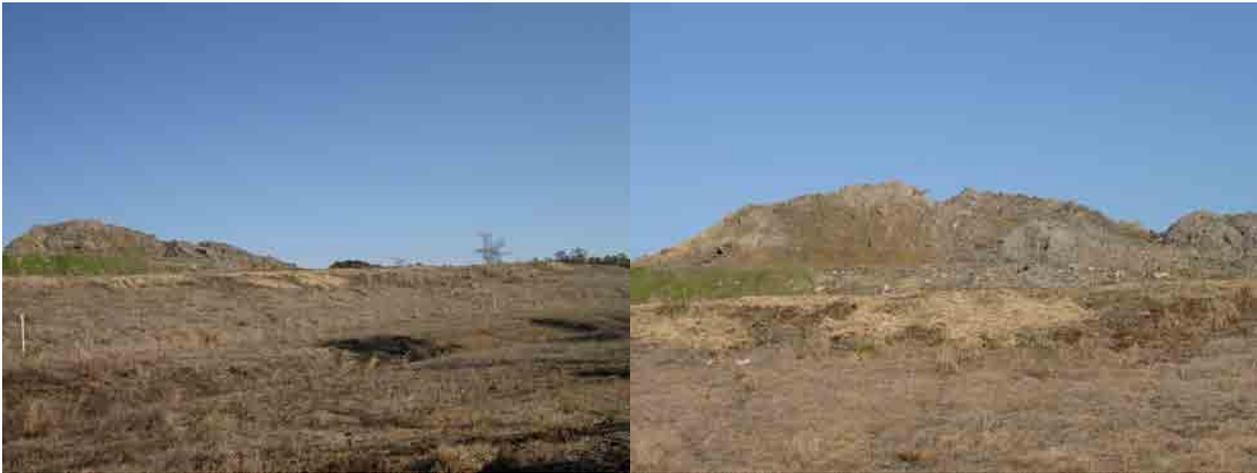
- 9) The bare areas noted on the sideslopes during the previous audit have been seeded and mulched to establish a cover crop suitable to prevent erosion of the cap system.

- 10) Soil has been stockpiled adjacent to the active working face to ensure an adequate supply of cover material.
- 11) Digital photographs were taken during this audit. Please see below.

View of sideslope showing repaired areas and soil stockpile

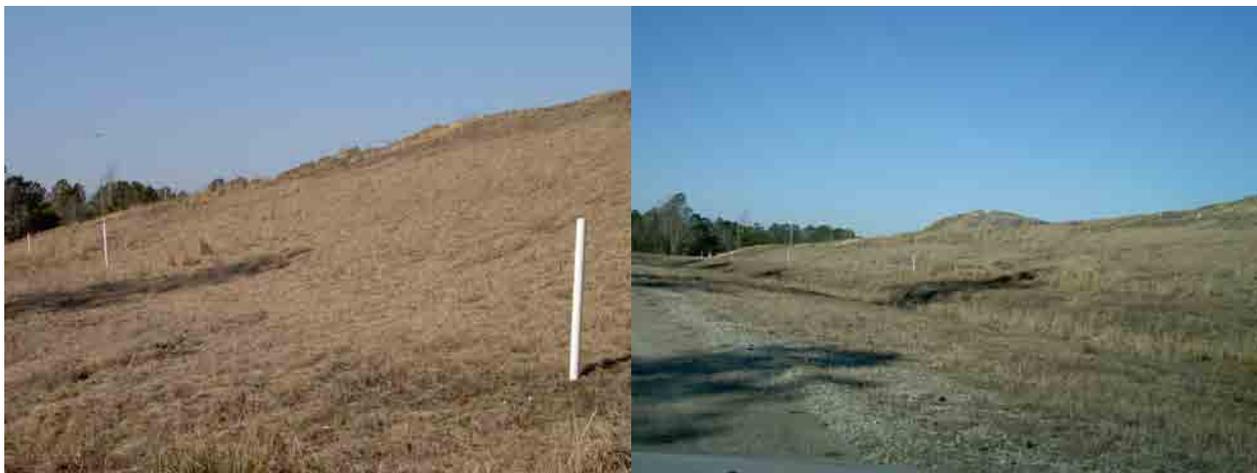
- 6) Markers delineating the landfill waste disposal footprint have been installed.
- 7) The active working area is compact and well managed.
- 8) The sideslopes have been covered and graded and are being maintained at a slope not greater than 3:1.

View of sideslope showing newly installed waste boundary markers
