FACILITY COMPLIANCE AUDIT REPORT
Division of Waste Management
Solid Waste Section

Date of Audit: January 11, 2011.

Fort Bragg Closed MSWLF
Lamont Road

Comprehensive Audit

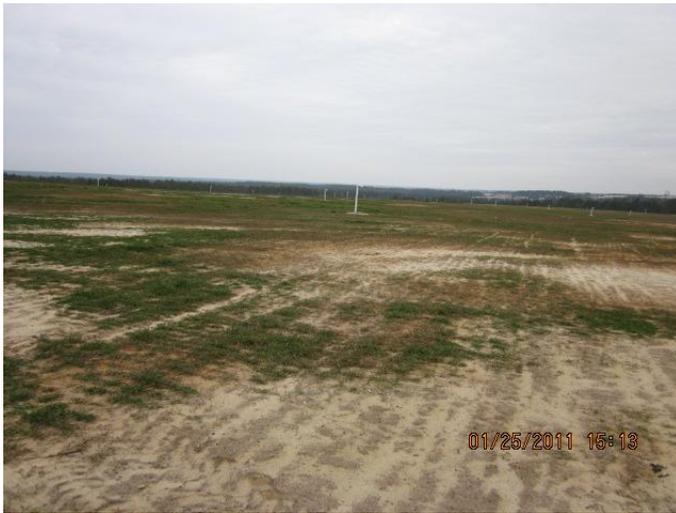
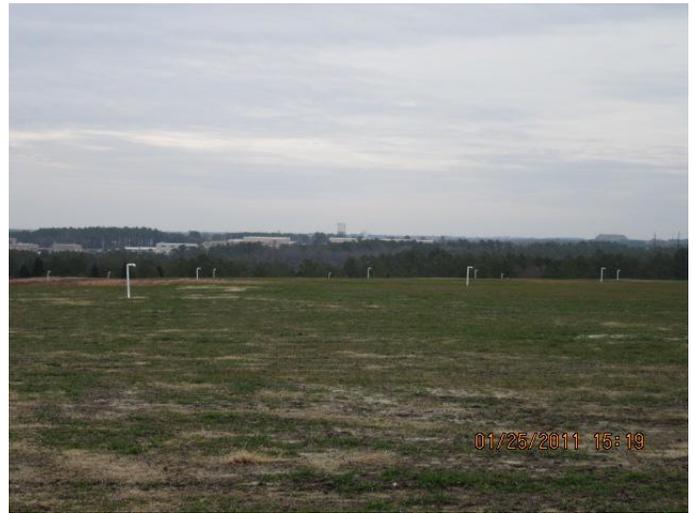
1. The landfill cap repair to provide positive drainage of surface water and eliminate areas that impound water over waste has been completed.
2. The edge of waste markers has been installed around the perimeter of the LF.

3. The LF gas vents have been raised and a concrete base installed to reduce settling.
4. There was minimal erosion on the new cap and bare areas observed during this audit.
