FACILITY COMPLIANCE INSPECTION REPORT
Division of Waste Management
Solid Waste Section

Date of Site Inspection: August 17, 2011 **Date of Last Inspection:** February 17, 2011

Currin Brothers, Inc. LCID Landfill (No. 1)
 Coley Road
 Durham, NC 27703

Comprehensive Audit

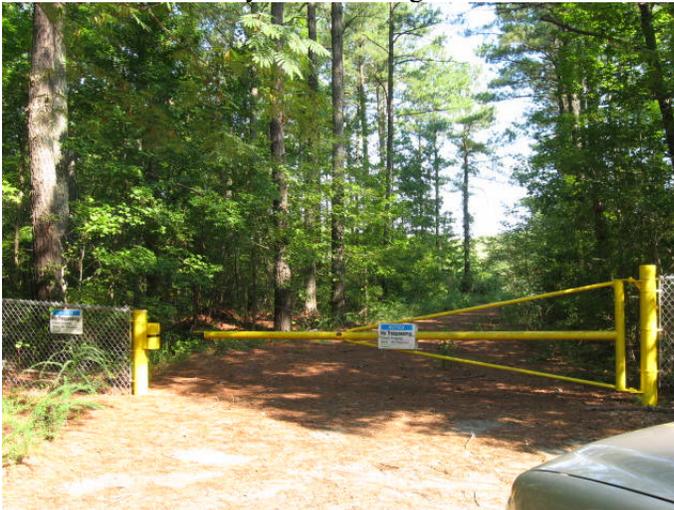
Facility access road/gate

11. The facility is secured by a locked gate. The entrance/gate is also used by a local power authority to access high voltage transmission lines.
12. Ensure the facility has proper signage.

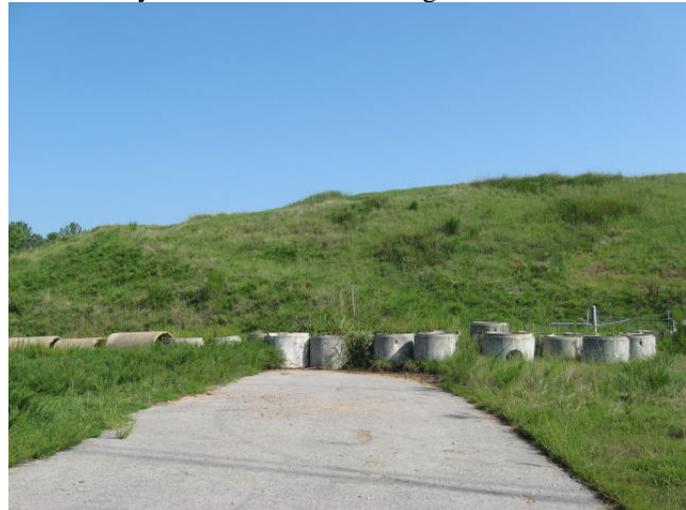
Facility access road to front/edge of fill area

10. The facility has an all-weather access road leading to the front/edge of the fill area. The landfill cap does not allow vehicle access. Ready access to the landfill cap and around the fill area perimeter should be established and maintained such that routine inspection can be conducted.

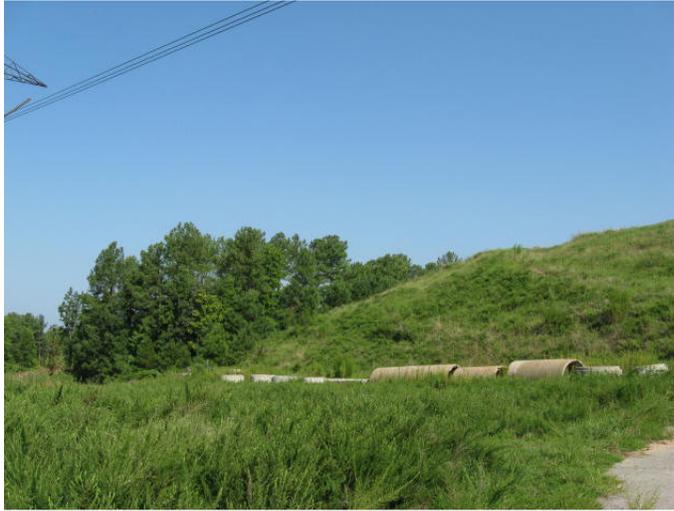
Left front of fill area

8. Permanent disposal unit boundary markers shall be installed and maintained.
9. Ensure that the landfill cap is routinely mowed and woody vegetation removed.

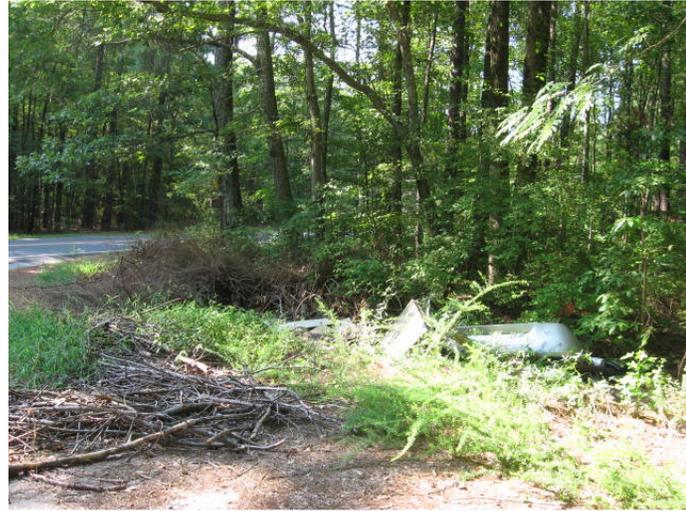
Dumped material at facility gate

13. Ensure that the waste material dumped at the facility entrance/gate (to include the scrap tire inside the facility, adjacent to the gate) is picked-up and brought to an approved solid waste disposal facility.

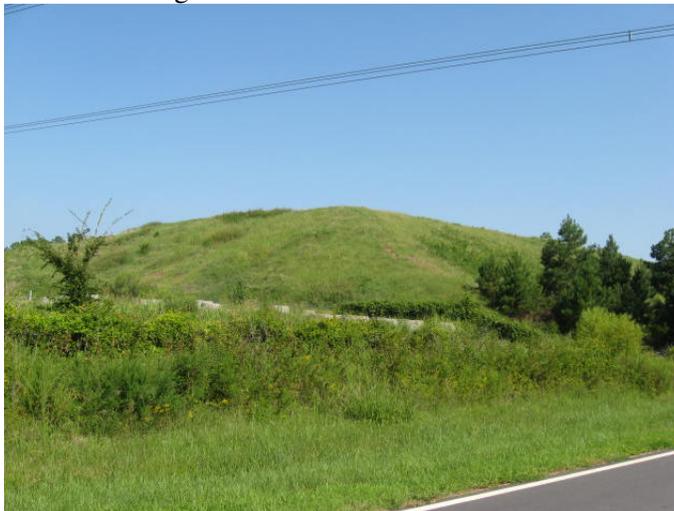
Right front corner of fill area

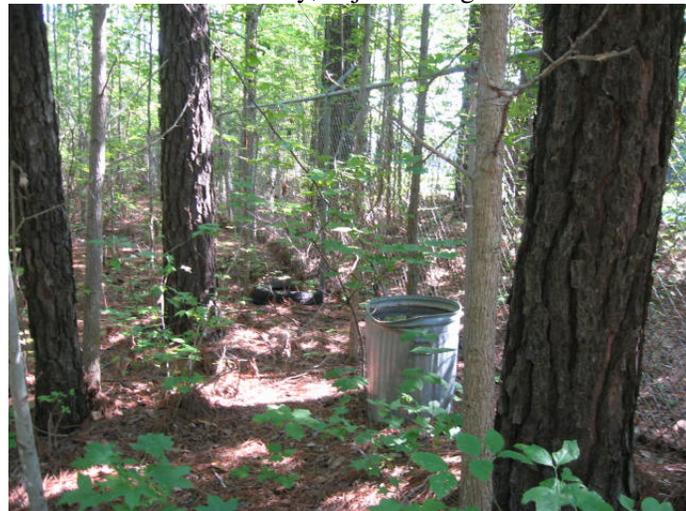
Tire and metal garbage can (filled with water) inside facility, adjacent to gate

14. Ensure that the metal garbage can filled with water (inside the facility, adjacent to the gate) is dumped-out/does not cause a nuisance condition.
15. The facility is permitted for a land clearing debris treatment and processing (T&P) operation.
