FACILITY COMPLIANCE AUDIT REPORT
Division of Waste Management
Solid Waste Section

Edgecombe Co. MSW Transfer
 2797 Colonial Road
 Tarboro, North Carolina 27886

Comprehensive audit of MSW Transfer

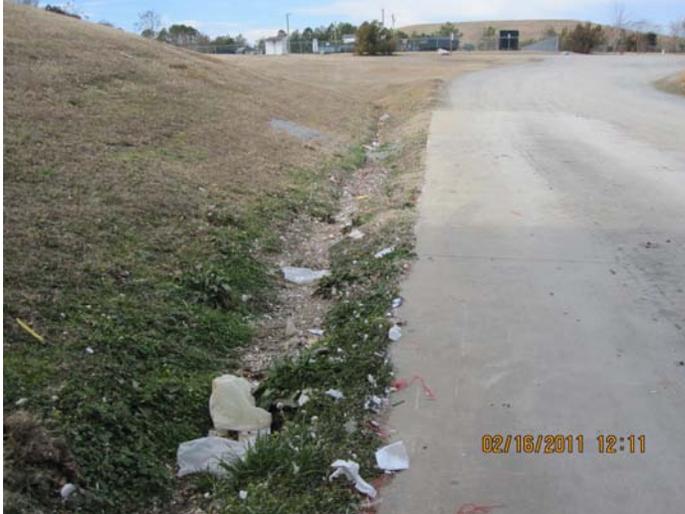
Blown waste in ditch along the trailer entrance

- 5) There is much waste in the ditch below the facility and the drainage ditch that drains it. This must be cleaned daily. Procedures need to be implemented to curb the amount of windblown waste. It might be advisable to clean the trailer dump area between each load.

- 6) Extending and adding new wind screens might be worth investigating.
- 7) Might consider reworking the ditch or filling so waste does not collect there. This ditch has been a collection point for blown waste in the past.

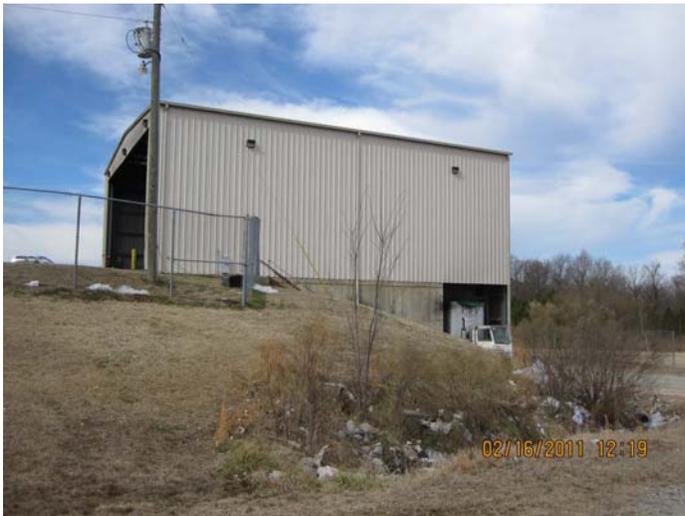
Blown waste in ditch along the trailer exit road

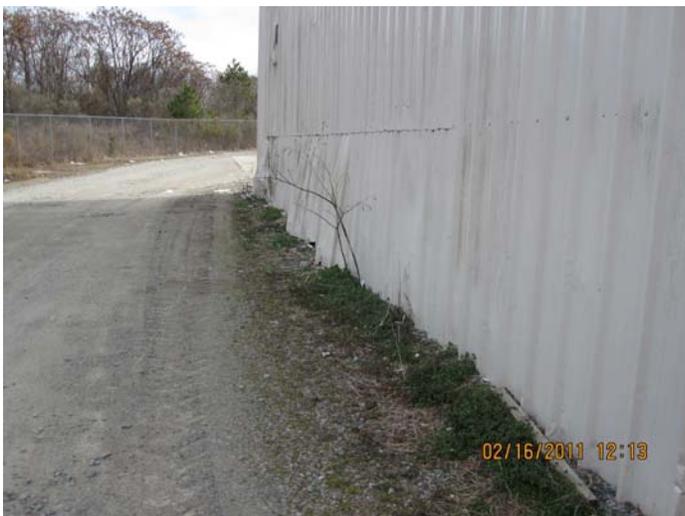
Back of facility along the trailer loading area showing damage to the wall

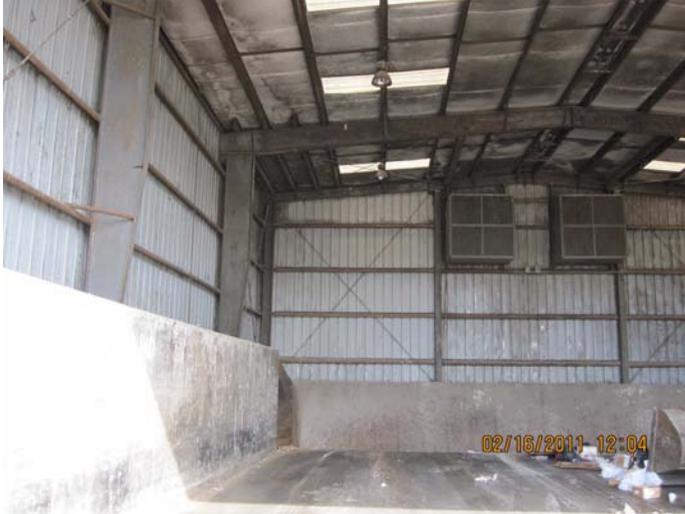
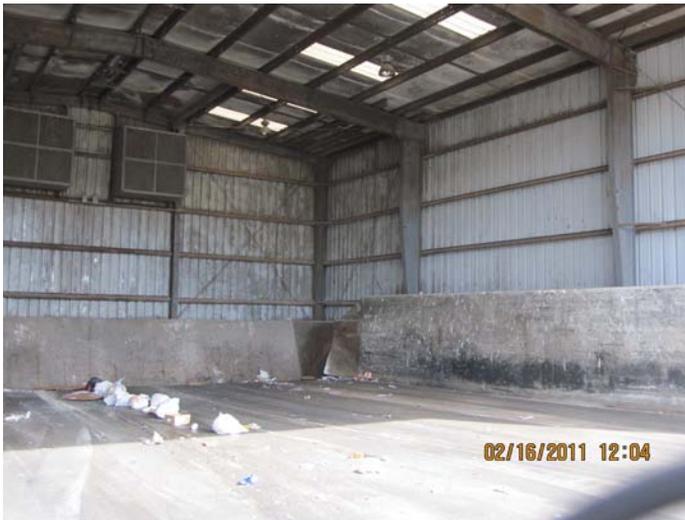
1. Facility is receiving approximately 50 TPD.
2. The operating hours are from 8-4:45 MF, and 7:30-11:30 Saturday.
3. The service area is Edgecombe, Nash, Halifax, Wilson, Martin, and Pitt Counties.
4. Certificated operators: Mike Cummins, 12/5/11, Eddie Kilby 12/5/11, Travis Hudson 12/5/11, Charles Cross 12/5/11.
5. Waste water from the floor washing is transported to the Rocky Mount WWTP, there are two underground storage tanks and with a high water warning light.
6. Shavender Trucking does the hauling and owns the trailers, three were not covered. Cummins indicated that the trailers are covered during windy conditions.
7. The floor was in fairly good shape, Cummins stated it is cleaned two to three times per year.

Tipping floor

- 1) The lights are apparently not working. This needs to be checked and repaired as necessary.
- 2) The floor needs to be cleaned more frequently than 2 to 3 times per year, probably should be cleaned weekly.

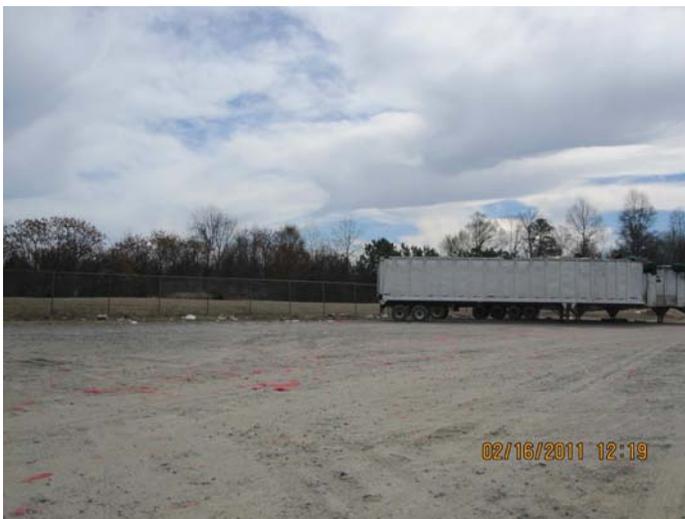
Trailer storage area.

- 8) It would be a good idea to orient the trailers on the lot so that they tilt forward and any liquid in the trailer drains forward. The gaskets around the rear gate need to be kept in good repair so that the trailers do not leak during storage and transport.
