FACILITY COMPLIANCE AUDIT REPORT
Division of Waste Management
Solid Waste Section

Date of Audit: November 9, 2010

Franklin County Transfer Station
 10 Landfill Road
 Louisburg, NC 27549

Comprehensive audit of a transfer facility.

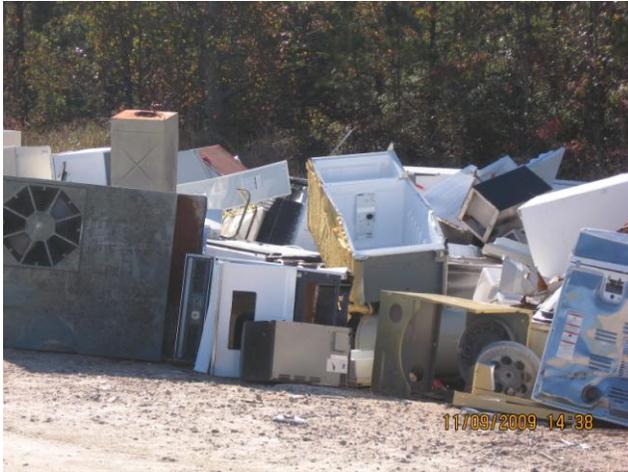
1. The white goods without CFC's, should be kept separate from the white goods with CFC's to prevent CFC release. At the time of this inspection there were quite a few white goods and non CFC white goods such as microwaves, stoves, hot water heaters, etc. mixed together. It looked like some of the refrigeration units were put

on top of other units due to lack of space, thus increasing the potential of broken lines with CFC's escaping. The paperwork showing CFC removal was not checked during this visit. CFC's are removed by the scrap contractor. The scrap shall not be in water, the area needs to be graded to promote positive drainage away from the waste. Many of the white goods were positioned in such a way as to collect water, which could become mosquito breeding areas. It is strongly recommended that a white goods pad be installed. Contact Bill Petrakis, NCDENR, for information on a white goods grant.

White goods area showing non CFC white goods included with CFC units and refrigeration units being stacked

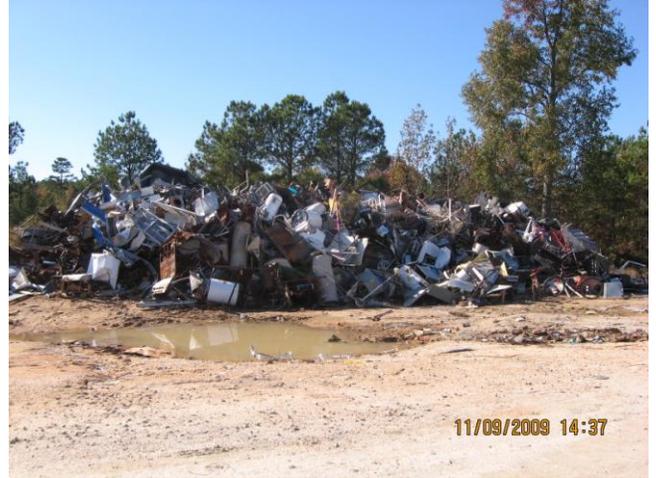
White goods area without a pad

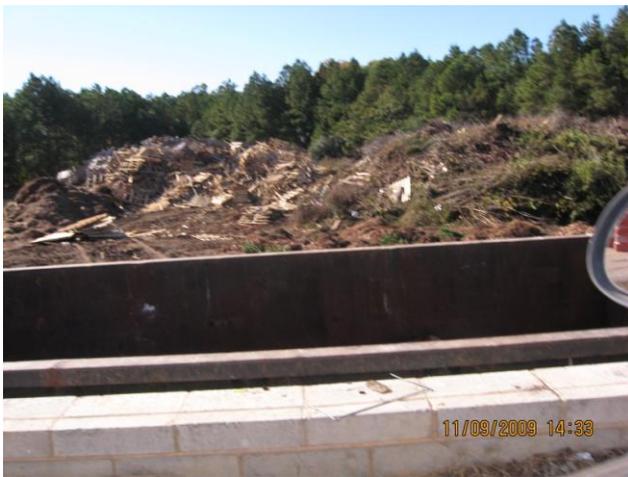
13. The Yard Waste area **MUST** follow the compost rules, 15A NCAC 13B Section .1400 for a Type 1 facility if grass clippings and other yard waste resulting from landscaping activities is accepted. It is recommended that a separate area be designated for yard waste that can be composted according to the rules. All of the other acceptable wastes (no yard waste) must be windrowed with fire equipment accessibility around the perimeter and between the windrows. **This was commented on in the previous audit.** There shall be no waste in water. The area needs to be graded to promote positive drainage away from the waste. It is suggested that you contact Novozymes to look into their taking your yard waste and brush.

Yard waste area

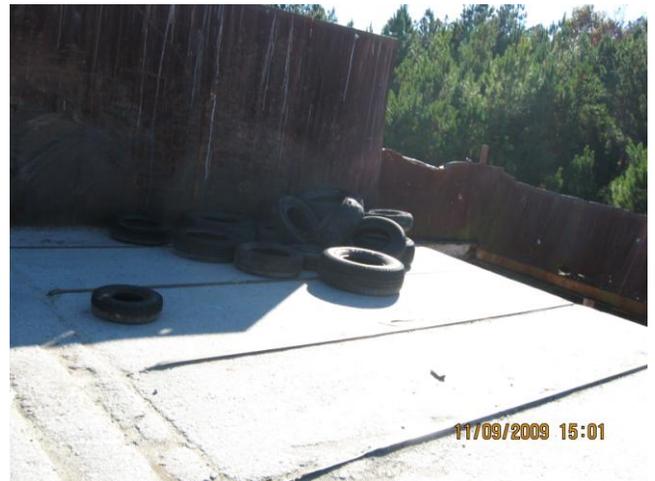
Old transfer facility being used for tire collection

4. The scrap tires are being removed within 10 days. It is strongly recommended that a roof be put over the trailers with the tires, in order to prevent water from being included in the cost for removal.

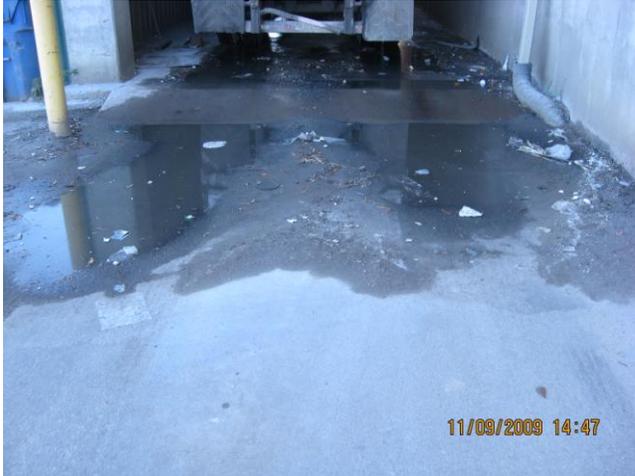
6. The facility does not take asbestos.
7. The transfer facility looks very good.
8. There is a depressed area at the entrance to the tractor trailer loading area. There was some ponded water mixed with waste causing leachate in this area. All leachate must go into the leachate tanks. **This area must be repaired within 30 days of receipt of this audit.**

Area of ponding leachate at entrance of trailer loading area

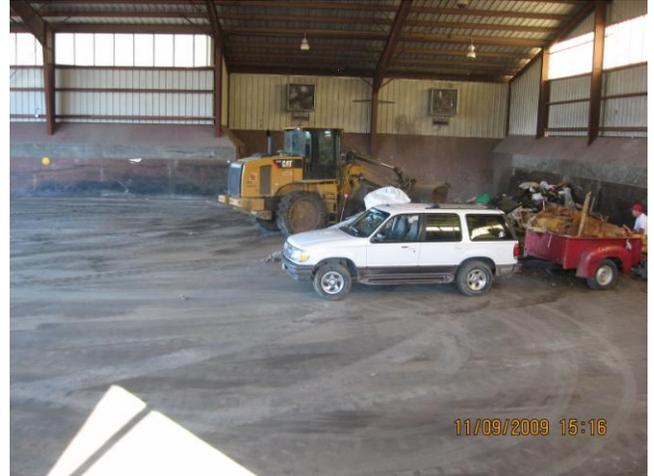
11. Waste Screening is being done and records are being kept.
12. Unacceptable waste streams are removed on a daily basis from the tipping floor Transfer Facility.

Tipping floor
