FACILITY COMPLIANCE INSPECTION REPORT
Division of Waste Management
Solid Waste Section

Date of Site Inspection: 7/27/11, 7/28/11, and 8/23/2011

Haywood County Municipal Solid Waste Processing Facility
 278 Recycle Road
 Clyde, NC 28721

Site inspection conducted to observe LFG system construction activities.

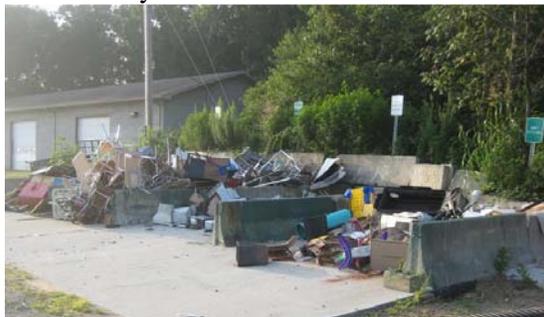
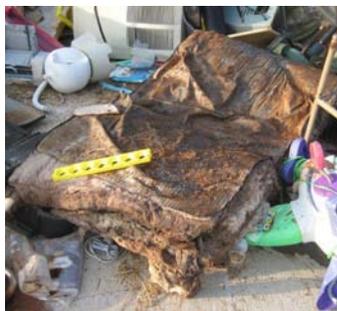
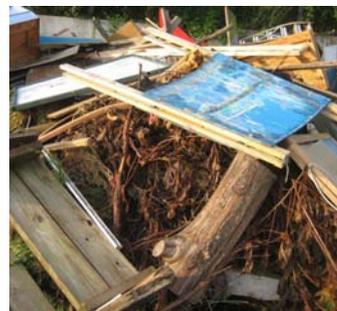
1. On site with S. King to conduct site inspection. Construction activities associated with the LFG system installation were underway. Payne McGinn & Cummins, Inc. on site for the construction of the trenching/piping systems.
2. During the inspection S. King emphasized to construction supervisor that all waste generated from the trenching activities required soil cover at end of day (and no new waste generated from construction activities could be landfilled).
3. Waste storage areas created and utilized by the Haywood County school systems (maintenance facility on site) were observed during the site inspection. Areas were labeled: scrap wood, metals, electronics, plastics, and non-recyclable. Waste was not stored under cover (recommended for electronics) or in containers.

The “non-recyclable” bin material appeared to be co-mingled Solid Waste and as such requires management in accordance with the 15A NCAC 13B .0104 Solid Waste Storage Rules. In addition, the “scrap wood” bin contained what appeared to be Yard Waste and Construction & Demolition wastes.

Please note that **all activities occurring within the footprint of the facility boundary are governed by the existing Permit** and associated closure conditions and that the intake, storage, and management of un-containerized materials may require a permit modification.

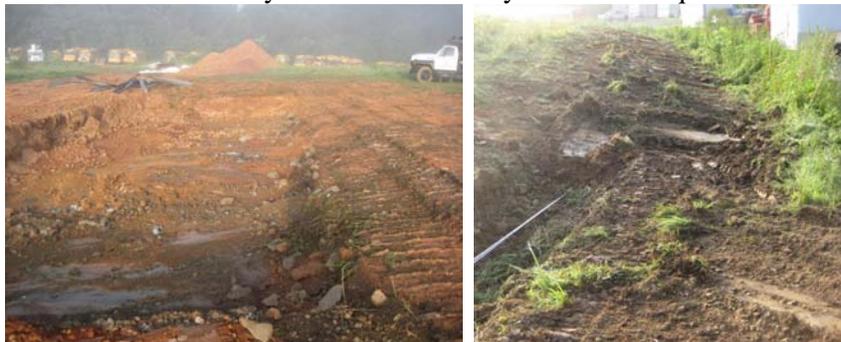
1. Returned to the facility ~8:00 a.m. to verify that cover requirements had been met. No issues noted.

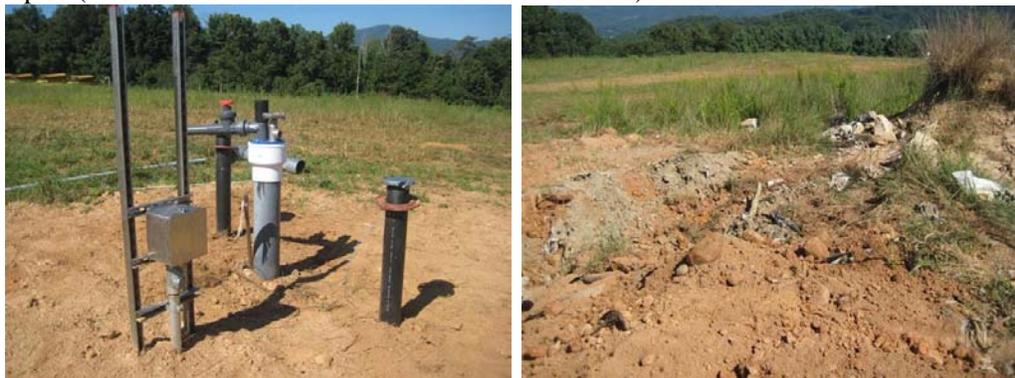
1. Site inspection was conducted to observe on-going construction activities. Weather was dry, clear, 80's.
2. Gas extraction wells were being tied-in to the piping system (LFG flare) on the top cap of the closed landfill. The excavation activities required trenching through the soil cap – note that all waste generated from this excavation requires proper disposal. Soil co-mingled with wastes is considered waste and cannot be utilized for the cap repair (A. Keller discussed this on-site with contractor).

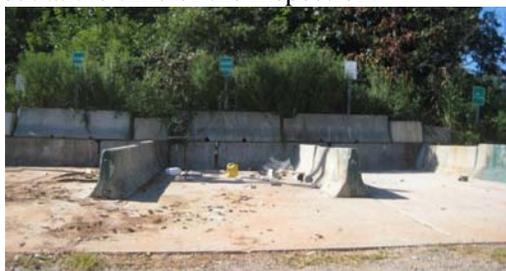
3. All wastes and stored materials in the bin storage system noted above (July 27, 2011 Item #3) had been cleared out at the time of the inspection.

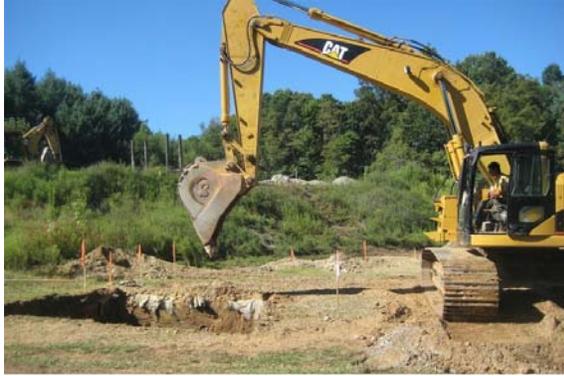
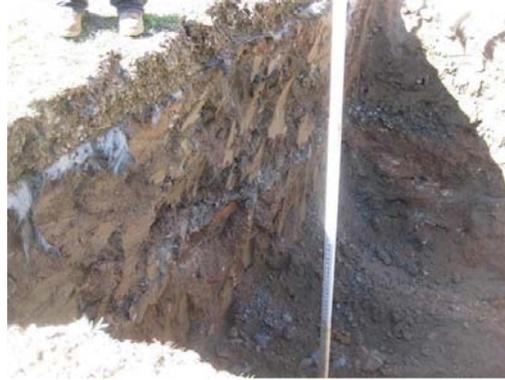
4. Piping/trenching had progressed to the access road portion of the facility. Wastes had been encountered along much of this trench location (between vents). Excavation for the flare station foundation was underway at the time of the inspection. Fabric matting was encountered approximately 6-inches below grade but no wastes were encountered during the inspection (observed to depth of 8-9'). (see photo below).
