Subject: Cell VI – Valley Fill and Vertical Extension
Landfill No. 6, Permit Number 44-06

DOCUMENTATION REPORT

**CONSTRUCTION OF THE
LANDFILL NO. 6-AREA A
VALLEY FILL**

**BLUE RIDGE PAPER PRODUCTS, INC.
CANTON, NORTH CAROLINA**

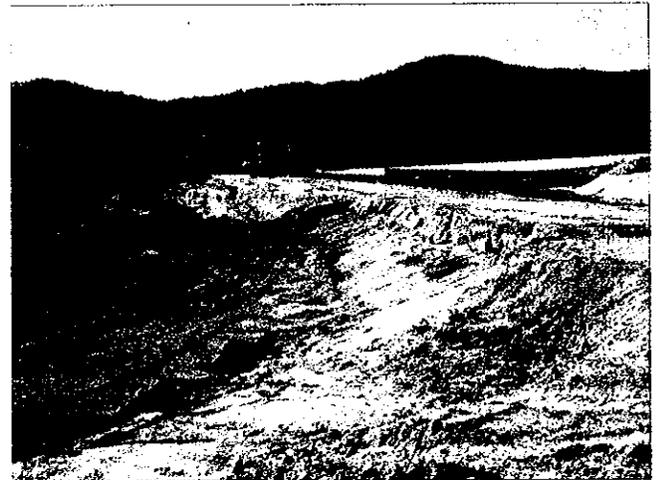
slope excavation 6A east

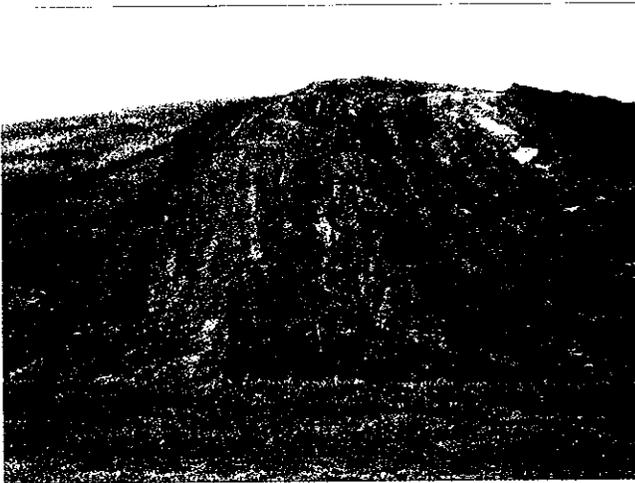
completed berm north end

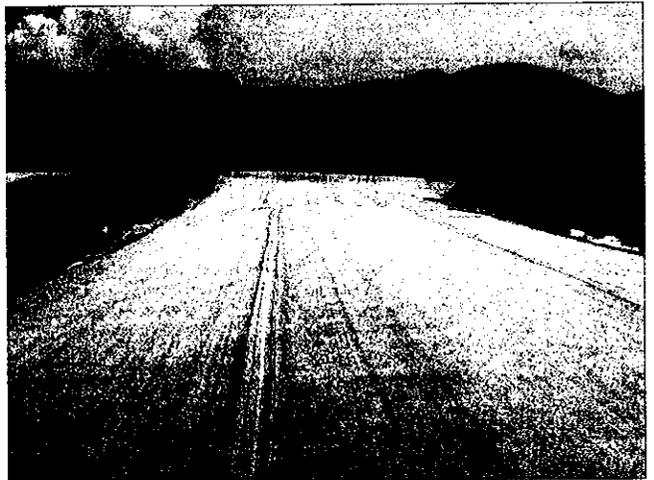
completed GCL

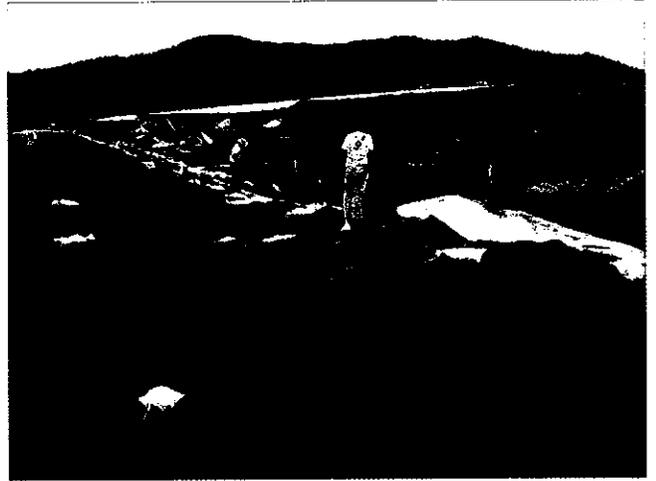
tie-in prep 6A west

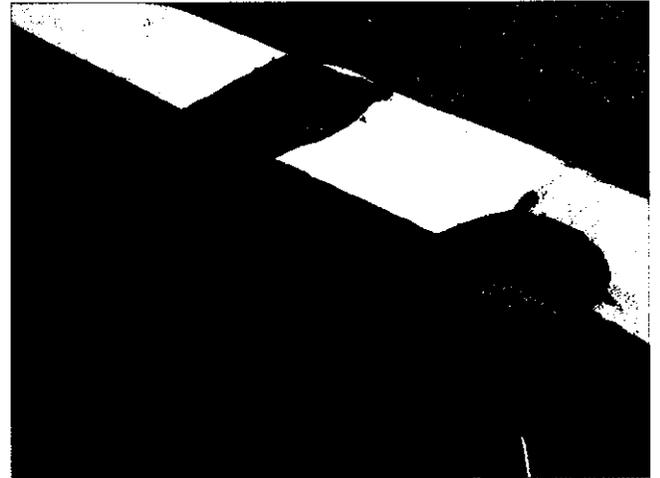
6A west tie-in

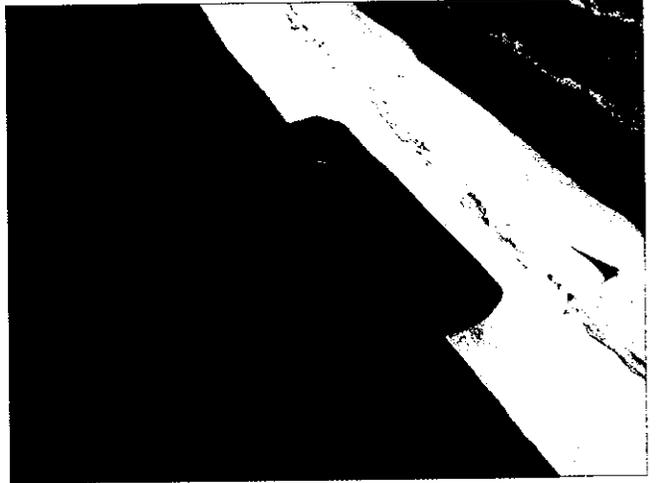
repair on DT-2

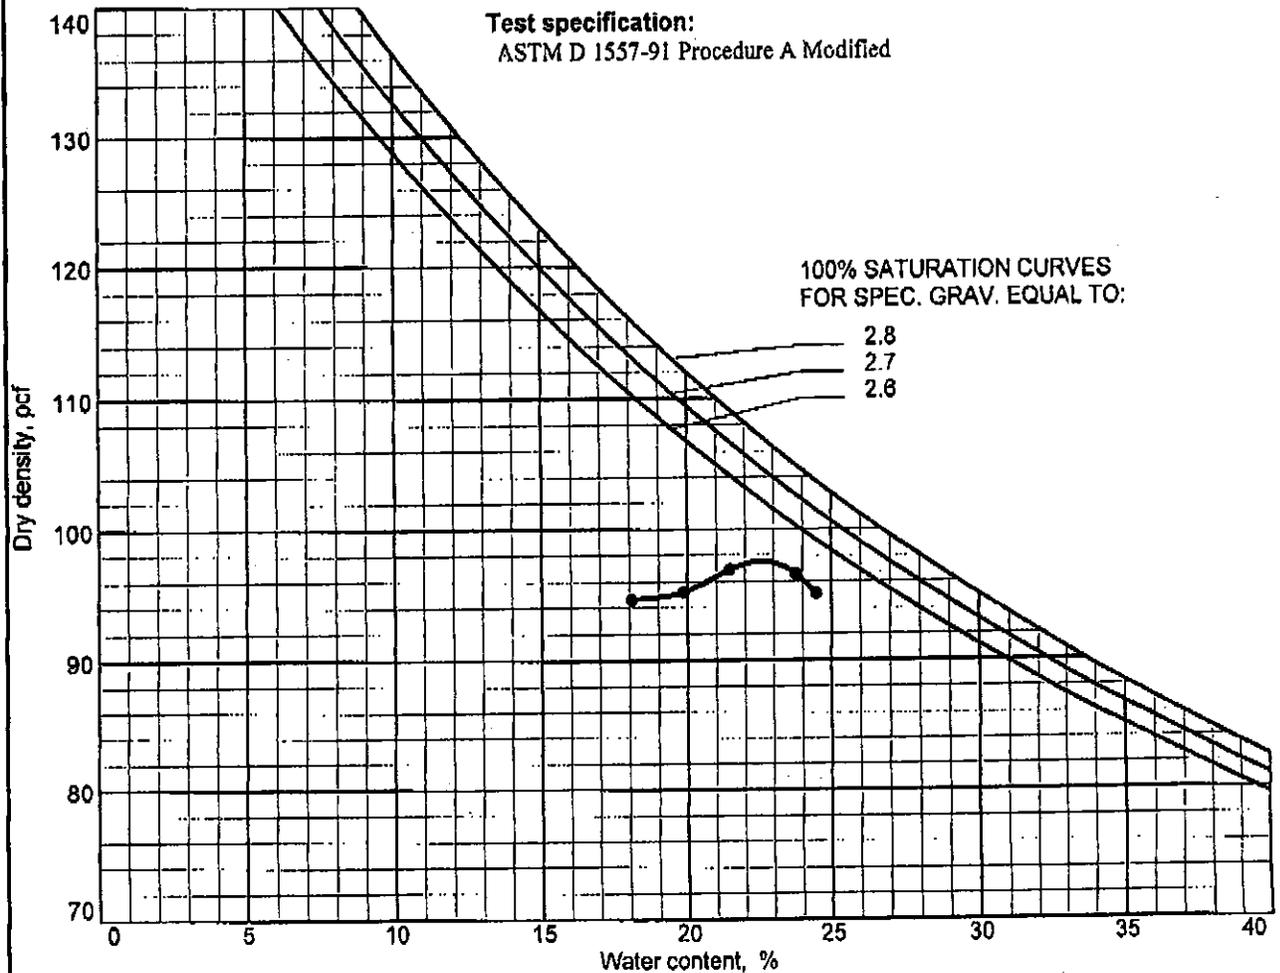
Plate

Maximum dry density = 97.5 pcf

Optimum moisture = 22.6 %

MOISTURE DENSITY TEST DATA
