FACILITY COMPLIANCE AUDIT REPORT
Division of Waste Management
Solid Waste Section

Dates of Audit: 03/08/11

Haywood County Municipal Solid Waste Landfill
 State Road 1338, White Oak Community
 Waynesville, N. C. 28786

Comprehensive Audit

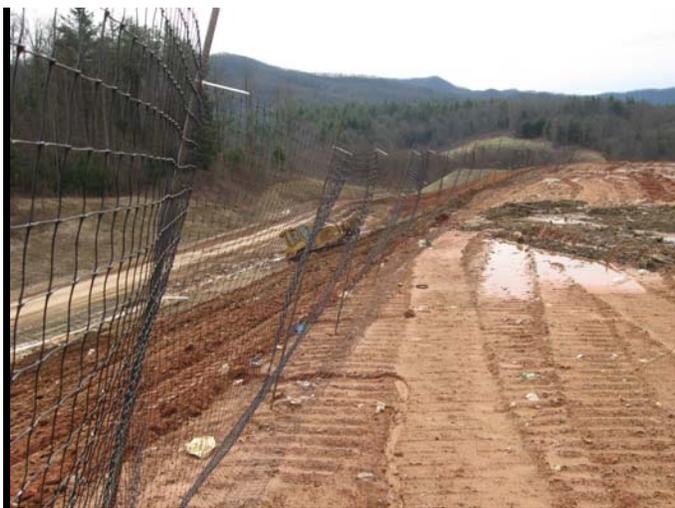
03/08/11

Repair of side slopes and windblown fencing.

4. The operators were managing a small working face, compaction was ongoing, and daily soil cover appeared adequate (some waste flagging was noted and discussed with M. Shumpert). Repair work to the active face side slopes was underway at the time of the inspection – recent heavy rains had created erosion rills. **It appeared as though the**

drainage ditches in these regions had received silt run-off from the side slopes and may require further maintenance.

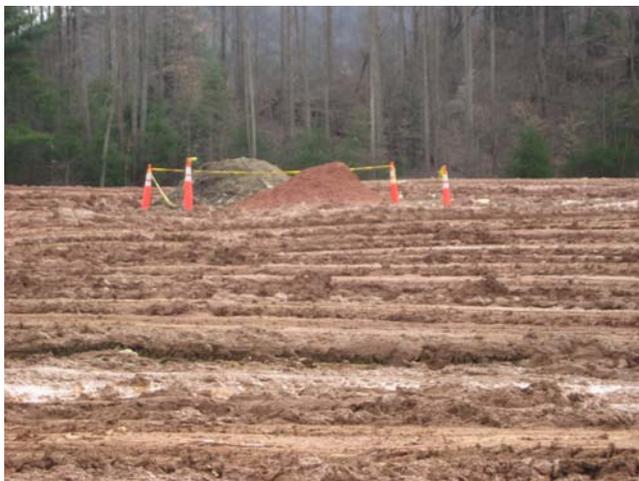
03/08/11

5. Use of fabric tarps as an alternative daily cover is approved by permit condition. **Please note that the ACM demonstration project for use of a soil/mulch ACM expired on October 15, 2010.** No report summarizing the demonstration of the ACM has been received by the Section and the current PTO does not authorize use of soil/mulch as an ACM. For the County to continue forward with plans to utilize any ACM, they must submit in writing (to A. Keller) a request for a new demonstration period.
6. The facility appeared well-managed, traffic flow was controlled with barriers and signs at the active working face. During the inspection a waste-screening was performed at the working face in accordance with the facility Operations Plan. No issues were noted.
7. Asbestos disposal was being managed away from the working face in accordance with Rule and Operations Plan requirements.

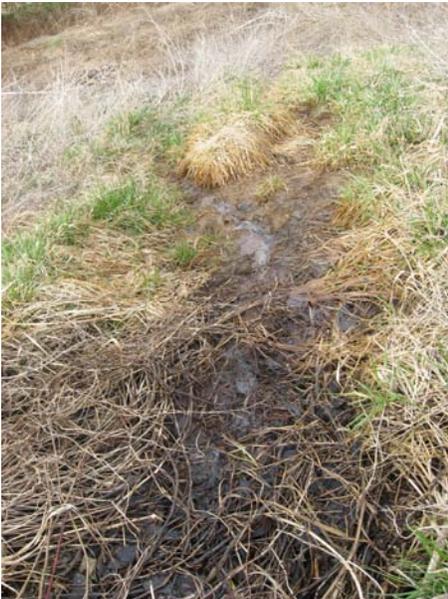
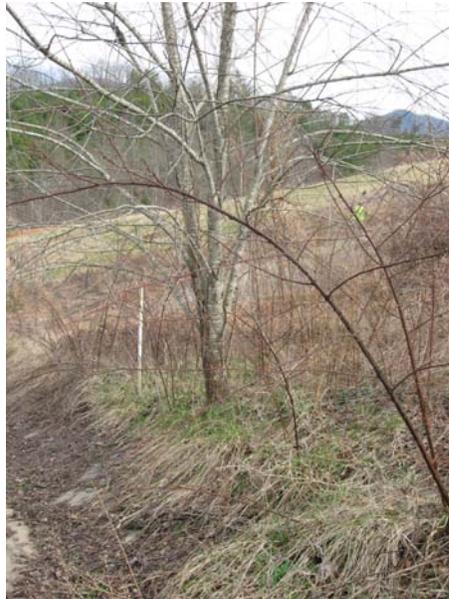
03/08/11

12. A seep was observed on the north side of Phase 1 near the leachate pond. It was identified to M. Shumpert for repair. No leachate was observed leaving the disposal unit at the time of the inspection. Also noted in this region was the encroachment of woody vegetation inside the marked edge-of-waste boundary.

Please remove all woody vegetation and materials that impede the facility's ability to inspect and maintain cap integrity (briars, etc).
