FACILITY COMPLIANCE AUDIT REPORT
Division of Waste Management
Solid Waste Section

Date of Audit: 02/09/2011

Haywood County Municipal Solid Waste Processing Facility
 278 Recycle Road
 Clyde, NC 28721

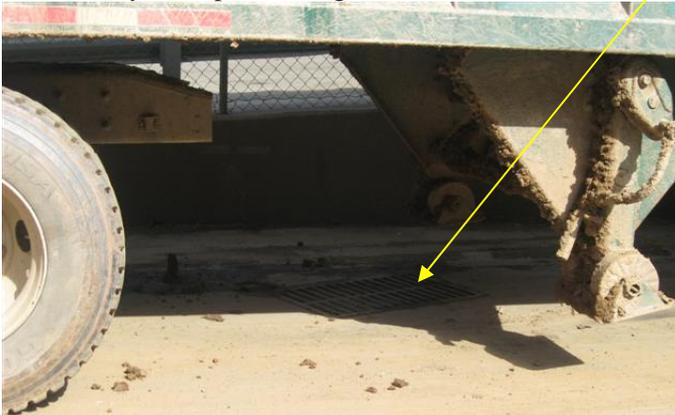
8. Fire extinguishers were available in all structures. Extinguishers had been checked/rated as of September 2010.
9. The baler is currently not in operation. The Facility pushes waste from the tipping floor into transport vehicles via a loading dock. Drains in the tipping floor, and the drain beneath the transport vehicle loading area tie in to the sewer system (per S. King).

The Transfer Station and tipping floor appeared to be in good condition, no accumulation of wastes on walls or support beams was noted at the time of the audit. Leachate drains on the tipping floor are cleaned weekly or as needed (per S. King).
