FACILITY COMPLIANCE AUDIT REPORT
Division of Waste Management
Solid Waste Section

Date of Audit: 06/11/10

Henderson County Solid Waste Transfer Facility
 802 Stoney Mountain Road
 Hendersonville, NC 28791

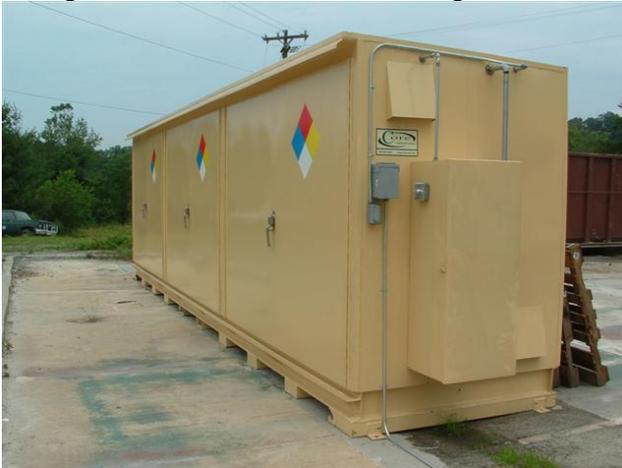
06/11/10

1. The Permit and Operations Plan was reviewed prior to site inspection. The Operations Plan for the Transfer Station is located within the Permit Application dated February 22, 2006.
2. The service area consists of Henderson, Polk, Transylvania, and Buncombe Counties – per the Permit Modification dated March 21, 2006. Waste is disposed of at the Waste Management Palmetto Landfill located near Spartanburg, South Carolina.
3. The permit modification referenced above was for the addition of household hazardous waste collection and management (HHW). The HHW storage unit is currently on site, east of the transfer station.

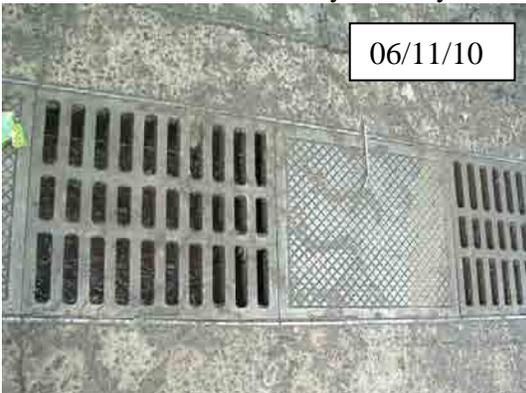
4. The tipping floor and transfer trailer loading area were controlled and considered to be maintained in a clean and sanitary condition. Be aware of potential buildup of waste in the trailer loading bay and on the push walls.
5. The previous audit referenced the need for the windblown litter at the facility to be collected and controlled on a daily basis. Since the audit, significant work had been conducted to improve the collection and maintenance of windblown litter and the site looked well-maintained.
6. Leachate is contained by a trench drain system on the edge of the tipping floor and associated floor drains. The leachate drains to the sanitary sewer system. The trench drain had been cleaned since the previous audit.

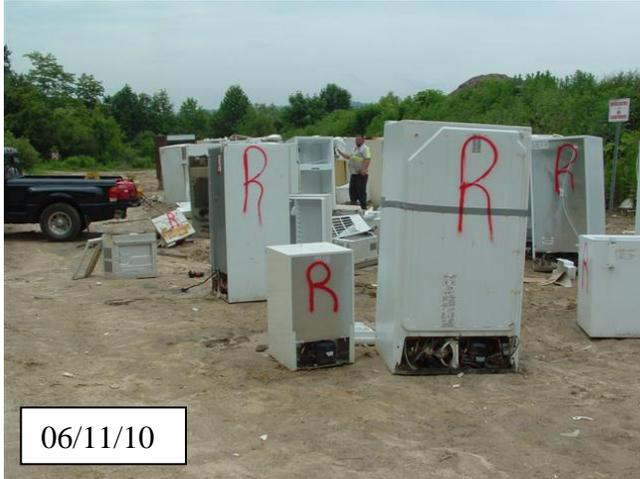
7. White goods are being managed at the facility in an area located next to the yard waste/grinding operation.

OmniSource Corporation was present and collecting CFFs during the time of the audit. The white goods are marked ("R") following removal of the CFCs.

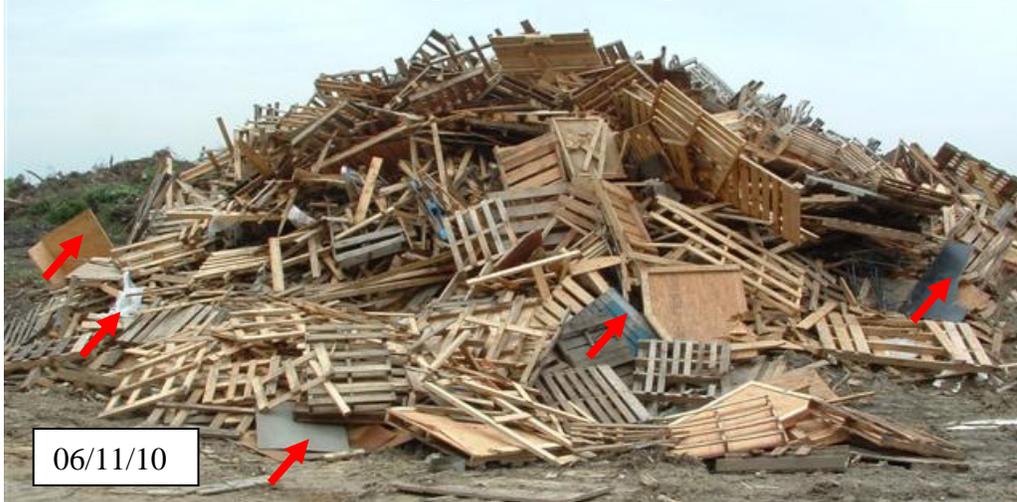
8. The yard waste /grinding operation had a wooden pallet pile which contained some materials which need to be removed for disposal prior to grinding (painted and/or engineered wood, some plastics).

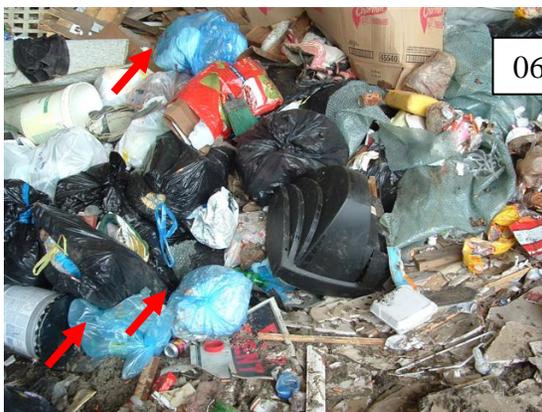
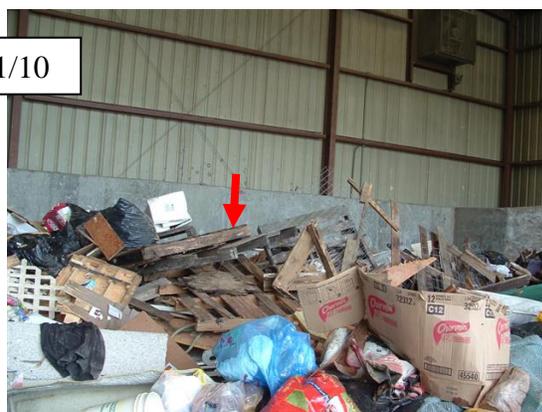
9. During the transfer station site inspection, the piled waste in the public access bay contained some materials which are banned from disposal. Blue bags containing recyclable materials and wooden pallets were visible. Note that wooden pallets, unless associated specifically with Construction and Demolition activities are a banned item. These items are expected to be removed from the waste stream for proper recycling/recovery.
