FACILITY COMPLIANCE AUDIT REPORT
Division of Waste Management
Solid Waste Section

Date of Audit: April 15, 2010

Macon County Transfer Facility
 1080 Rich Gap Road
 Highlands, NC 28741

Comprehensive Audit of Transfer Station

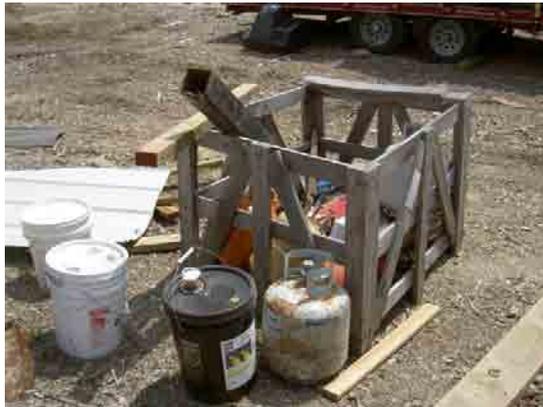
10. All material collected for recycling was being taken to the Macon County Recycling Facility in Franklin.
11. White goods were taken to the facility in Franklin for removal of Freon. No white goods were at the site during the audit.
10. TV's and computer monitors are placed in dumpsters next to the Transfer Station tipping floor. Propane tanks

and other pressurized tanks are collected near this location.

Pressurized Tanks

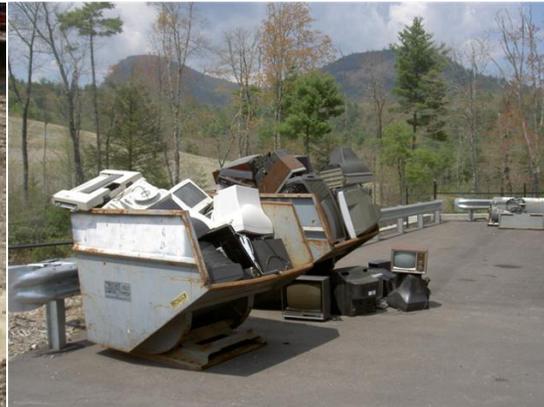
Television and Computer Monitors

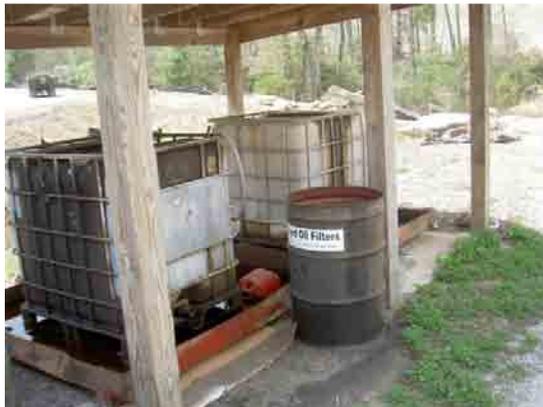
12. Used oil was being collected in two tanks with secondary containment. Used oil filters are also collected at this location.

Used oil and filter containers

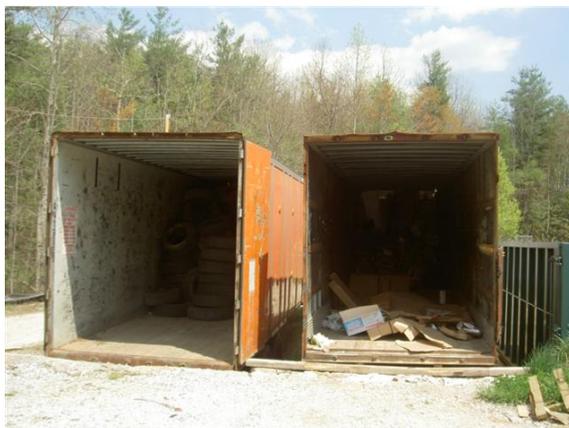
13. There were also barrels for used cooking oil. Bears had apparently, turned over the barrels and spilled some on the concrete where they were placed. **This area must be secured to prevent future spillage.**
14. The tire trailer was observed. All tires were placed in the trailer and covered. There was also a cardboard/paper trailer and all material was in the trailer.

Tire and Cardboard/Paper Trailers

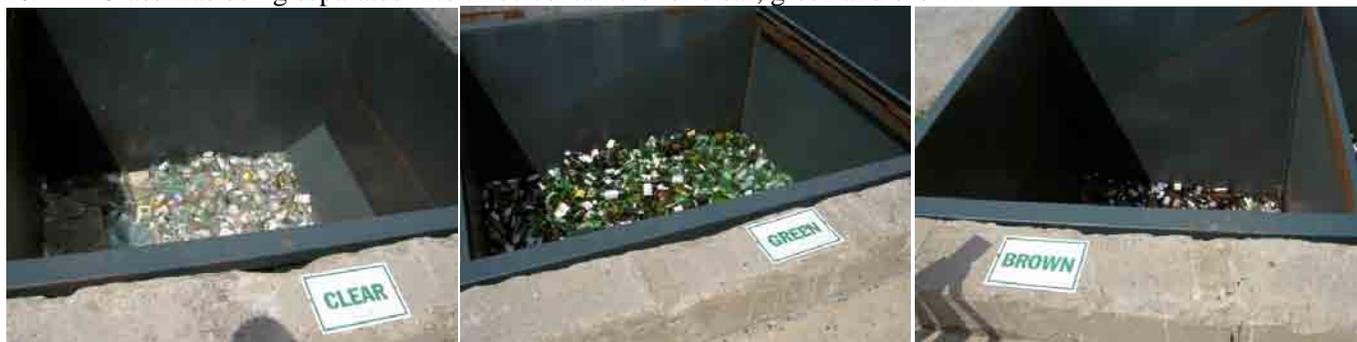
16. Glass was being separated into three containers for clear, green and brown.

Glass recycling

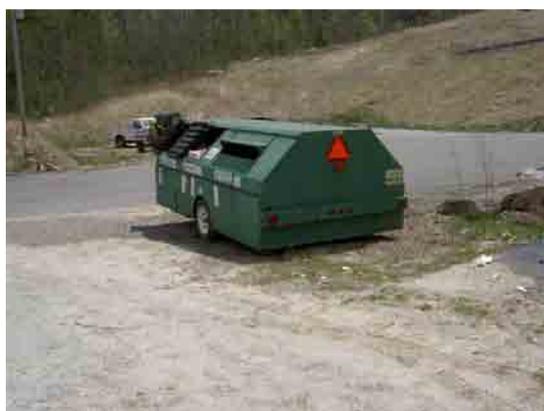
17. There was a recycling trailer on site that receives aluminum and plastic.

Recycling Trailer

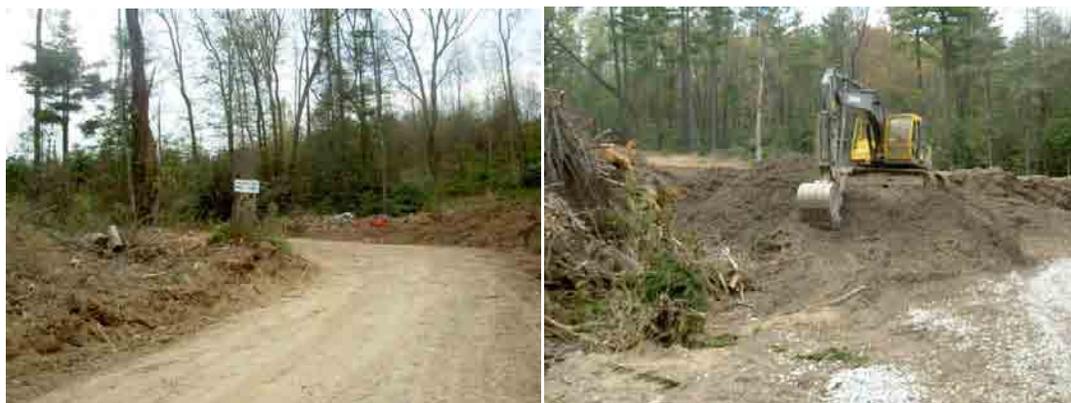
18. This facility is permitted to receive yard waste. This area receives a small amount of leaves and a greater amount of brush and land clearing material. After the material is ground it is transported to the Macon County Landfill for use as a soil amendment. No material is distributed to the public according to staff. **The permit requires the operation of this area to be conducted in accordance with the approved operations plan; however, the plan does not mention this activity. The Operation Plan will need to be modified to incorporate this activity. Please contact Allen Gaither, Permitting Engineer regarding the modification.**

Yard Waste Area

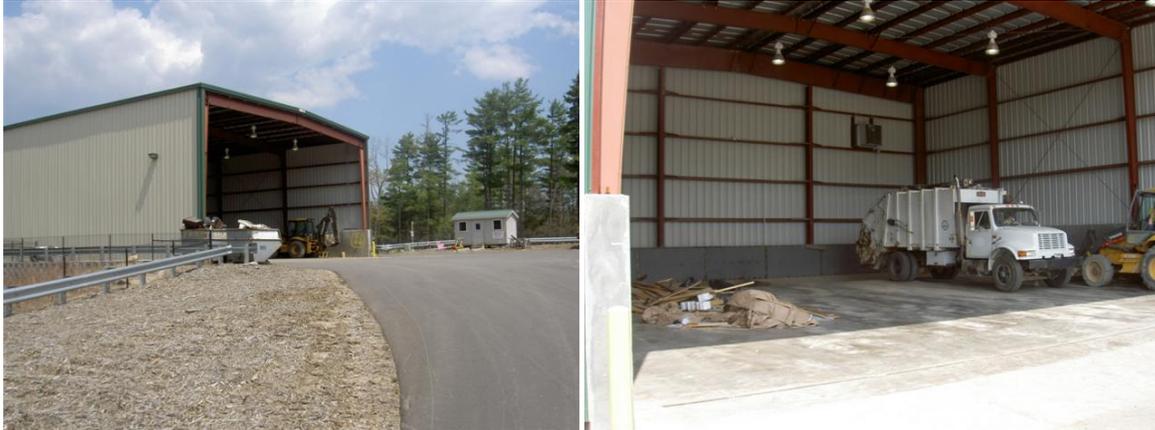
19. Waste is placed on the tipping floor, with the exception of the Highlands Sanitation Department (HSD), which dumps directly into the trailer. One bag of leaves and a television was observed being dumped by the HSD. Staff immediately reported this to the drivers. Material that is on the tipping floor is pushed into the trailers using equipment. Staff appeared to be doing a good job of keeping this area clean.

Tipping Floor
