FACILITY COMPLIANCE AUDIT REPORT
Division of Waste Management
Solid Waste Section

Date of Audit: 10/05/09

MADISON COUNTY SOLID WASTE FACILITY
 271 Craig Rudisill Road
 Marshall, NC 28753

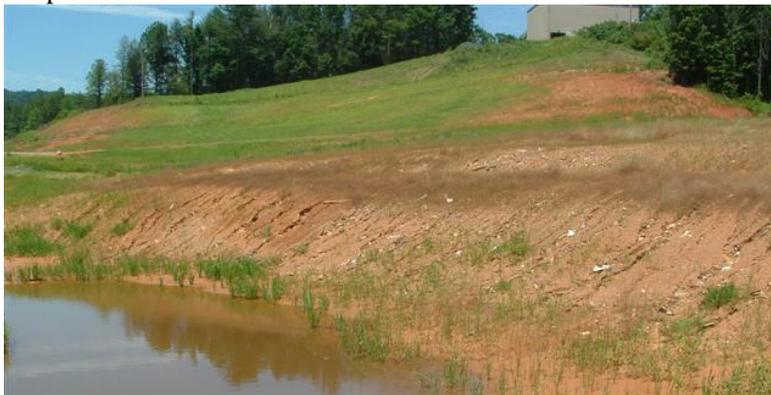
06/25/09

1. No issues with Wind Blown materials at the C&DLF.
2. The permitted edge-of-waste boundary stakes were maintained and visible.
3. The waste type in the C&D was reviewed and is according to permit. No unacceptable waste streams were noted.
4. The active working face of the C&DLF was kept to a controlled area, and the recently applied cover was adequate and in good condition. However, as seen in the picture below, the areas of the C&DLF which were less recently active (toward the sediment basin region) are eroding and waste has been uncovered. **These areas require repair/cover.** It did not appear that this issue had been addressed since this issue was noted in the previous audit.
