FACILITY COMPLIANCE AUDIT REPORT

Division of Waste Management Solid Waste Section

Date of Audit: January 25, 2011Date of Last Audit: October 9, 2009**FACILITY NAME AND ADDRESS:**

Warren County MSWLF (Closed)
 Baltimore Road
 Warrenton, NC 27589

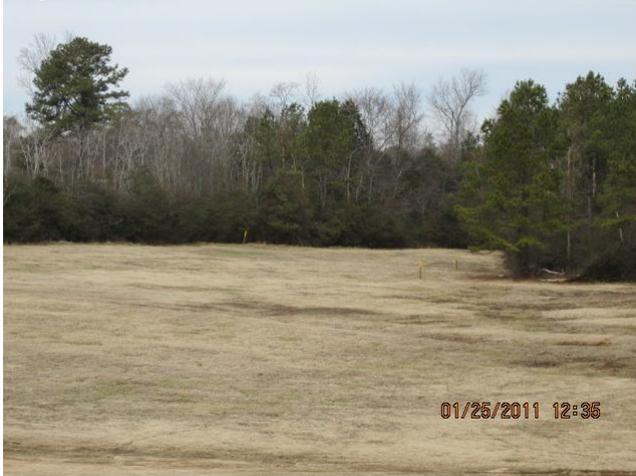
- 3) There were a couple of depressed areas at the landfill that closed in the 70's, to the roadside and behind the old dog pound. It is recommended that these areas have soil added to prevent any ponding of water.

Old LF, closed in 1970's, showing a few depressed areas and EOW marker.

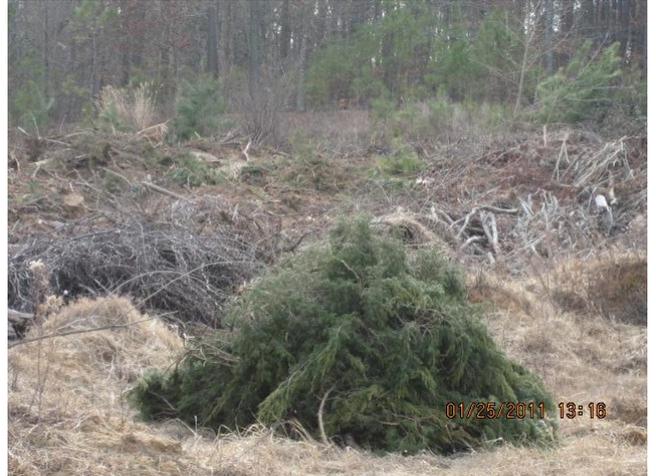
- 4) The LCID area needs to be covered with a minimum of six inches of soil, monthly or when it reaches an acre in size, whichever comes first.
- 5) The yard waste area, separate from the Notified LCID, can have the yard waste kept in manageable windrows, with fire equipment access around the site and between windrows. There is no yard trash accepted at the site.

Yard waste area to be windrowed.

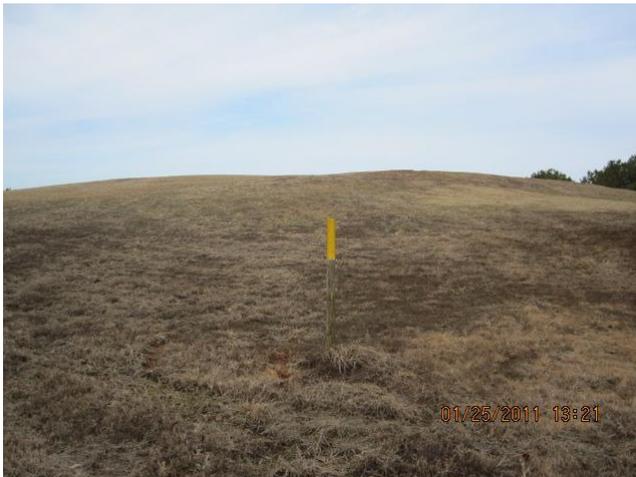
- 1) The 'Edge of Waste' markers are clearly visible. The old landfill to the back of the facility needs to have the 'Edge of Waste' markers.
- 2) There were a just a few small trees. Mr. Brothers stated that they will be cutting them down in the near future.

EOW marker.
