**FACILITY COMPLIANCE AUDIT REPORT**  
**Division of Waste Management**  
**Solid Waste Section**

**Date of Audit:** January 25, 2010

Wayne Co. MSWLF Landfill  
 460-B South Landfill Rd  
 Dudley, North Carolina 28333

Partial Audit

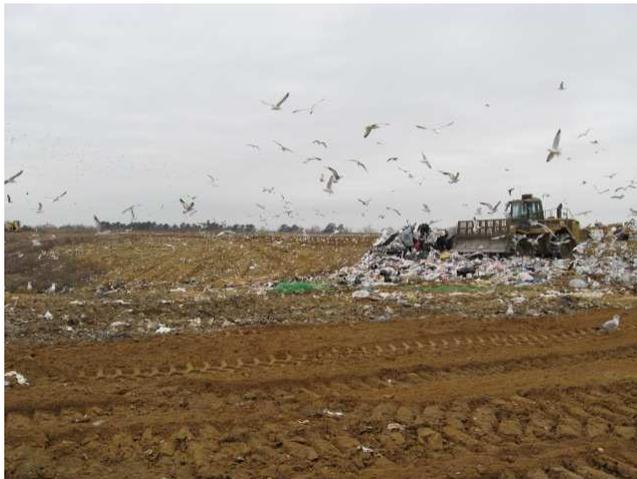
1. No banned materials were observed during the audit.
2. White goods and metals ultimately go to Kemp Recyclers.
3. Tires are loaded into a trailer.
4. The working face is kept small and is covered, as required.

Small working face

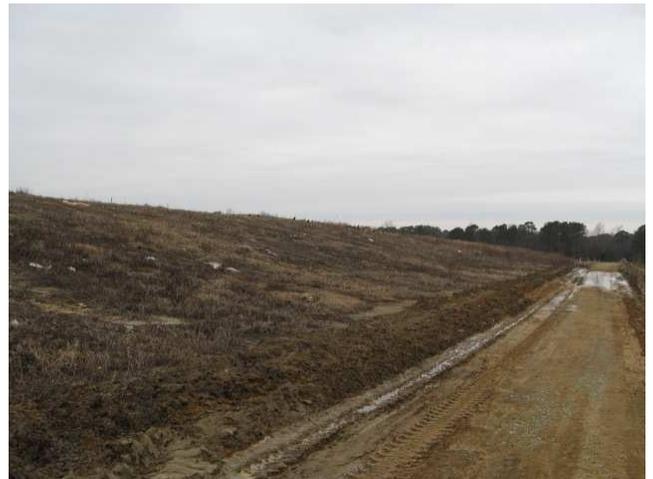
11. Several break-outs were visible on the east and north slopes, but were contained. The facility is addressing break-outs on the slopes as they arise.\*

Northeast corner slope

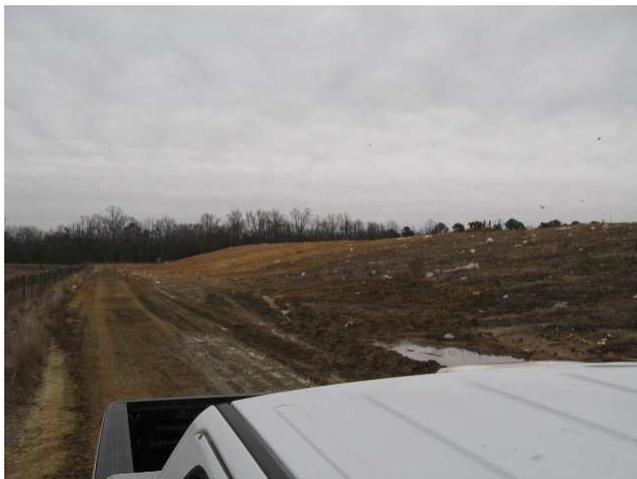
Southeast slope

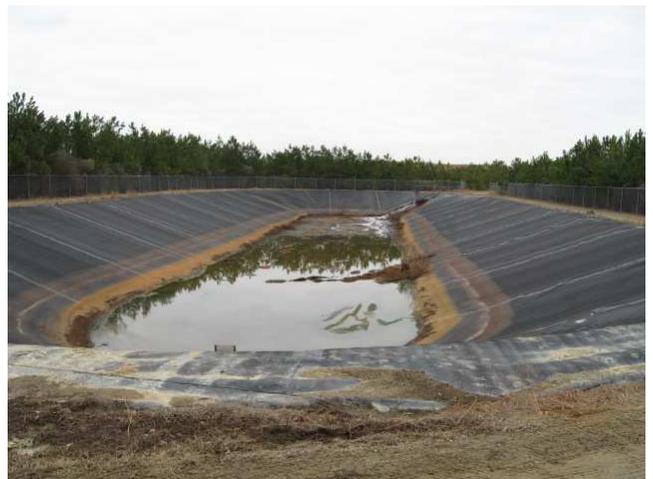
8. Monitoring wells that were visited were locked and labeled, as required
9. Leachate is pumped to the Goldsboro wastewater treatment plant.
10. Some ponding was visible on the top of the MSWLF due to recent rain and snowfall. Filling/grading needs to be done in those areas conducive to ponding.\*

Leachate pond
