**FACILITY COMPLIANCE AUDIT REPORT**  
**Division of Waste Management**  
**Solid Waste Section**

Old Coca Cola Plant  
 Hwy 158  
 Weldon, NC 27890

CCB fill site, no permit required

Comprehensive Audit

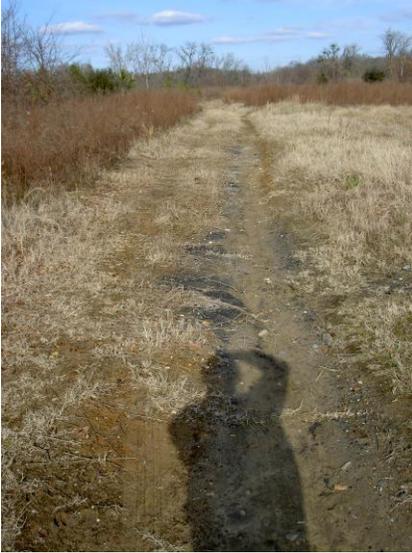
Access Road through property- showing exposed coal ash.

- 6) There is an access road going into the property that has exposed coal ash showing and in places, where there is not ash exposed, there is 2-3 inches of soil cover. The access road must have at least 12 inches of compacted soil and a gravel or some other cover in order to prevent any erosion. **The addition of the 12 inches of compacted soil and gravel or other cover must be completed within thirty days of receipt of this audit.** The grassy areas off of the access road appear to have approximately 18 inches of soil cover. There is vegetation established on the site. The slope towards the Roanoke River appears to be greater than 3:1 and there is vegetation, including small trees established on the slope.

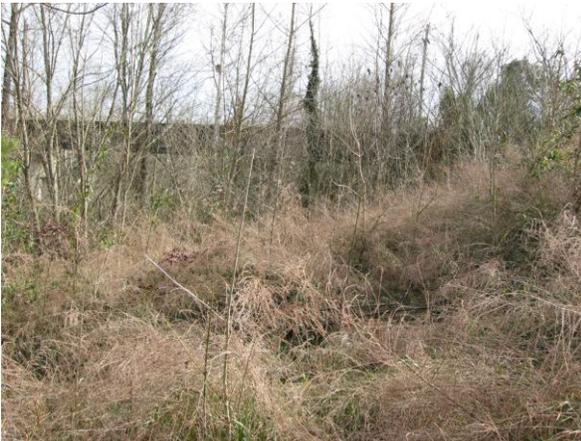
Side slope going towards Roanoke River

- 7) **The edge of the coal ash needs to be clearly marked on the Roanoke River side, to insure the setback is achieved, within two weeks of receipt of this audit. Call Mary Whaley, 919-693-5023, within two weeks to schedule a meeting at the site to insure compliance.**

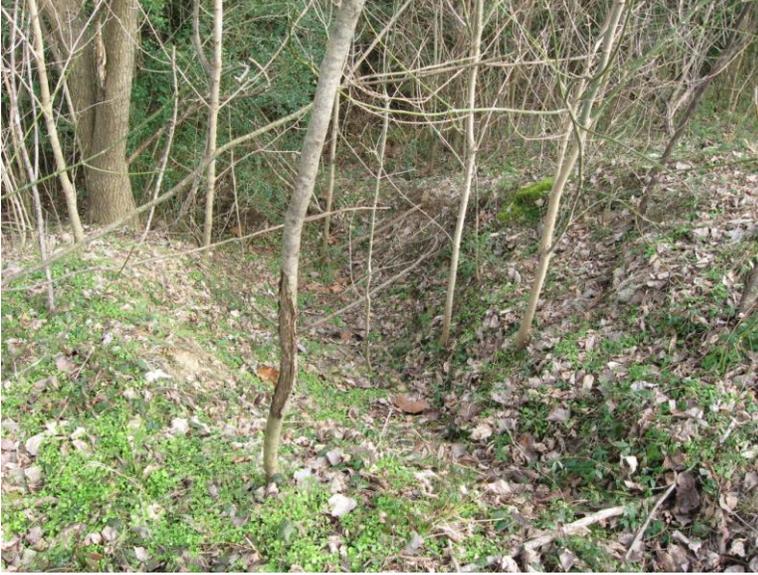
Side slope towards Roanoke River
