FACILITY COMPLIANCE AUDIT REPORT
Division of Waste Management
Solid Waste Section

UNIT TYPE: Structural Fill/CCB

BK Barringer Lots 7 & 8
 Located off Mazzeppa road, off Hwy 115.
 135 Bevan Drive, Mooresville, NC

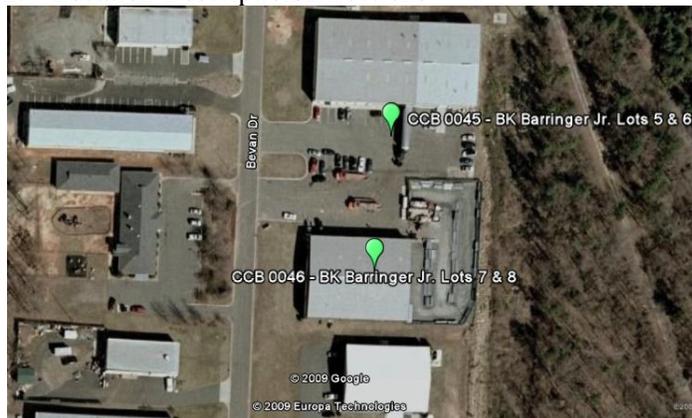
Google Earth 12/17/09

1. Historical Information
 - a. Estimated Fill Volume = 9,500 cubic yards fly ash
 - b. Proposed End Use: develop the property for marketing.
 - c. Facility Information:
2. Location Description/Directions
