**FACILITY COMPLIANCE AUDIT REPORT**  
**Division of Waste Management**  
**Solid Waste Section**

**Date of Audit:** 23 April 2010

Rocky Run LCID Landfill  
 Staten Road  
 Rocky Run, NC 28560

**Follow up** for resolution of NOV issued 16 April 2009

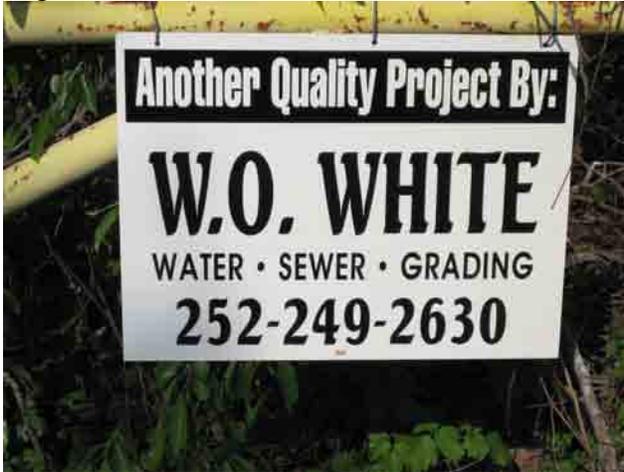
Sign posted at facility entrance

- 8) **15A NCAC 13B .0566 (16)** A sign shall be posted at the facility entrance showing the contact name and number in case of an emergency and the permit number. The permit number requirement is not applicable for facilities not requiring an individual permit. **Resolved:** A sign has been posted at the facility entrance with the facility name and emergency contact number clearly posted.

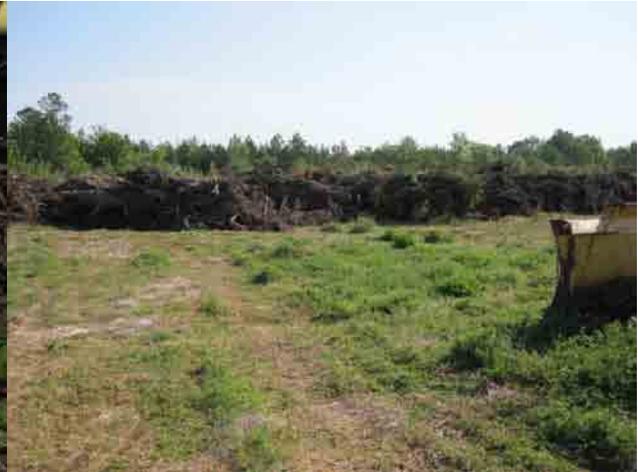
No unpermitted waste in active working area

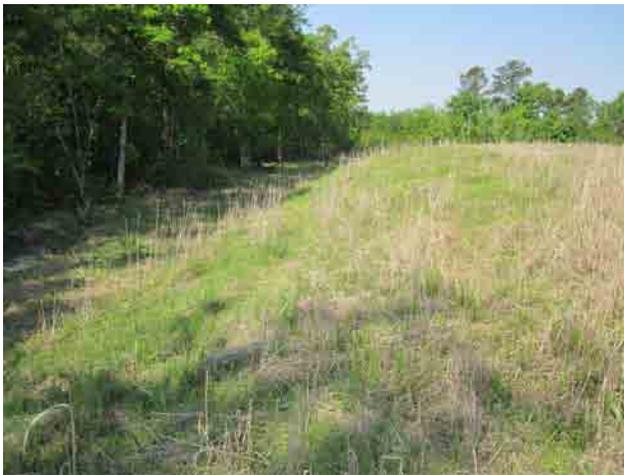
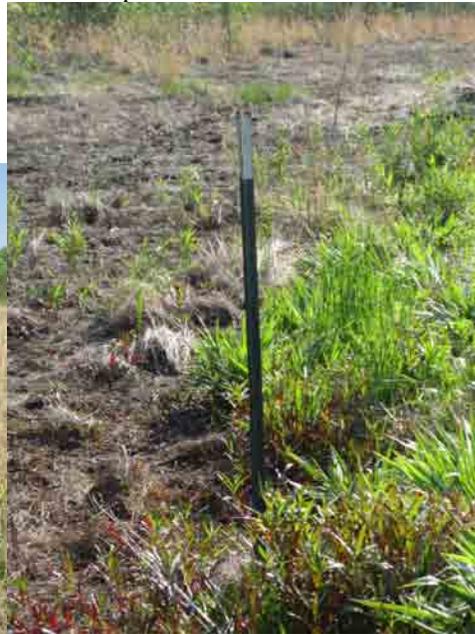
Sideslopes covered and graded, with groundcover established Boundary markers installed

- 7) **15A NCAC 13B .0566 (7)** Provisions for a ground cover sufficient to restrain erosion must be accomplished within 30 working days or 120 calendar days upon completion of any phase of landfill development. **Resolved:** The facility has been graded and seeded to establish a groundcover suitable to prevent erosion.
