FACILITY COMPLIANCE AUDIT REPORT
Division of Waste Management
Solid Waste Section

Date of Audit: 23 April 2010

Coastal Dragline Services LCID Landfill
 175 Brown Farm Road
 Vanceboro, NC 28586

Follow-up to review progress on actions taken to gain compliance with NOV issued 3 February 2010.

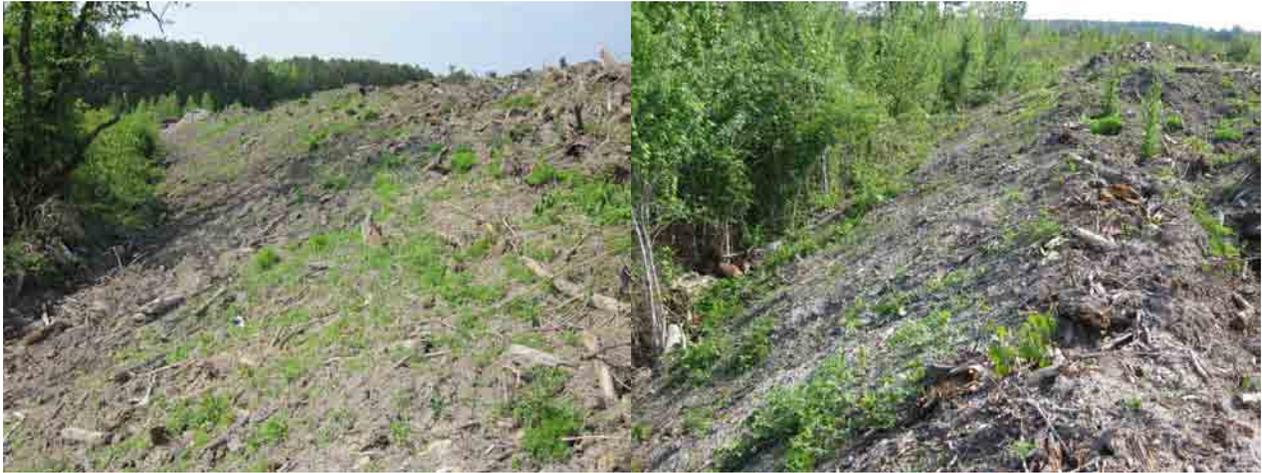
Sideslopes graded, needing groundcover established

- 3) **15A NCAC 13B .0566 (6)** Adequate erosion control measures, structures, or devices shall be utilized to prevent silt from leaving the site and to prevent excessive on site erosion. **Unresolved**
- 4) **15A NCAC 13B .0566 (7)** Provisions for a ground cover sufficient to restrain erosion must be accomplished within 30 working days or 120 calendar days upon completion of any phase of landfill development. **Unresolved**
- 5) **15A NCAC 13B .0566 (8)** The facility shall be adequately secured by means of gates, chains, berms, fences, etc. to prevent unauthorized access except when an operator is on duty. An attendant shall be on duty at all times while the landfill is open for public use to assure compliance with operational requirements and to prevent acceptance of unauthorized wastes. **Resolved:** the facility is adequately secured by means of a gate at the facility entrance.

- 5) *As per our conversation; please ensure that a groundcover suitable to prevent erosion is established on all landfill sideslopes.
- 6) The facility access road is of all weather construction and is being well maintained.

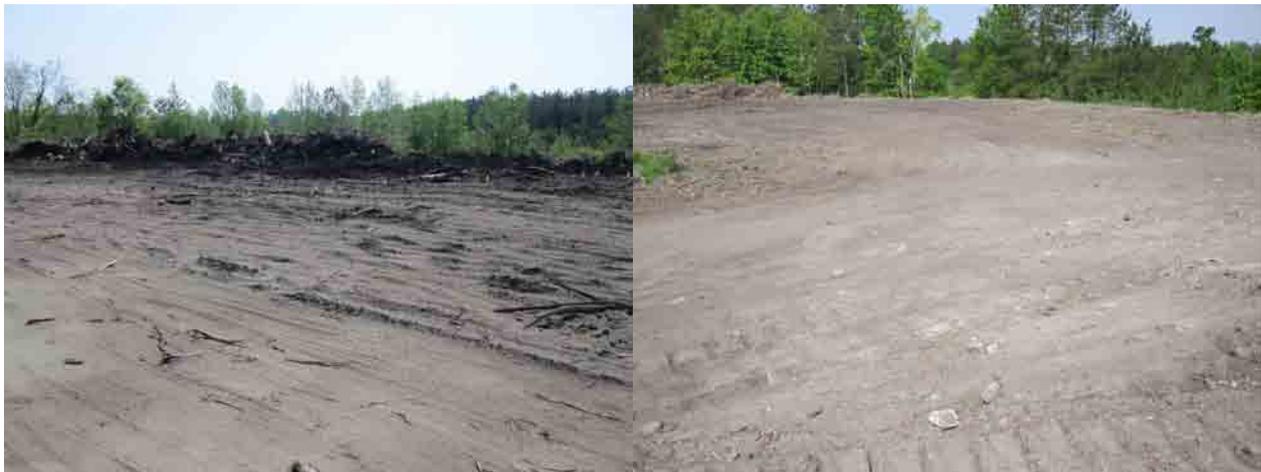
- 1) This facility is a Notified Land-clearing and Inert Debris Landfill.
- 2) The facility now has only one active working face. As per our conversation; please continue to ensure that the active working face is properly compacted and maintained in the smallest feasible area possible.

Single working face, covered and compacted

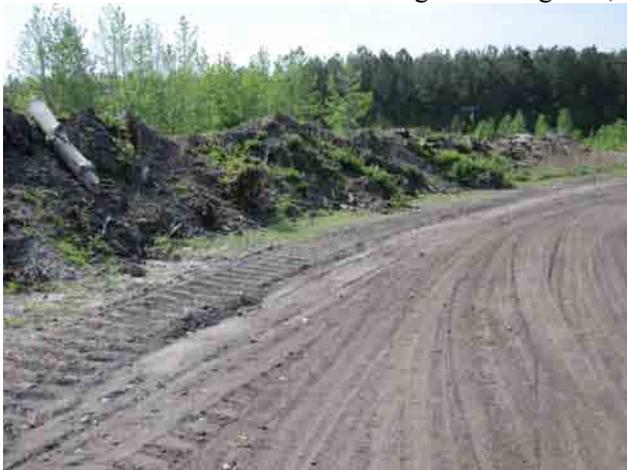
Soil for cover stockpiled adjacent to access road
