**FACILITY COMPLIANCE INSPECTION REPORT**  
**Division of Waste Management**  
**Solid Waste Section**

**Date of Site Inspection:** 26 October 2011      **Date of Last Inspection:** 6 April 2011

Dare County C&D Landfill  
 1603 Cub Road  
 Manns Harbor, NC 27953

Partial audit without records review to review TSDMS element #DS28-011 and Dare County storm debris management operations

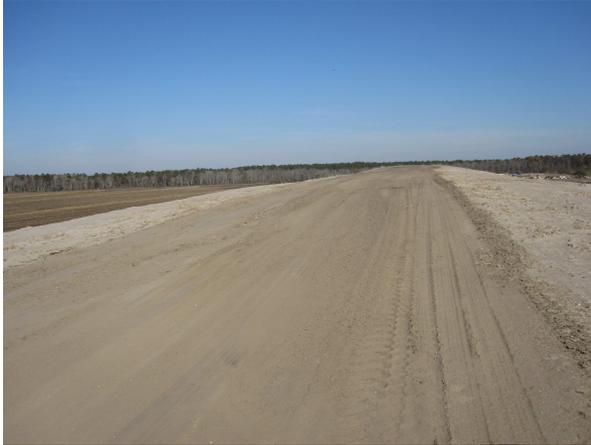
Closure progress in Cell #3

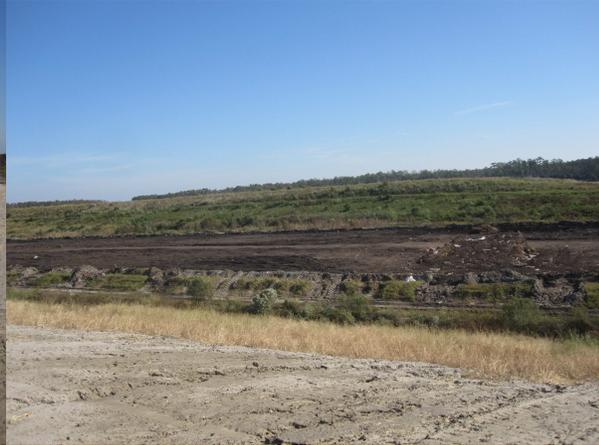
- 17) This facility is transferring all Demolition Waste generated during hurricane Irene brought on-site to the East Carolina Environmental Regional MSW Landfill, permit #08-03 in Bertie County for final disposal.

Cell #4 C&D storm debris area

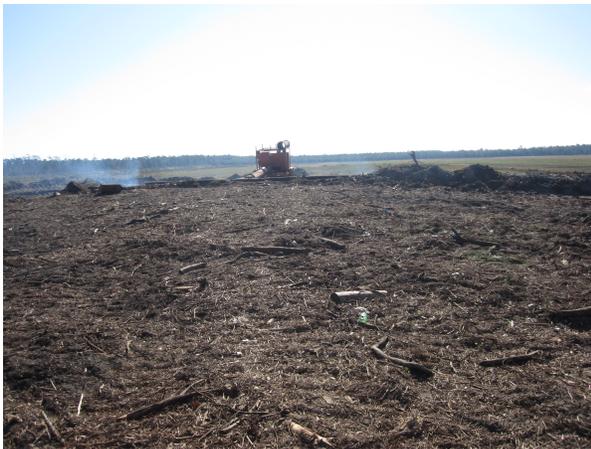
- 18) Vegetative debris generated during hurricane Irene is being staged for management with a trench-type Air Curtain Burner.
- 19) A portable Air Curtain Burner unit has been brought on site and was off-line during this site visit.

Vegetative debris management element

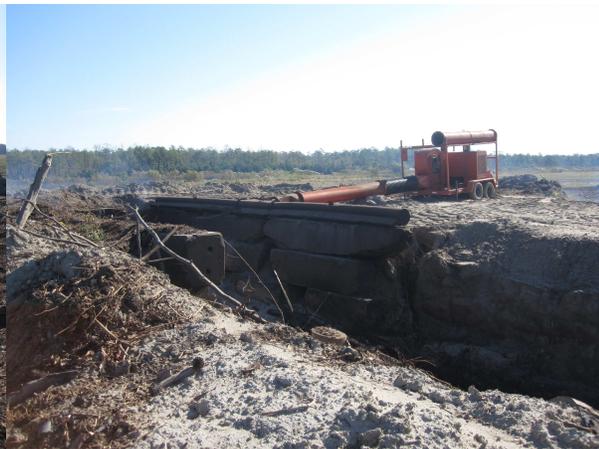
Air Curtain Burner and trench at vegetative debris element
