**FACILITY COMPLIANCE INSPECTION REPORT**  
**Division of Waste Management**  
**Solid Waste Section**

**Date of Site Inspection:** 8/4/11, 2/16/12      **Date of Last Inspection:** 5/6/11

Waste Stream Innovations (WSI)  
 4028 Haywood Road  
 Mills River, NC 28759

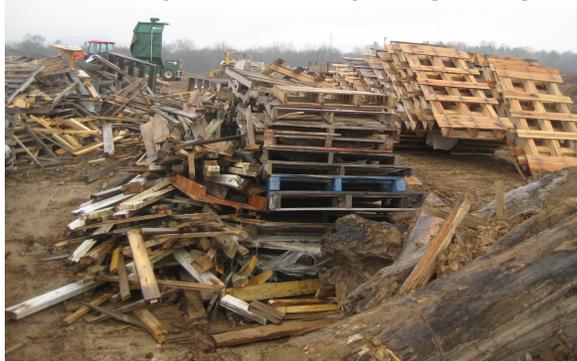
2/16/12

7. Facility access is controlled at the entrance (Haywood Rd), adequate signage was observed, roads were maintained, and operating areas were flagged.
8. Wooden pallets and Land Clearing debris at the T&P portion of the facility had been recently ground, new material was being accepted. Minimal unacceptable materials (plastics, painted boards) were noted and it was stated that they are removed by the operator prior to grinding. No issues noted.

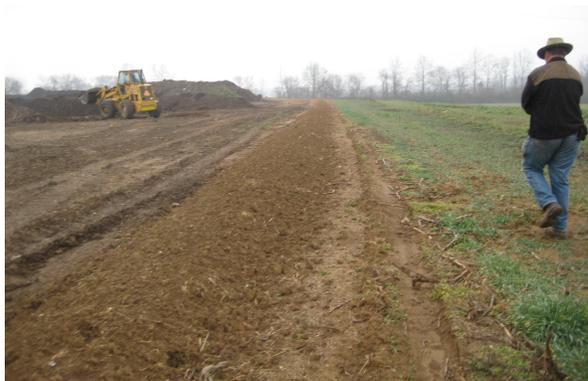
2/16/12

During the site inspection the edge of operation was bermed to prevent any compost/mulch material from leaving the working footprint. Stakes marking the edge of the facility had been damaged during operations – please replace and protect the markers.

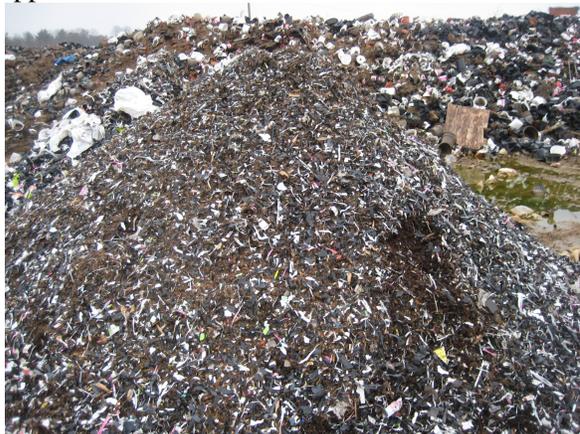
2/16/12

11. A small load of plastic materials (mixed with soils) had been ground and staged on site as part of a test process (per AHuske). Please note that your facility is not approved for the grinding of plastics. This material should be screened and containerized in order to minimize potential environmental impacts. No further grinding should occur unless the process is submitted and approved with your next demonstration approval.

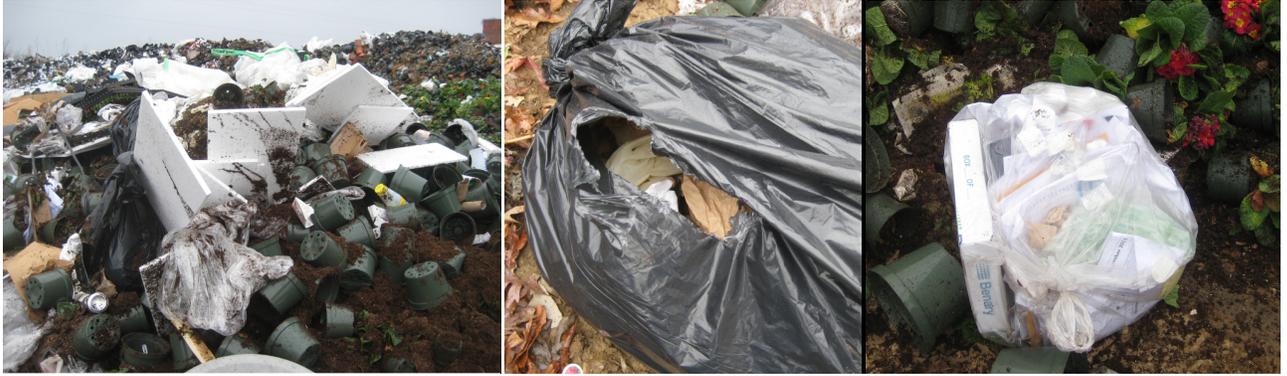
13. Incoming greenhouse-generated materials (plastics, compostable soils/plants) continue to contain wastes not approved for management or acceptance at the facility. One incoming load was reviewed, transported directly by Van Wingerden International Inc. (Fletcher, NC US DOT 358935; truck #91) – Styrofoam boards, bagged MSW waste were observed in this load. The facility must resolve this issue along with the plastics management noted in item #13, as it moves forward with the permitting process.

All materials which cannot be recovered or composted in accordance with the demonstration approval must continue to be placed in a roll-off waste container, covered, and removed to a facility permitted to receive this waste type. Please continue to containerize and properly dispose of the incidental solid waste received at the facility.
