**FACILITY COMPLIANCE INSPECTION REPORT**  
**Division of Waste Management**  
**Solid Waste Section**

**Date of Site Inspection:** January 18, 2012

Thornton Road Mixed Waste Transfer and Recycling Center  
 5565 Thornton Road  
 Raleigh, North Carolina 27616

Comprehensive Audit

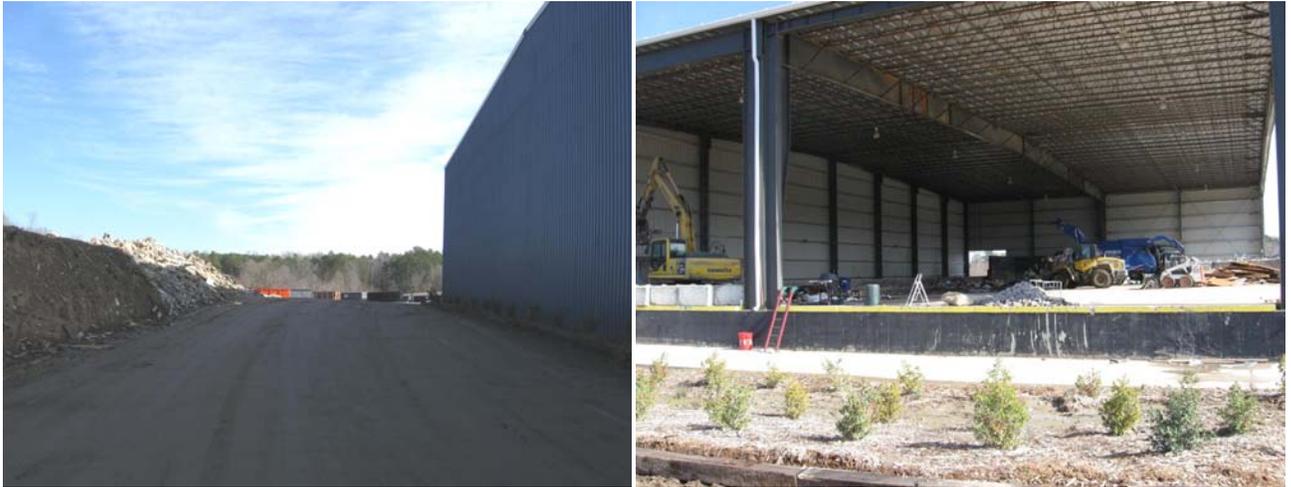
10. The facility segregates out some materials for recycling. The following are currently collected for recycling: metal, wood, some cardboard and concrete.
11. Leachate within the building is collected via floor drains both on the tipping floor and the trailer 'pit'. The drains lead to an oil/water separator and then to a connection to the City of Raleigh sanitary sewer.
12. Operations in the building were neat with the C&D waste clearly separated from the MSW waste. No blowing litter was observed outside the building during this inspection.

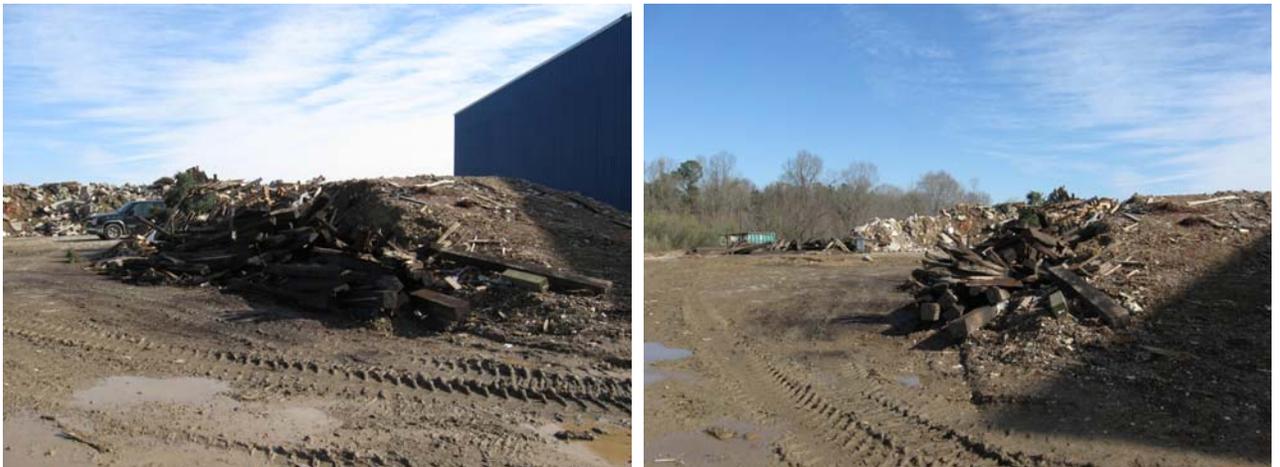
13. Railroad ties piled up on the backside of the facility need to be utilized as edging or removed from the site and properly disposed of.
