**FACILITY COMPLIANCE INSPECTION REPORT**  
**Division of Waste Management**  
**Solid Waste Section**

**Date of Site Inspection:** February 29, 2012

Highway 55 C&D Landfill, LLC  
 5940 Old Smithfield Road  
 Apex, NC 27502

Comprehensive Audit

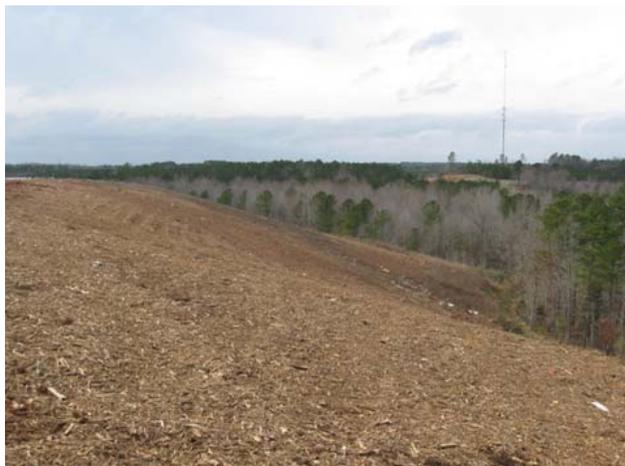
North slope - well graded but heavily mulched.

11. Operational cover is well maintained to promote runoff of surface water. No standing water was observed within the waste footprint during this inspection. **If mulch is being used as a soil amendment, it should be no deeper than 3 inches and vegetative groundcover sufficient to restrain erosion should be established.**
12. **Windblown waste was observed at the toe of the eastern slope. Ensure that windblown is collected at the end of each day and disposed of in the landfill.**

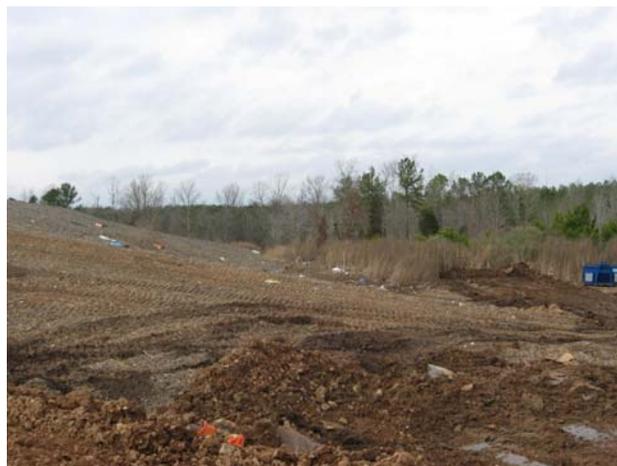
Toe of eastern slope.

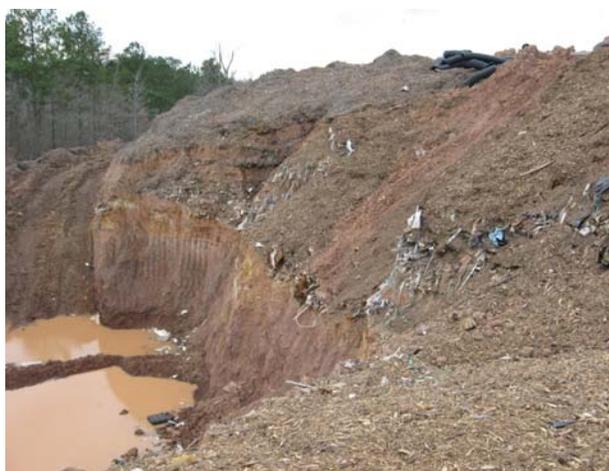
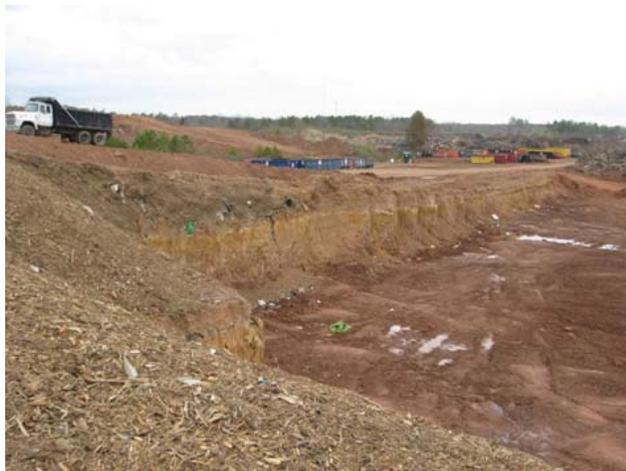
13. Material in the composting area is being maintained in windrows. Grinding of the materials is currently being performed by a contractor.
14. Concrete is stockpiled onsite and ground periodically. According to Mr. Jones, concrete was last ground about 6 months ago. Parts have been ordered for the crusher and crushing will resume after the crusher has been repaired. **The concrete storage and crushing area should be shown on the Site Plan.**
15. **Construction of Phase 2 had exposed buried waste at the time of the inspection. A small amount of waste had also fallen from the side slope and into standing water at the bottom of the excavation. Waste must not be disposed of in standing water. Corrective actions were underway during the audit. Positive drainage must be provided in all areas where waste disposal is occurring.**

**15A NCAC 13B .0542(I)( 3) *Solid waste must not be disposed of in water.***
